Sustainable Development Plan

Grout Remediation Plan - Site 2

West Wallsend Colliery

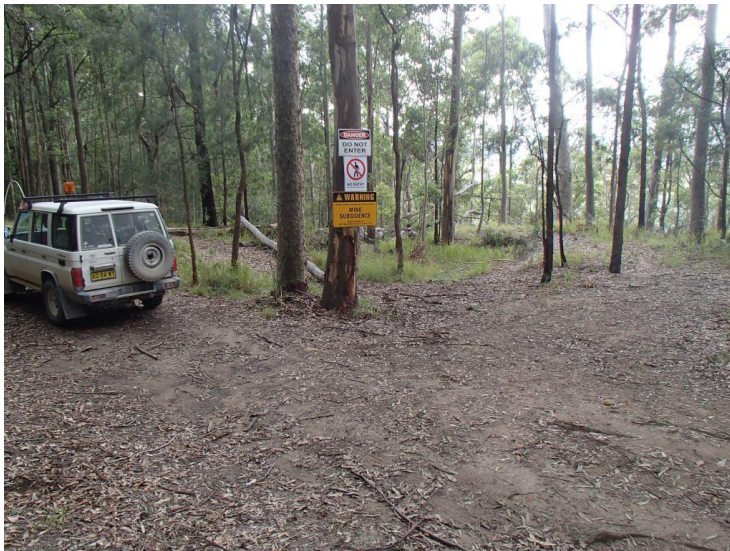
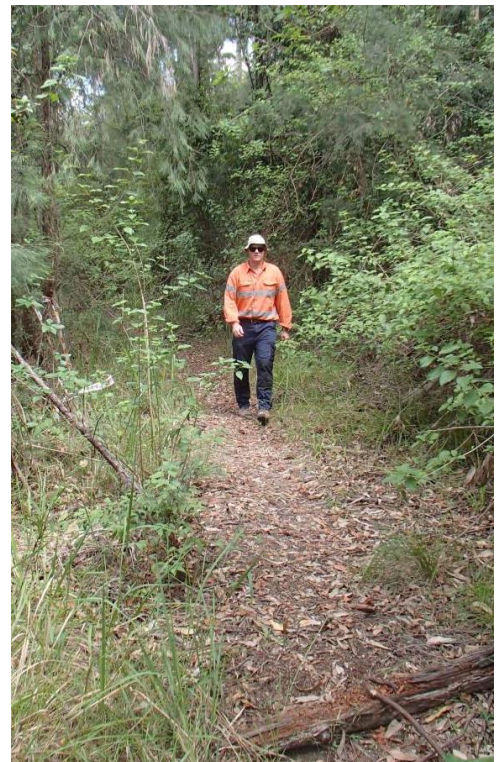
Photo 1 and 2. Existing Car Parking area that will be used and typical existing foot track to the remediation area

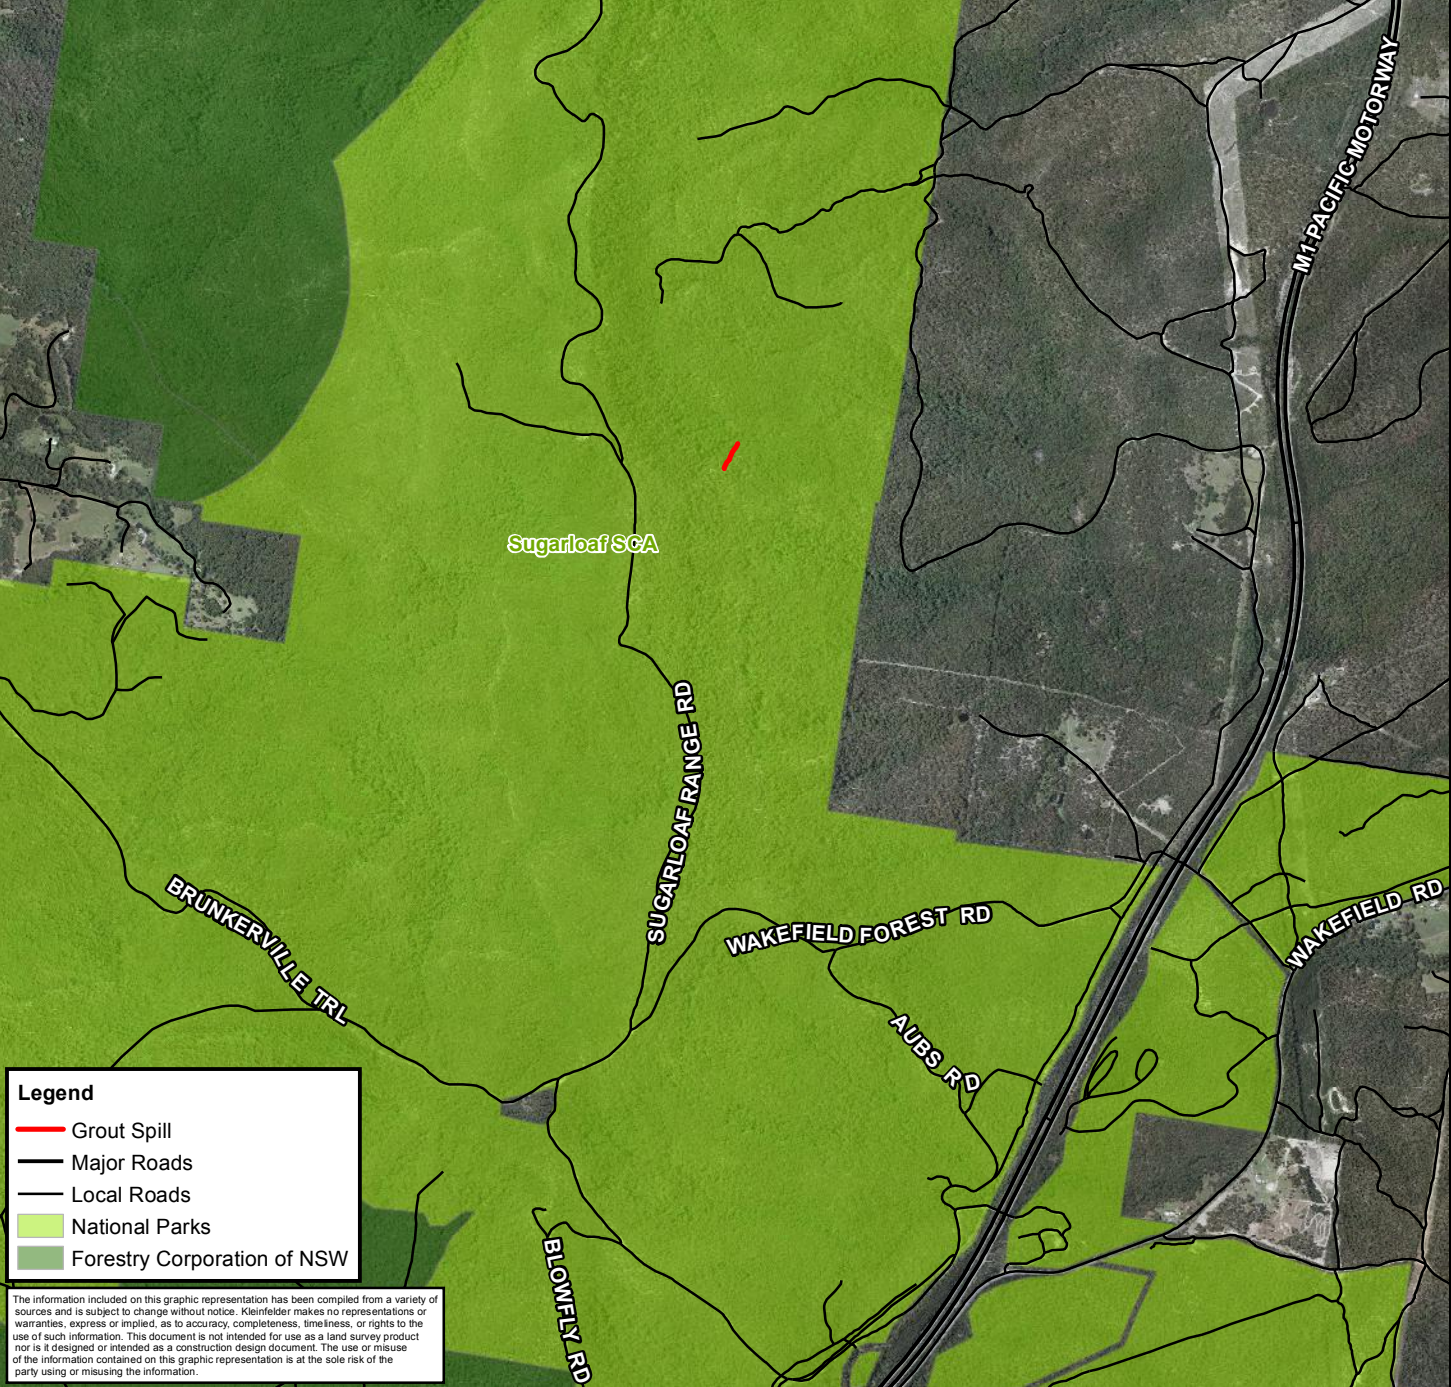
FIGURE: 1

At approximately 1pm on 20 September 2013, two ecologists from Umwelt who were engaged by WWC to undertake biodiversity monitoring at a site toward the northern extent of Longwall 41, identified the presence of the approved grouting product (Air – O – Cem), down slope of a previously remediated subsidence crack in the SSCA. Following the notification of the potential incident, WWC immediately conducted a site inspection of the affected area. Following confirmation of the incident, notifications to the relevant authorities were made by Oceanic Coal Australia Ltd (OCAL). **Figure 1** shows the location of the grout affected area within the SSCA.

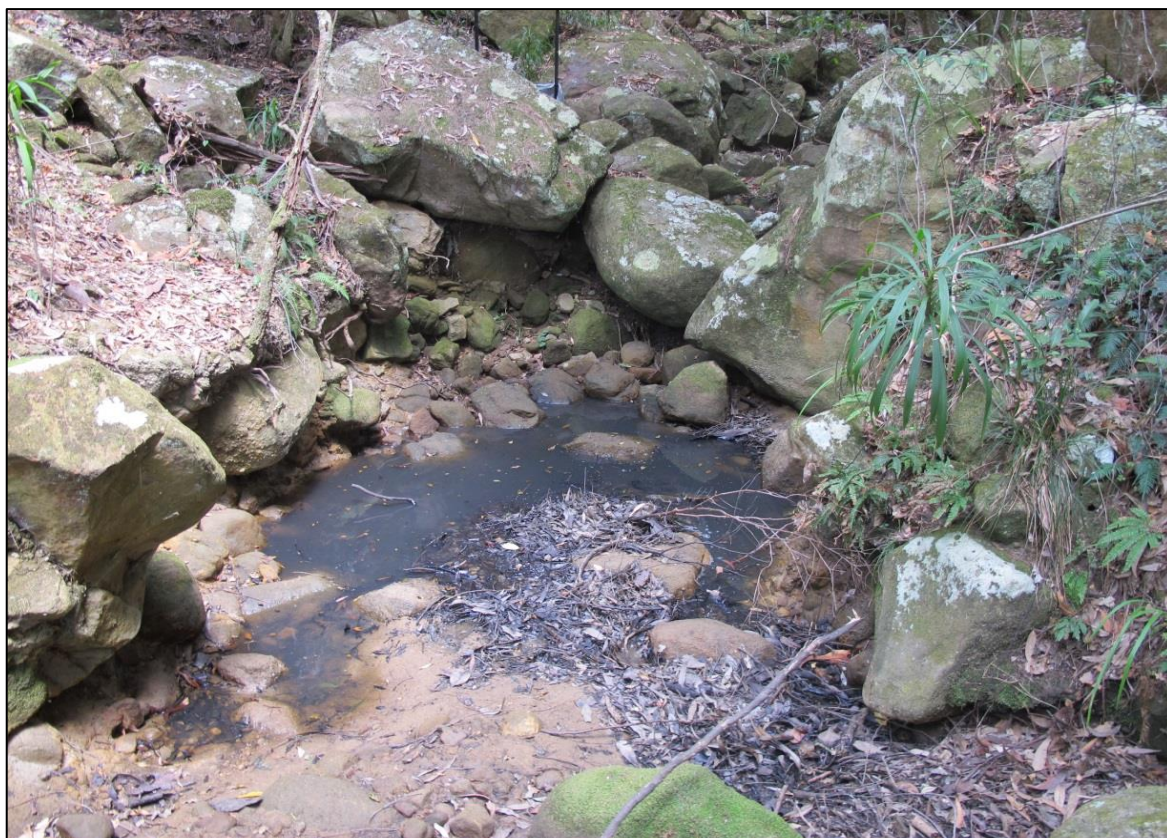
Plate 5: Minor Pooling Location 1

As part of the assessment, a survey of approximately 2 km downstream within the drainage channel below the affected area was undertaken to identify any permanent water bodies that may be present. There were no permanent water bodies identified during the survey. Three locations within the affected drainage channel (**Figure 4**) were noticed to be holding small pools of water and the habitat characteristics at each location were very similar and consisted of pooling water within the rock lines channel (**Plates 5, 6 & 7**).

Detrital accumulations within each habitat were dense and consisted mainly of leaves and woody debris from falling vegetation. The water was stained brown due to detrital accumulation (i.e. tannins from native flora). An anoxic odour was evident, which is an indicator of decomposing vegetation. Fauna habitat includes the associated vegetation (riparian areas), woody debris around the edges of the water, the water column and the benthic environment. No aquatic flora (macrophytes) was identified.
