Me-Mel (Goat Island) 1925 Electric Tower Crane

Assessment and Consideration of Structural Issues

Prepared for NSW National Parks and Wildlife Service / 21 October 2024

221366

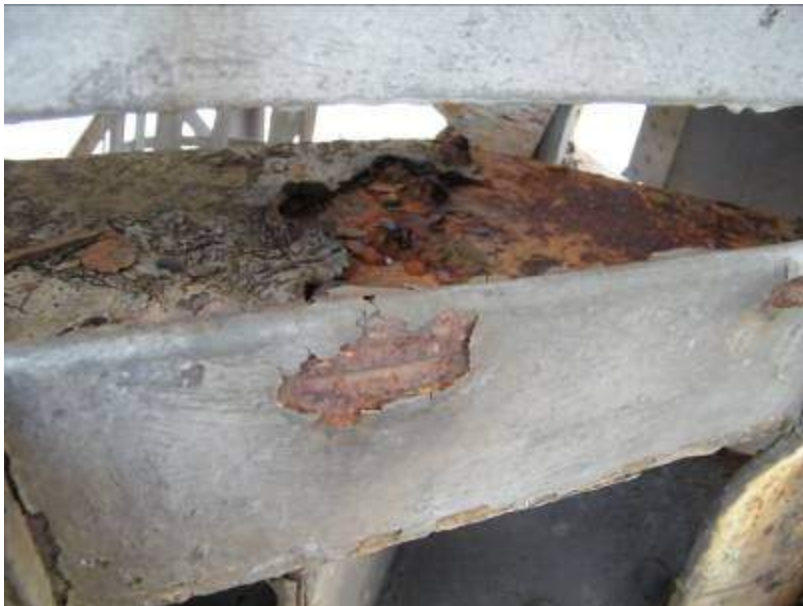
Figure 2 Typical Severe Corrosion - Rivet heads completely corroded away

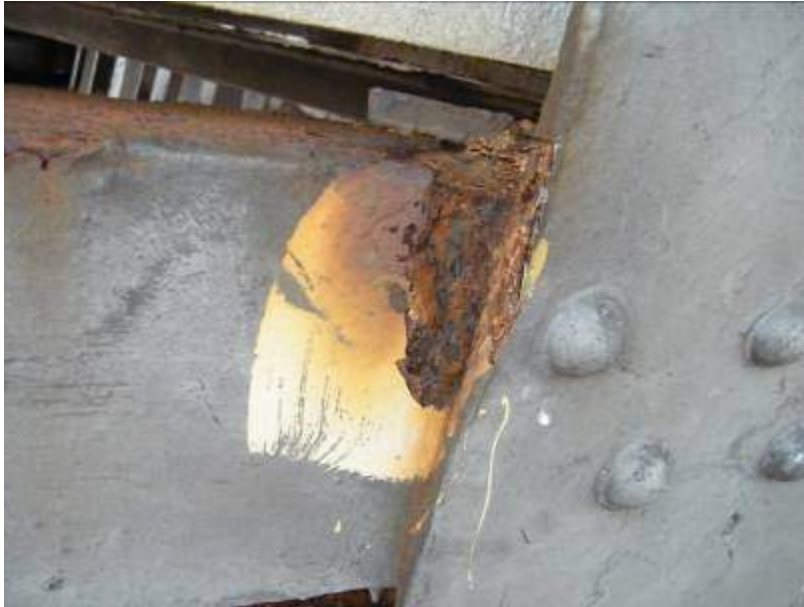
Figure 3 Typical severe corrosion

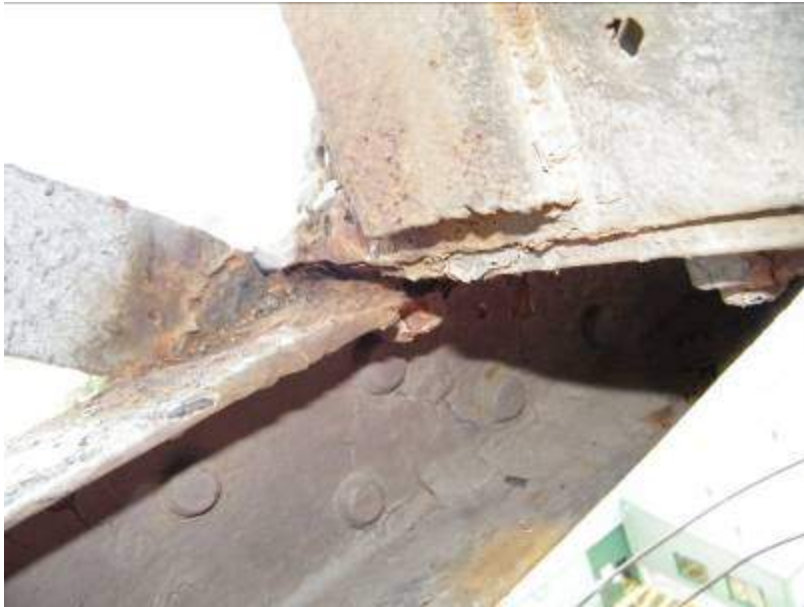
Figure 4 Main structural members reduced in thickness by over 50% by corrosion damage

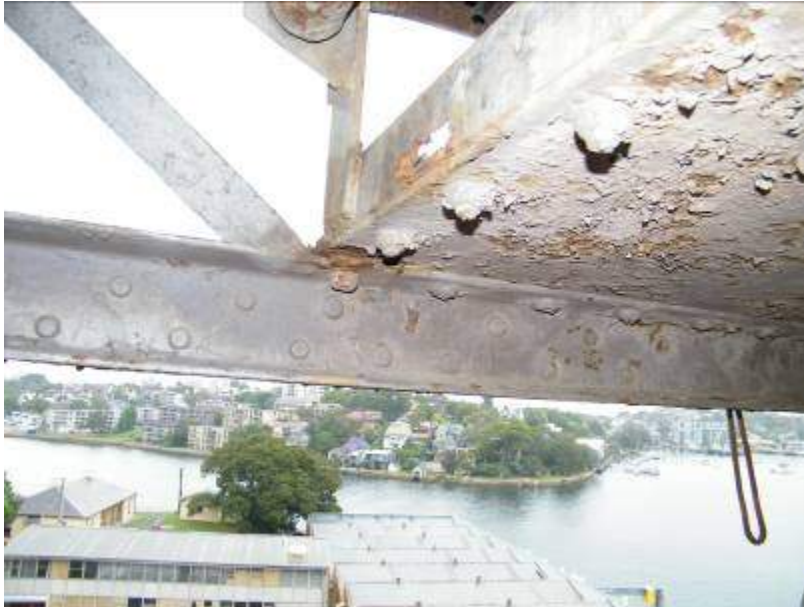
Figure 5 Excessive corrosion on racking winch mount

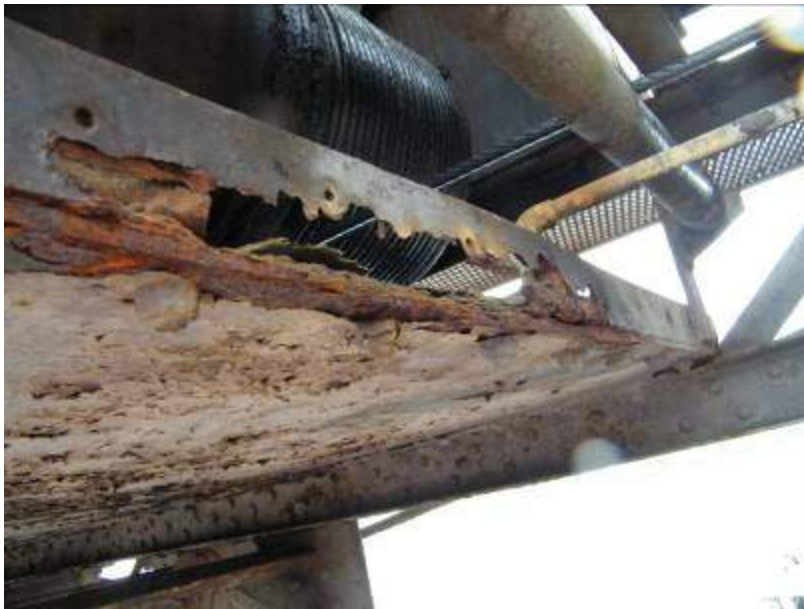
Figure 6 Excessive Corrosion on racking winch mount

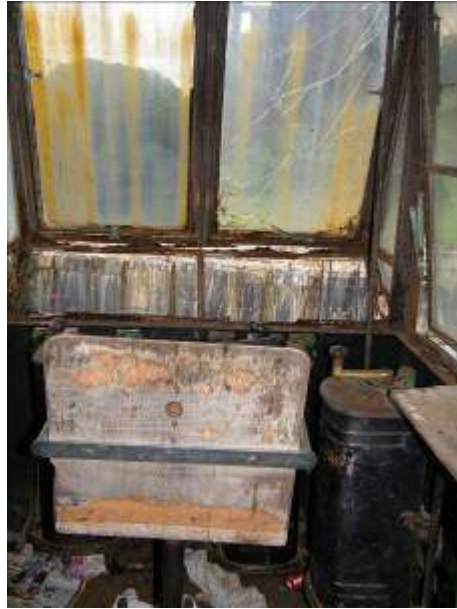
Figure 7 Damaged window in main control cabin

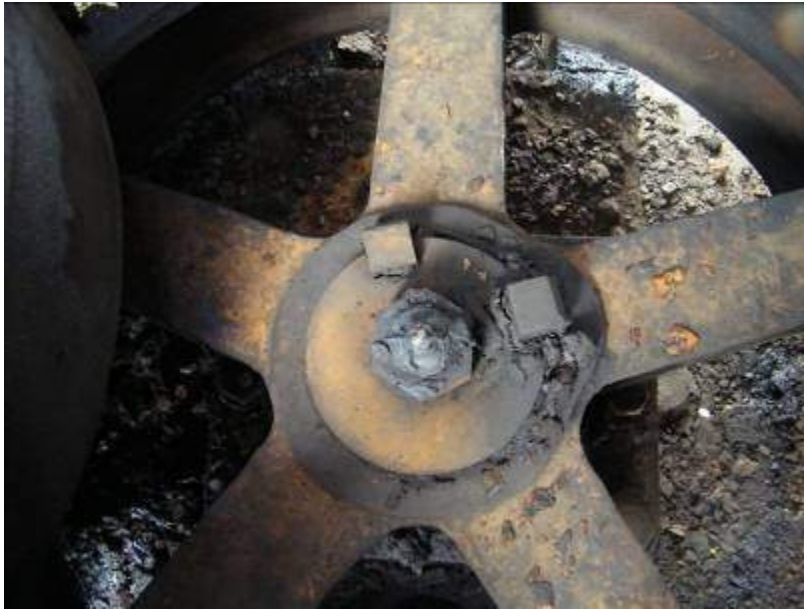
Figure 8 Worn Keyway on main slewing gear

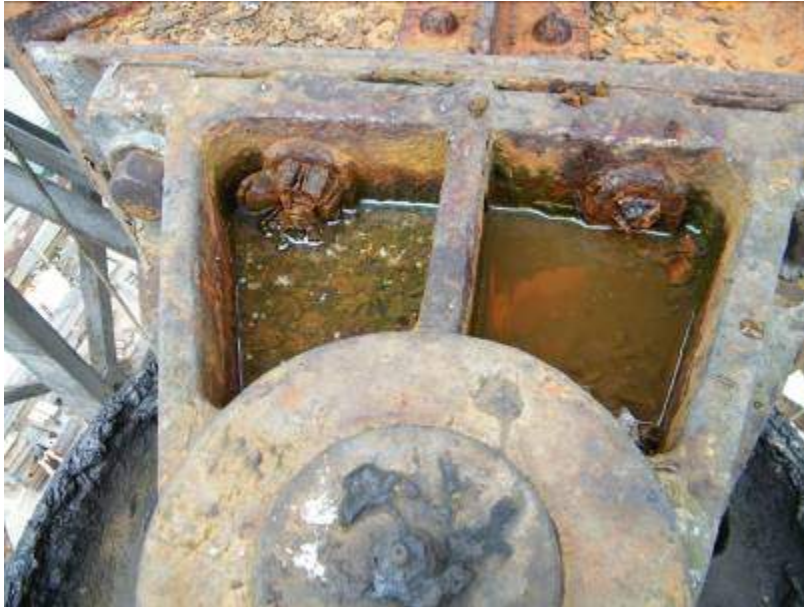
Figure 9 Bolt heads removed by corrosion damage on slew rollers

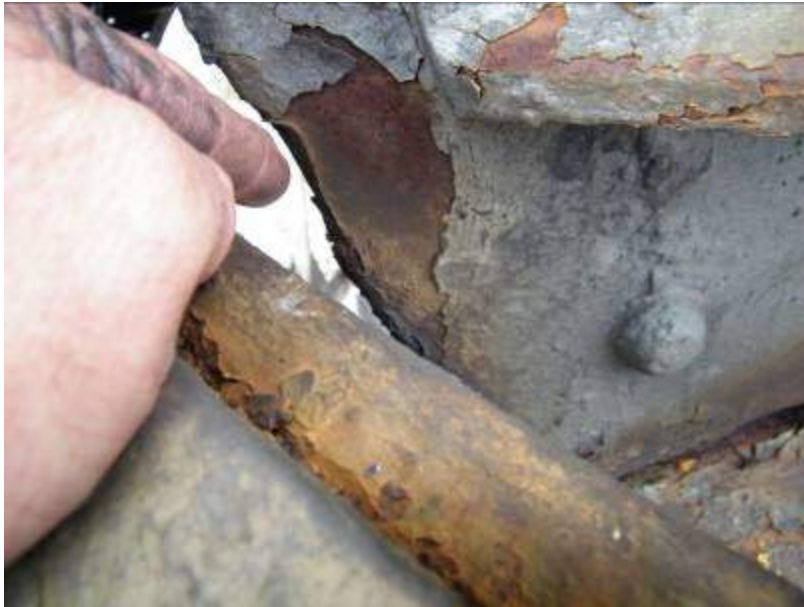
Figure 10 Evidence of impact between frame and slew ring

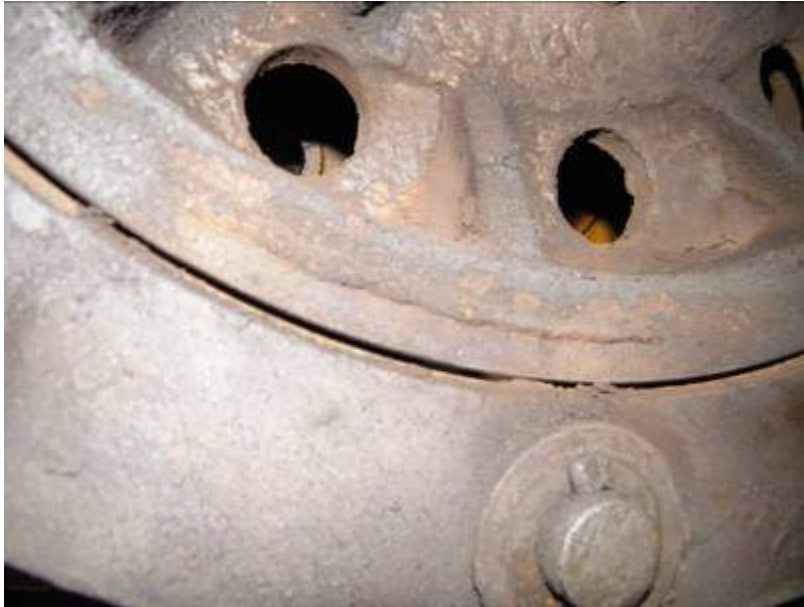
Figure 11 Main Winch Brake - Brake pad material requires replacement

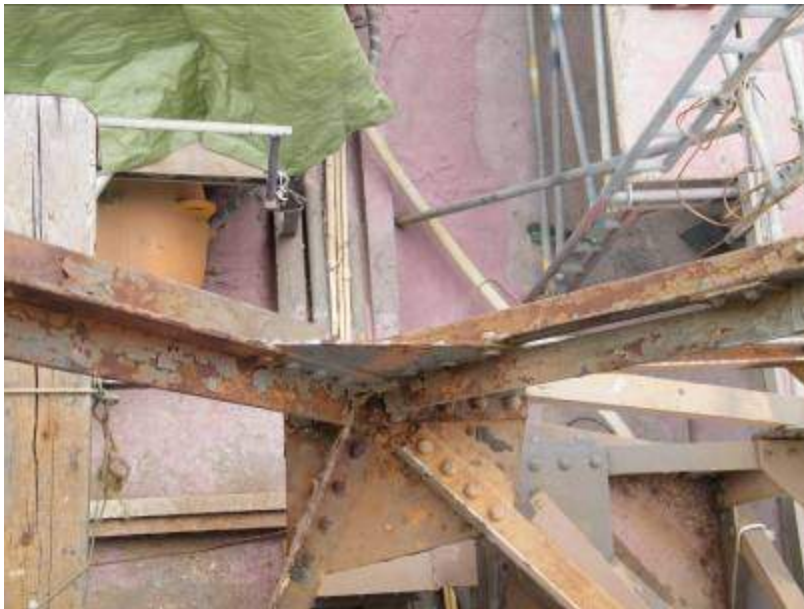
Figure 12 Typical Flaking Paint

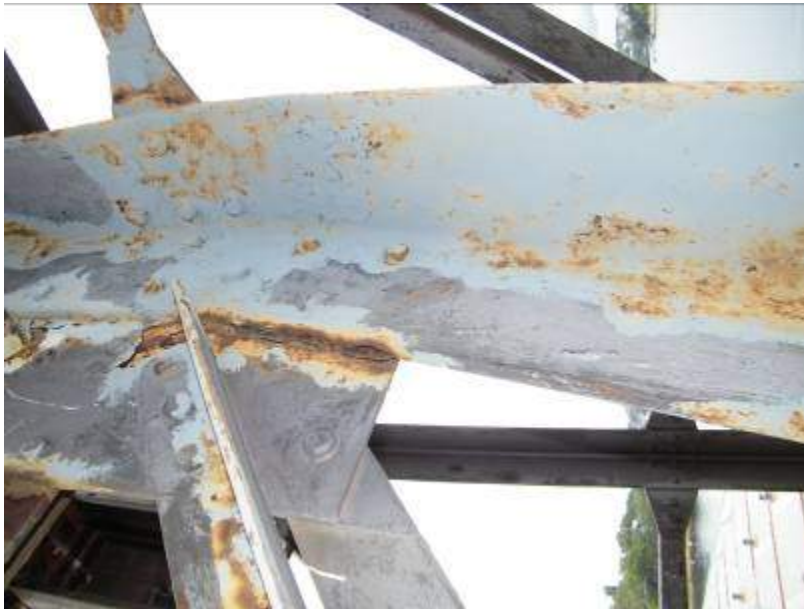
Figure 13 Corrosion between plates

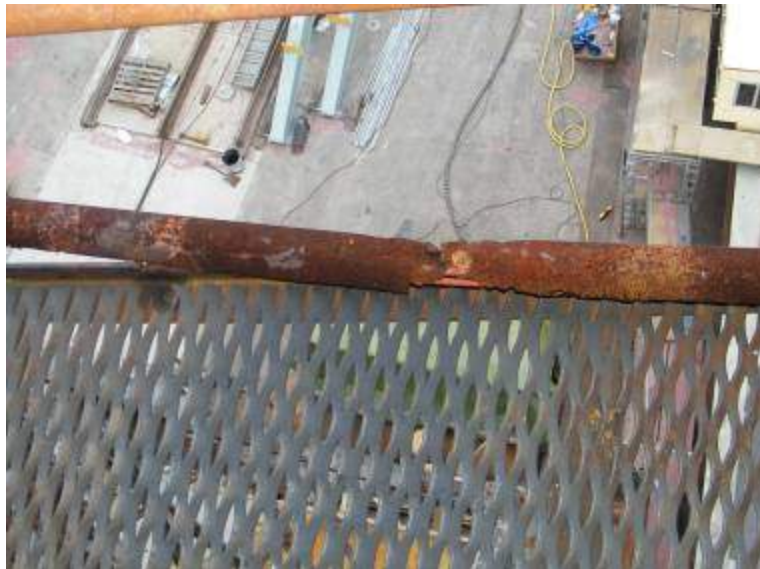
Figure 14 Severely corroded electrical conduit

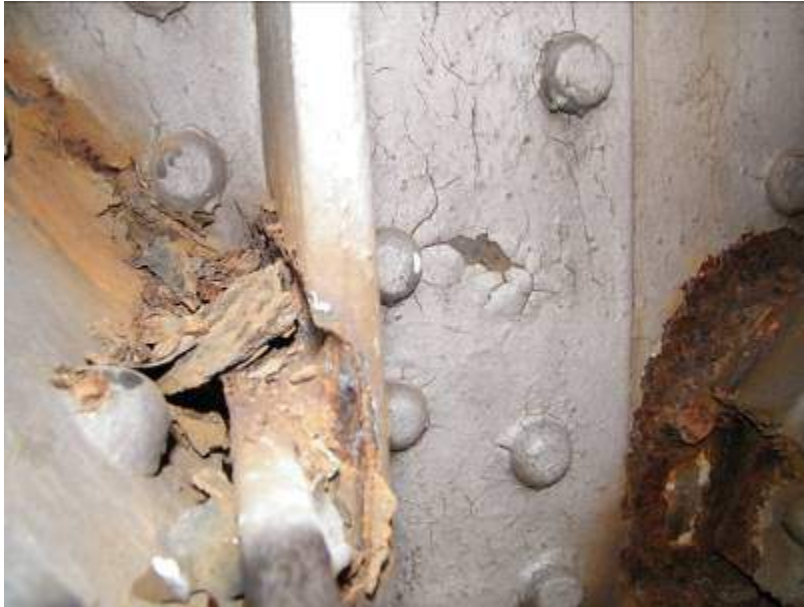
Figure 15 Severe corrosion in main frame plates

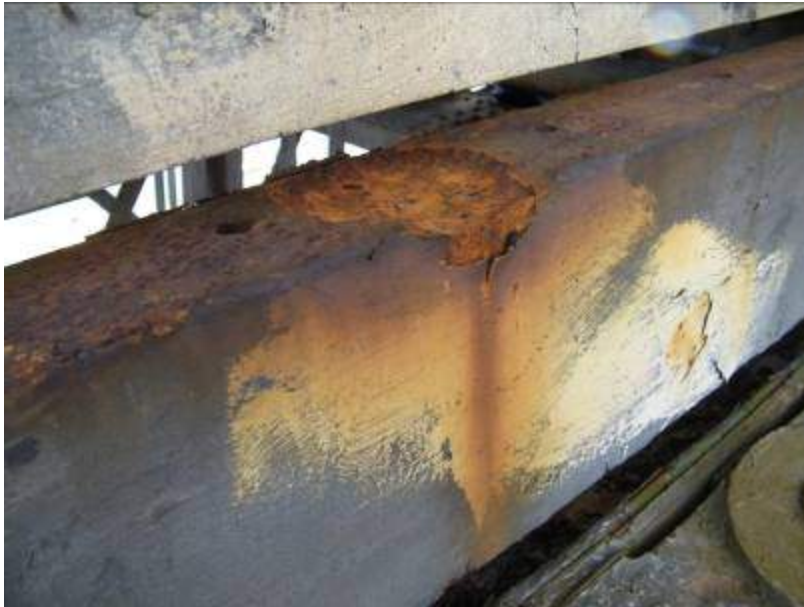
Figure 16 Corrosion in main boom structure

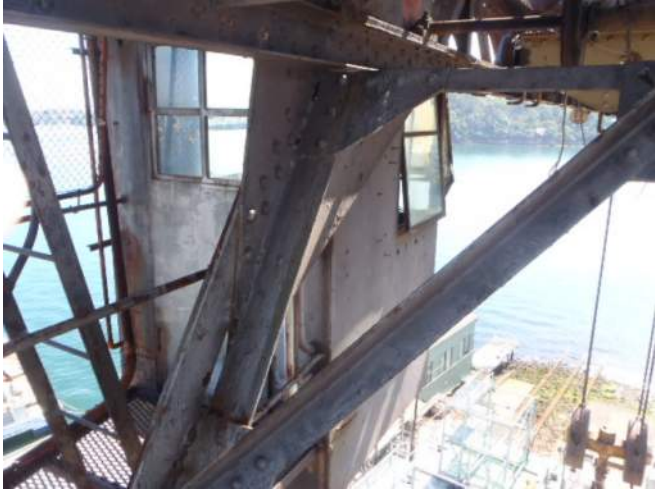
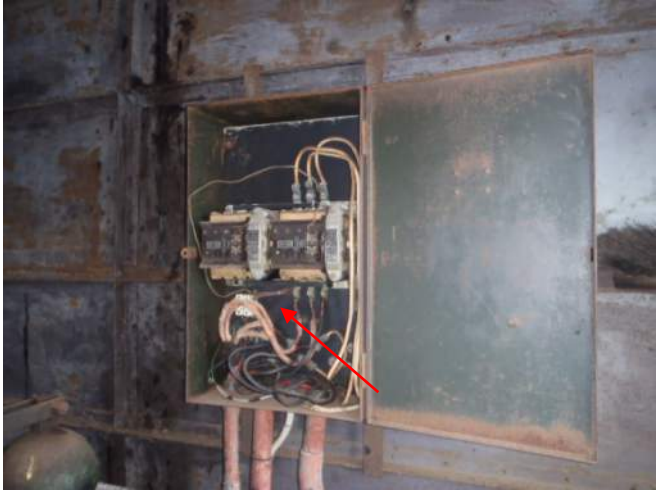
Photograph: 3356	Photograph: 3305
Description: High content lead grey paint to external steel frames and walls to rooms	Description: Presumed asbestos resin electrical mounting board to cabinet wall & asbestos paper internal to fuses
Locations Found: Externals	Locations Found: Rear motor room

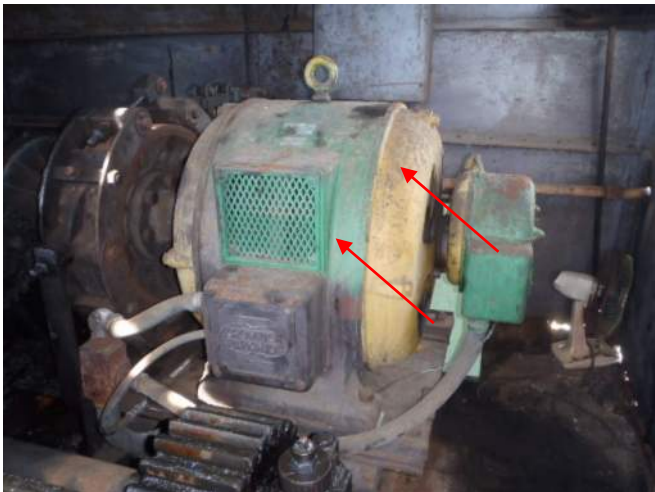
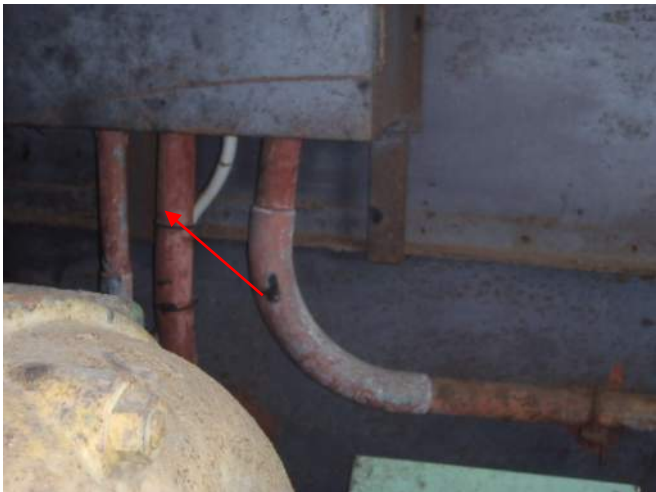
Photograph: 3309	Photograph: 3313
Description: Medium content lead to yellow and green paint to motor	Description: High content lead red paint to electrical pipes
Locations Found: Rear motor room	Locations Found: Rear motor room

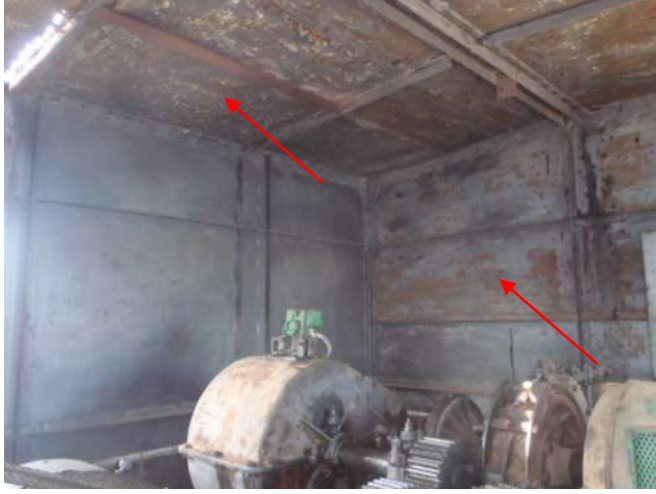
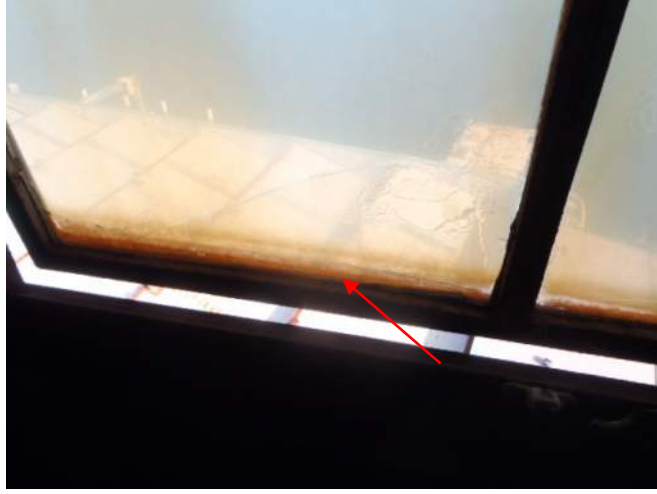
Photograph: 3315	Photograph: 3317
Description: High content lead grey paint to walls and roof	Description: Asbestos putty to windows
Locations Found: Rear motor room	Locations Found: Rear motor room
