NSW National Parks and Wildlife Service

# NSW alpine resorts environmental performance report 2020–21

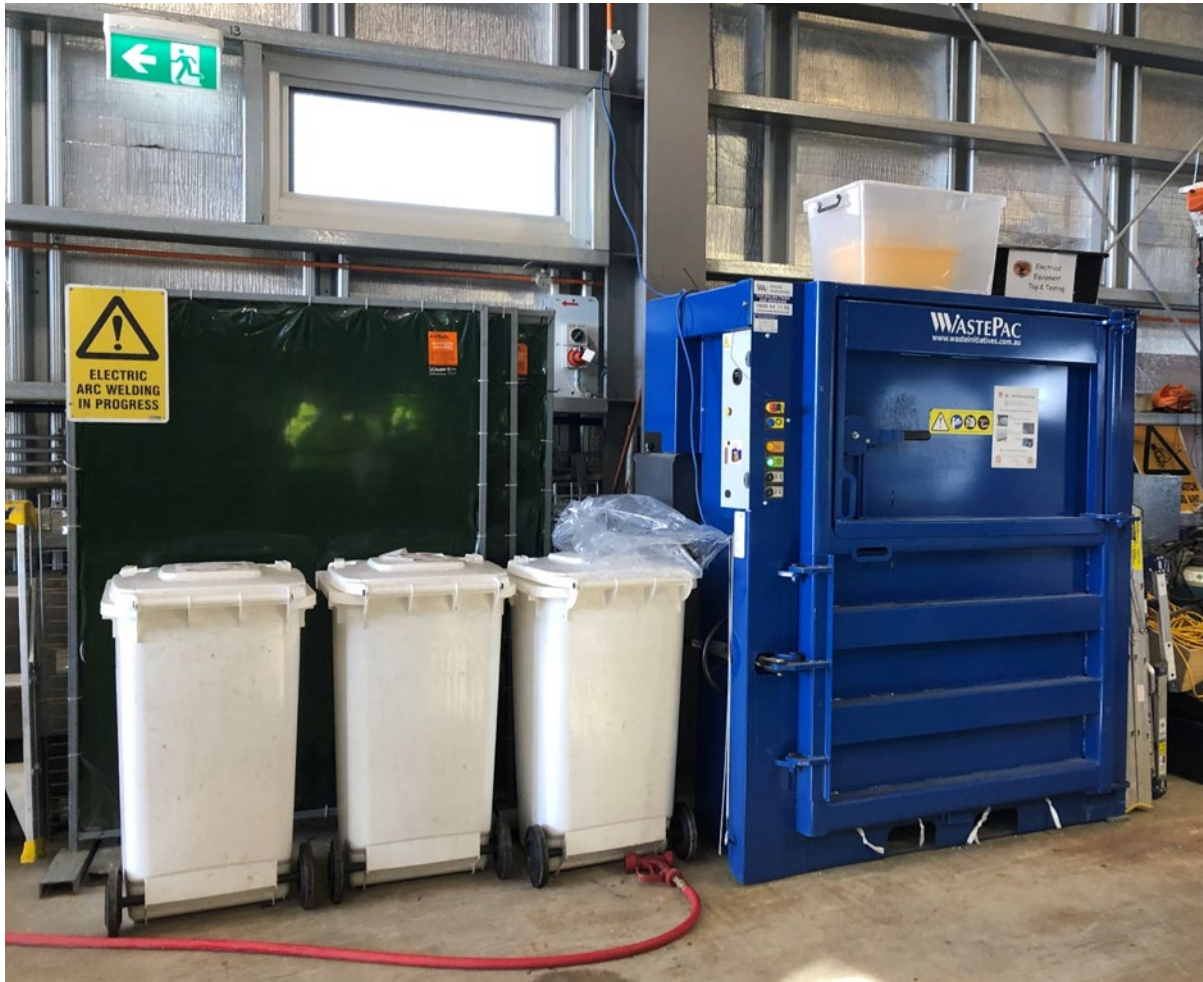
The soft plastics will be baled and stored, before being transported to Albury. Once there, the plastics will be made into a variety of useful products by a local company, Plastic Forests.

Image 5 Soft plastic baler in the NPWS Perisher Valley Waste Transfer Station. Photo: E Stafford/DCCEEW

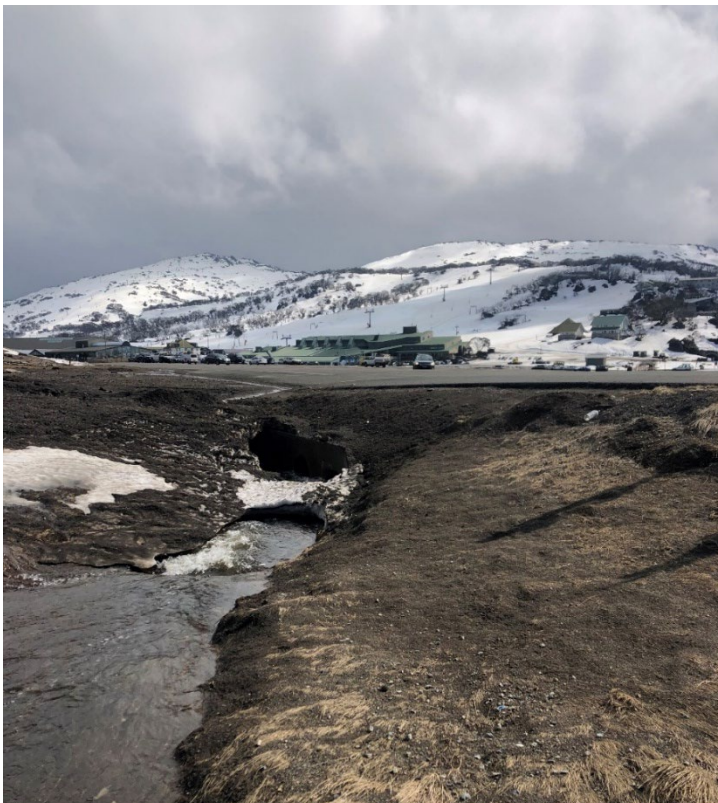
**Image 9** Gravel and asphalt removed from the Perisher Ski Resort car park surfaces during winter snow clearing, deposited into the surrounding creek and bog area. Photo: E Stafford/DCCEEW

- The overall number of reported pollution incidents reduced. The number of snow hydraulic fluid leaks over winter 2020 (5) remained similar to winter 2019 (7), indicating that alpine resort operations are continuing regular maintenance schedules for their over-snow vehicles.
- The impact from snow clearing activities on the surrounding waterways and riparian areas should continue to be monitored by NPWS and the alpine resorts. NPWS and alpine resort operators should investigate alternative clearing methods and undertake remediation at the end of each season to reduce the impact.
