Addendum 1

Goat Island Conservation Management Plan 2011

for the 4-10 Tons Fixed Electric Tower Crane.

Goat Island, Sydney Harbour National Park.

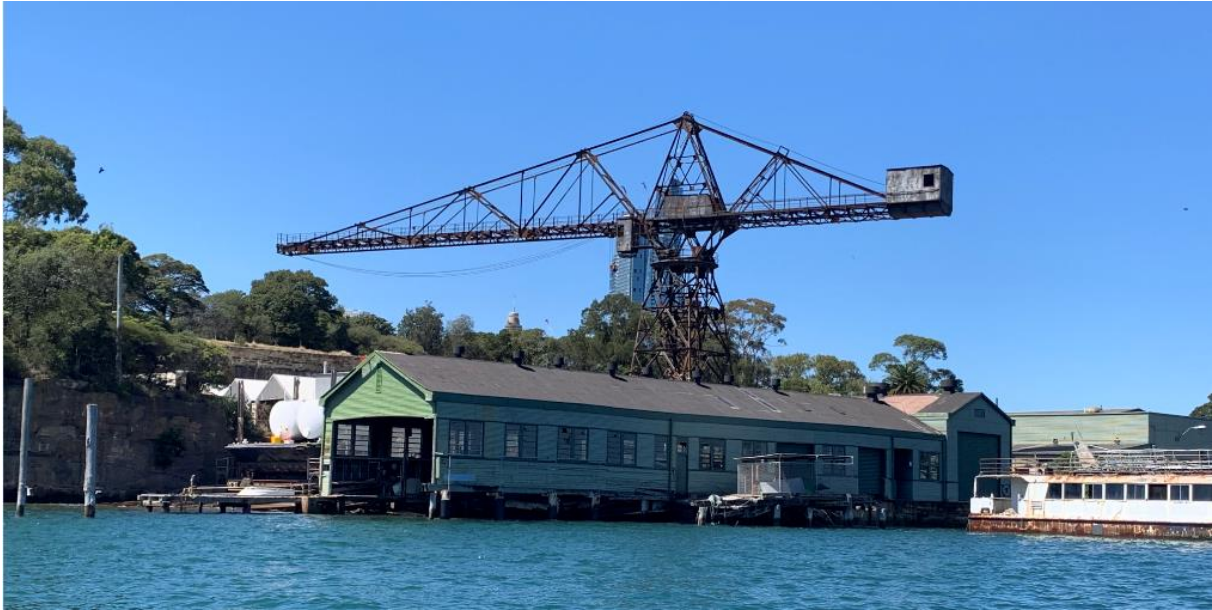
When seen from waters to the west of the island the crane's profile towers above the shipyard buildings (Figure 5).

Figure 5: The Tower Crane over the Shipyard and Magazine precincts (R Newton/NPWS)

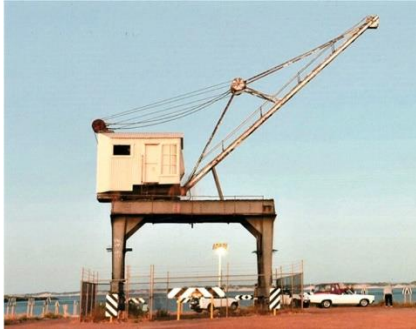
An Arrol designed mobile electric crane stands at Bunbury Harbour Western Australia (Figure 7). The jetty crane was originally erected in 1911 on the Bunbury Timber Jetty and travelled on rails along the jetty. It was decommissioned in 1982 and moved to near the end of the jetty causeway. The crane is identified by its inscribed plate 'Sir William Arrol and Co Ltd Parkhead Glasgow Order 543 Load 3 Tons 1911' (Figure 8).

Figure 7: Arrol designed Bunbury Jetty Crane 1911 (inherit.stateheritage.wa.gov.au)

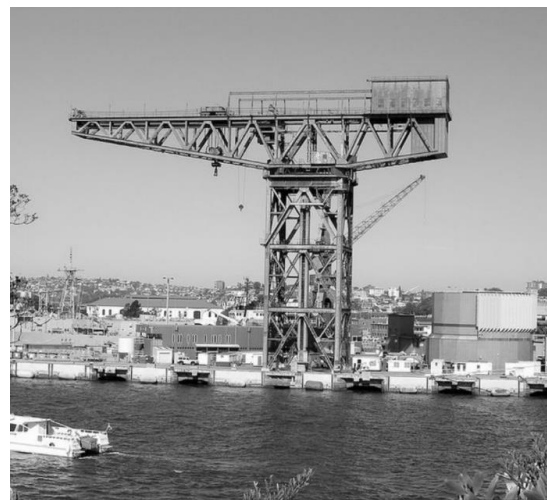
Figure 10: The Garden Island 250T cantilever crane

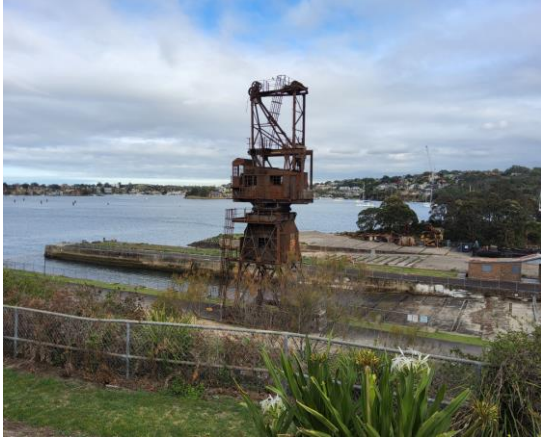
Figure 95: Northern Slipway Travelling Crane, Crane Number C300, with jib removed since 2019 for safety (Ed Beebe/NPWS)

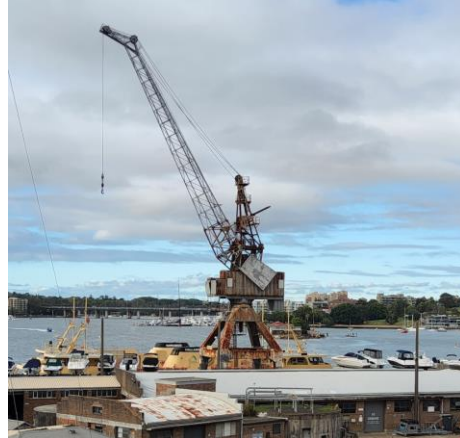
Figure 106: Southerland Wharf Electric Portal Travelling Jib Crane, Crane Number C277 (NPWS/Ed Beebe Nov 23)

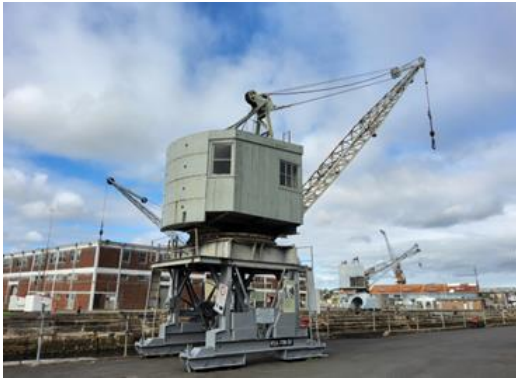
Figure 117: The northern of the two Electric Travelling Jib Cranes, AFD Crane 1, Crane Number C226 (NPWS/Ed Beebe)

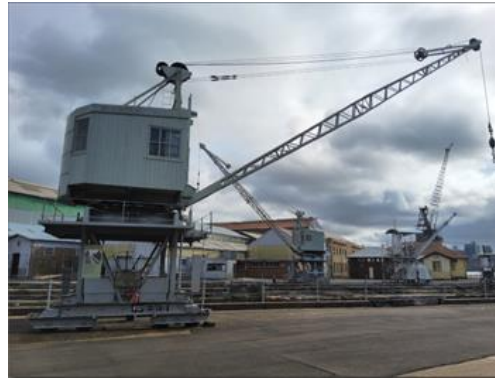
Figure 128: The southern of the two Electric Travelling Jib Cranes, AFD Crane 2, Crane Number C227 (Ed Beebe/NPWS)

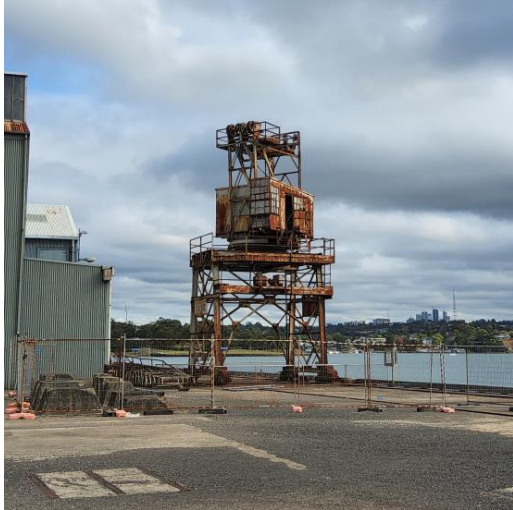
Figure 214: Cruiser Wharf Travelling Jib Crane, Crane Number C60, with jib removed since 2019 for safety.
Source NPWS/Ed Beebe Nov 23

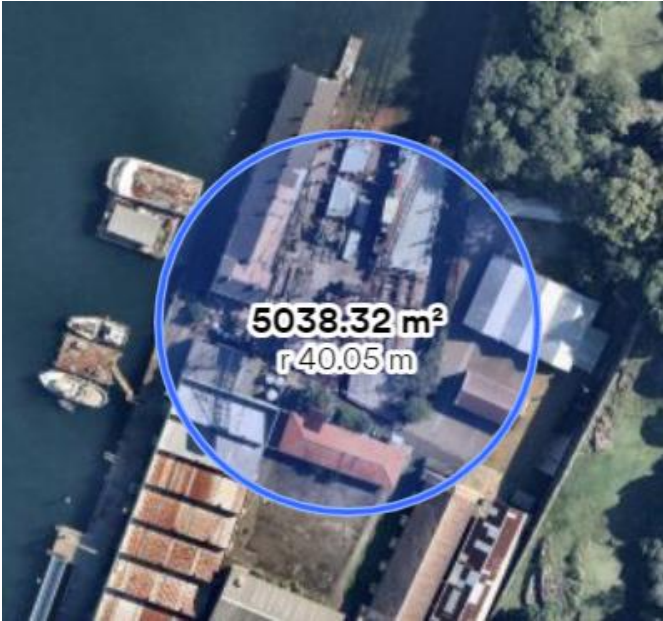
Furthermore, the need to ensure that the crane swings freely on its slew with the wind means that the crane jib routinely swings over elements of exceptional significance, including the Queens Magazine and Cooperage with risk of falling debris causing irreversible damage to these buildings. The Magazine and Shipyard precincts will also remain unavailable for public access as the risk to public safety cannot be eliminated while the crane continues to rotate over these areas. This risk also affects any future uses of these precincts.

Figure 21: The radius of the jib rotation (Nearmap, 2024)

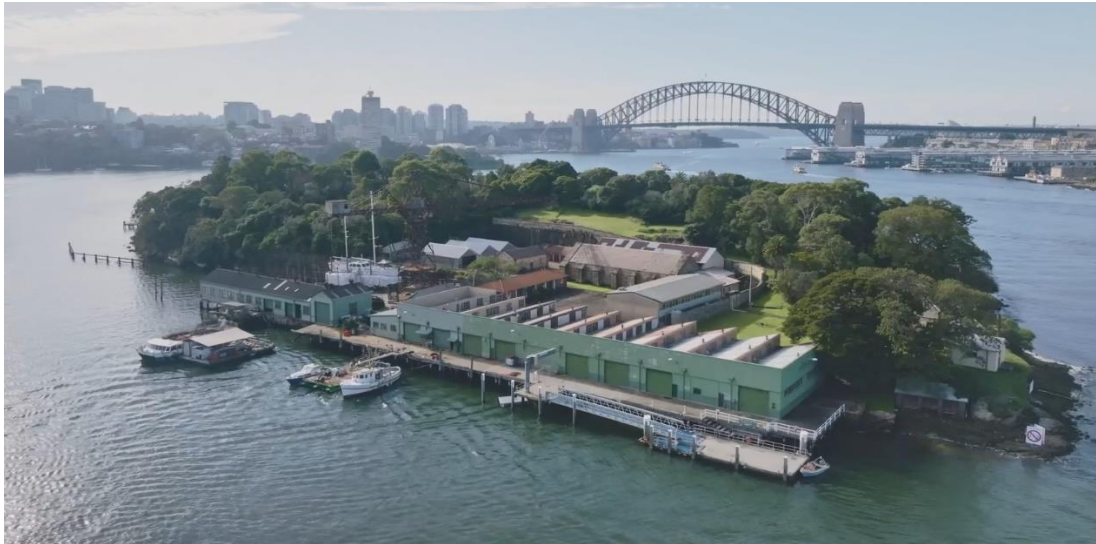
Figure 306 Current photograph looking from the southwest showing the shipyard and its Broadside wharf, the 2008 pontoon, the Shipyard slipways, the crane and 1940s workshops and ancillary buildings in the foreground. The 1830s Magazine within its compound wall is beyond the shipyard. (NPWS May 2022)

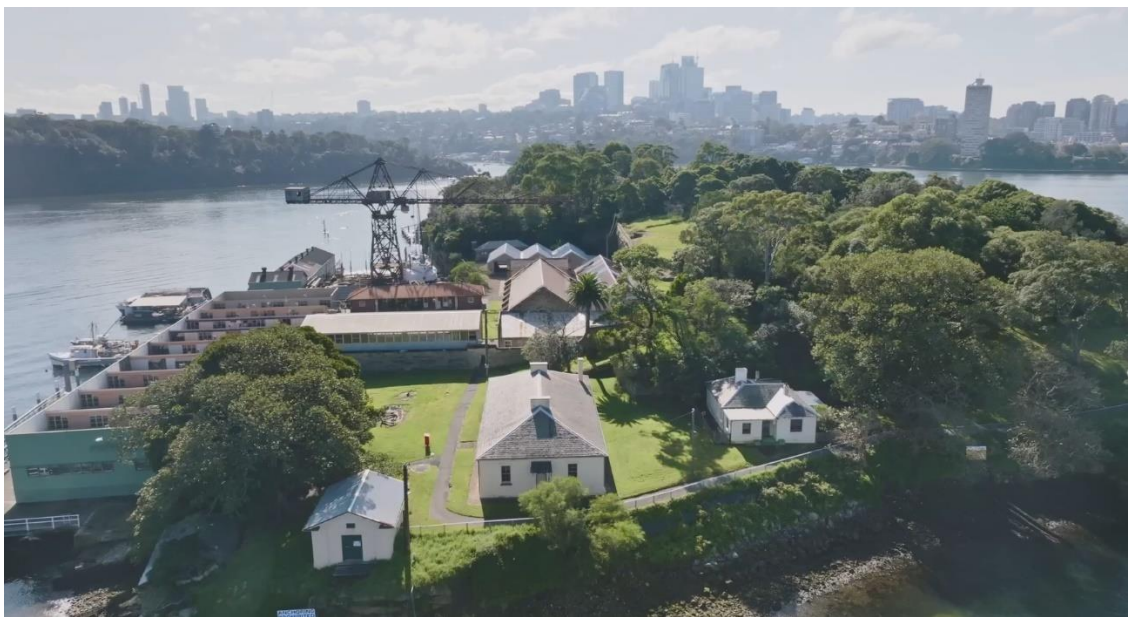
Figure 37 The Tower Crane over-sailing the Powder magazine Cooperage (NPWS 2022)

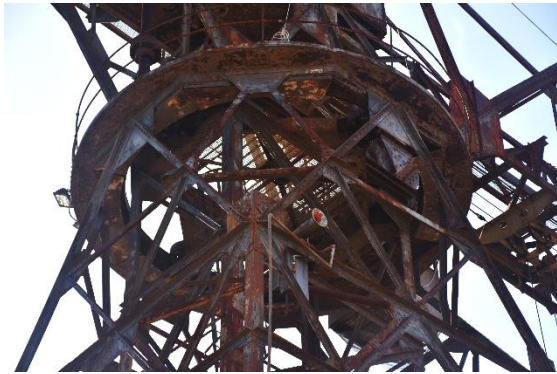
The crane structure is heavily corroded, with considerable loss of thickness on some members. There is crevice corrosion at joints and between plates, where rainwater collects, and the integrity of rivets between members has not been assessed.

Figure 3831. Looking up to the slew ring under the jib showing extensive corrosion. (TTW, June 2022)

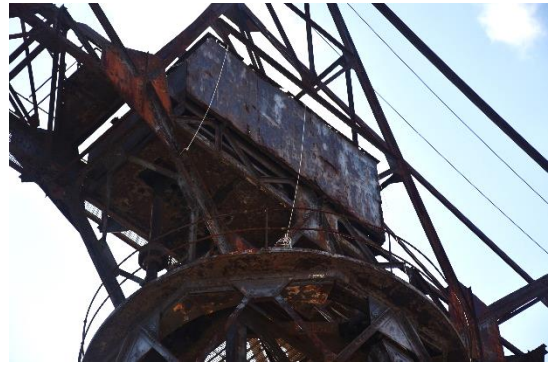
Figure 39. Looking up to the underside of the motor room showing extensive corrosion. (TTW, June 2022)

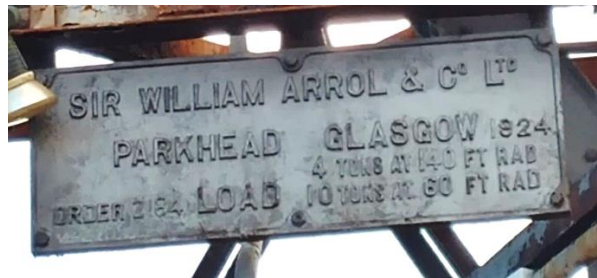
Figure 353. The manufacturer's plaque bolted to the tower. (TTW, June 2022)

If the crane is removed the manufacturer's plaque should be retained and used on-site to interpret the crane's history. Other elements of the crane could also be retained for purpose of interpreting the crane, providing these can be easily conserved and don't create a risk to visitors.

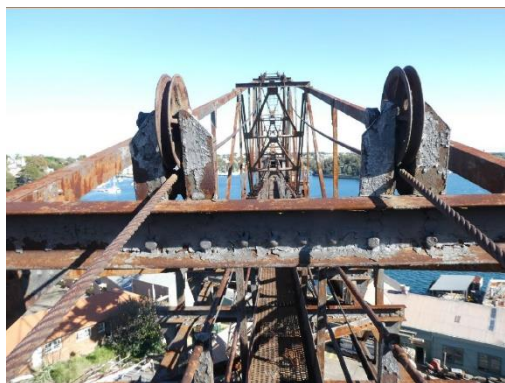
Figure 44. Looking along the jib when the crane was last climbed by an engineer showing extensive corrosion and paint loss (Arcadis, July 2021)

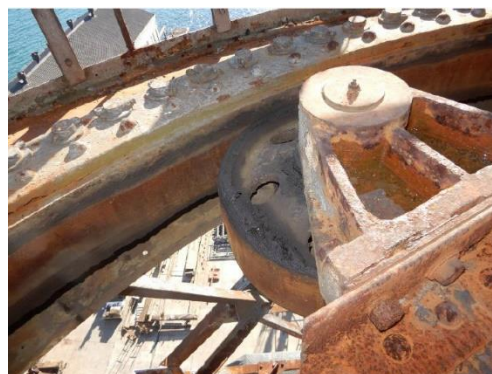
Figure 436. Looking at the slew ring mechanism when the crane was last climbed by an engineer showing corrosion. (Arcadis, July 2021)

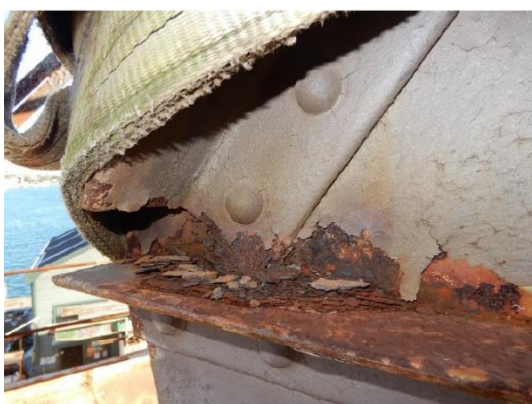
Figure 46. Looking at the bottom of the rotating mechanism when the crane was last climbed by an engineer showing extensive corrosion (Arcadis July 2021)
