Me-Mel (Goat Island) 1925 Electric Tower Crane

Assessment and Consideration of Structural Issues

Prepared for NSW National Parks and Wildlife Service / 21 October 2024

221366

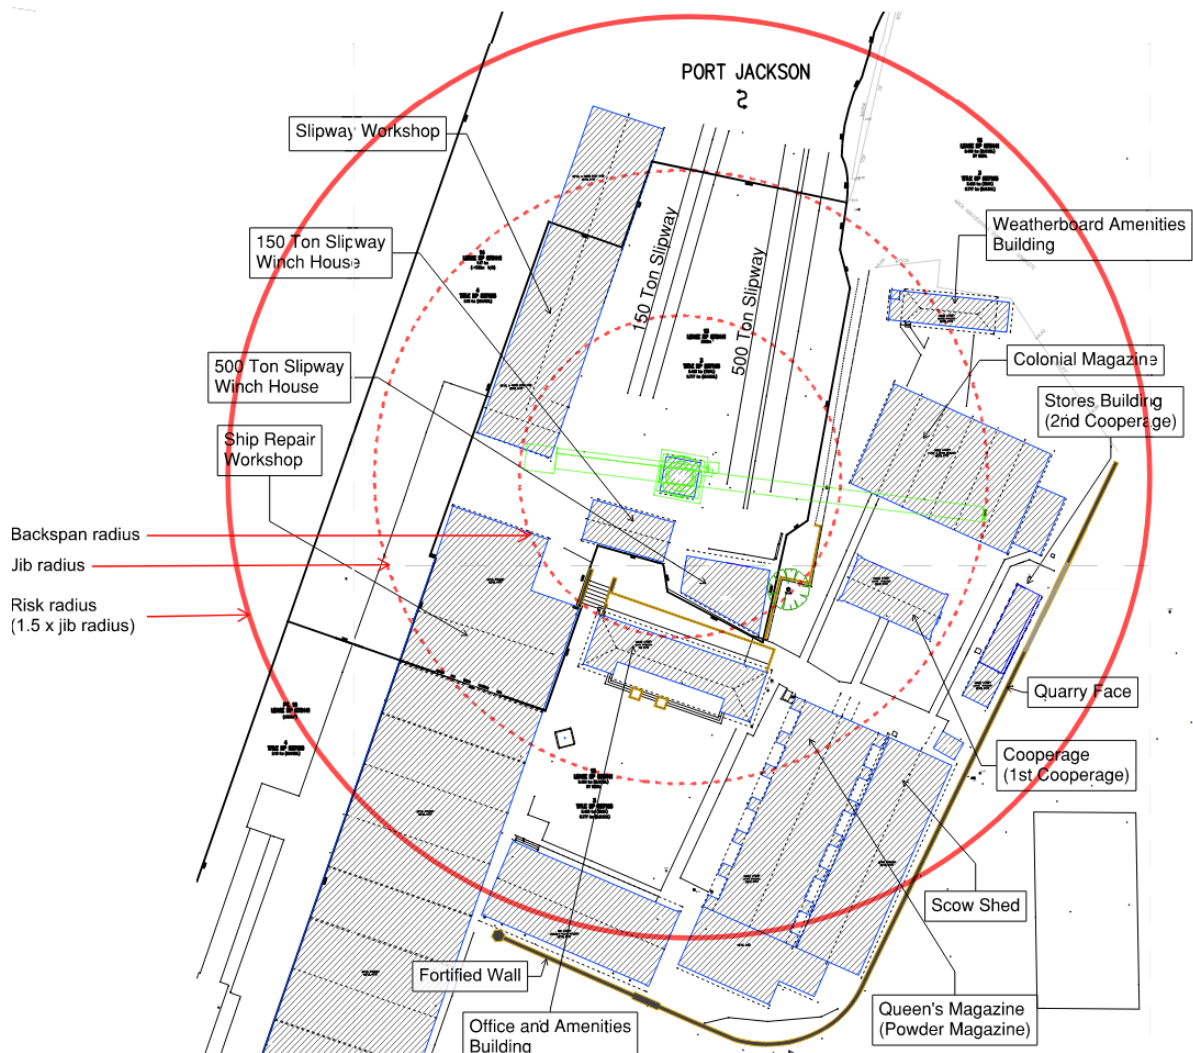
Figure 4 - 'Risk area radius', should crane jib collapse. A 1.5 times jib radius is recommended.^{5 6}

⁵ A 1.5x radius exclusion zone is recommended. Where this zone extends over the harbour it is recommended that the Maritime Authority place exclusion buoys.
