Ben Boyd National Park

Light to Light Walk

Recommended Alignment and Construction

TRACK AND TRAIL MANAGEMENT SERVICES PTY LTD

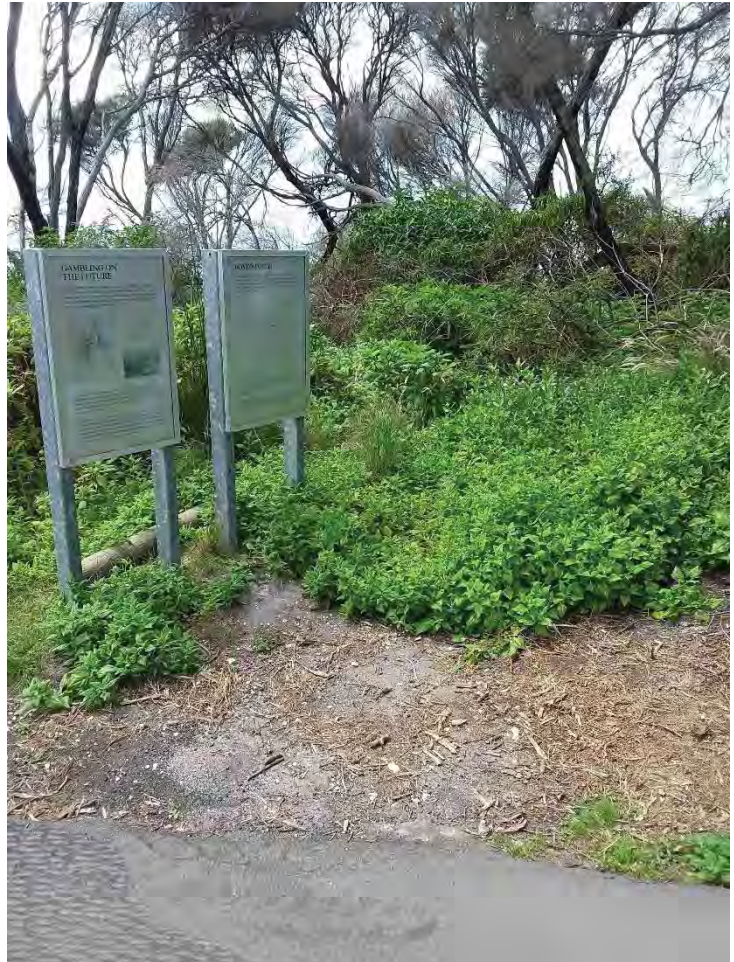
Work Section No.	1
Track Category	New Track
Length (m)	409
Cross Slope (%)	<5 - 5
Vegetation	Tall, open melaleuca. A fire has occurred recently so thick regrowth in patches.
Gradient (%)	0 - 5
Substrate	Sandy soil
Signage	Will need sign at start of section to indicate turn-off for Light to Light.
Descriptions/ Comments	This section starts from the existing Boyd Tower track.
Recommended Work (Text Details)	Machine benching. Incorporate grade dips as needed. May need stepping stone or two at shallow drainage. Use material from clearing vegetation and benching to rehabilitate closed old track.
Stone work - (Person Days)	1
Stepping stones 1000x400x400mm (ea.)	2
Machine benching (m)	404
Clear vegetation (Person Days)	1
Rehabilitate old track with soil and cleared vegetation.	y

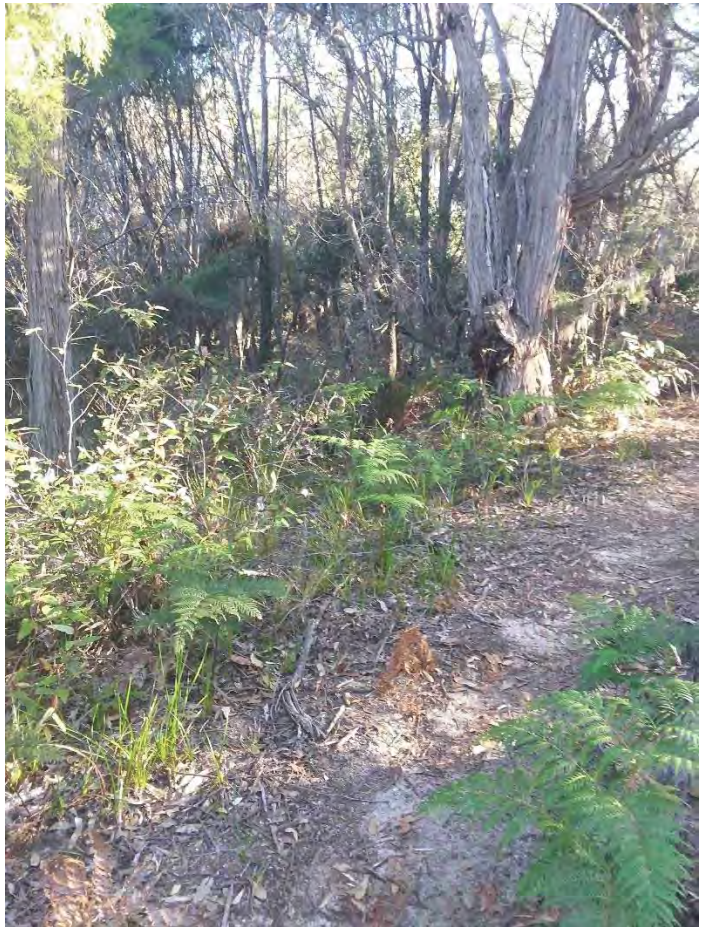
Work Section No.	2
Track Category	Recommended New Track
Length (m)	794
Cross Slope (%)	5 - 20
Vegetation	Open woodland and open melaleuca, some short patches of thick scrub.
Gradient (%)	0 - 10
Substrate	Soil
Viewing/Rest points	At least two viewing points
Descriptions/ Comments	This route contours around the edge of a swampy area then follows the clifftop with several good, relatively close up views of Boyd Tower. There is a midden site that will need to be avoided or require an AHIP.
Recommended Work (Text Details)	Machine benching, may need climbing turn.
Machine benching (m)	794
Clear vegetation (Person Days)	1
Rehabilitate old track with soil and cleared vegetation.	y

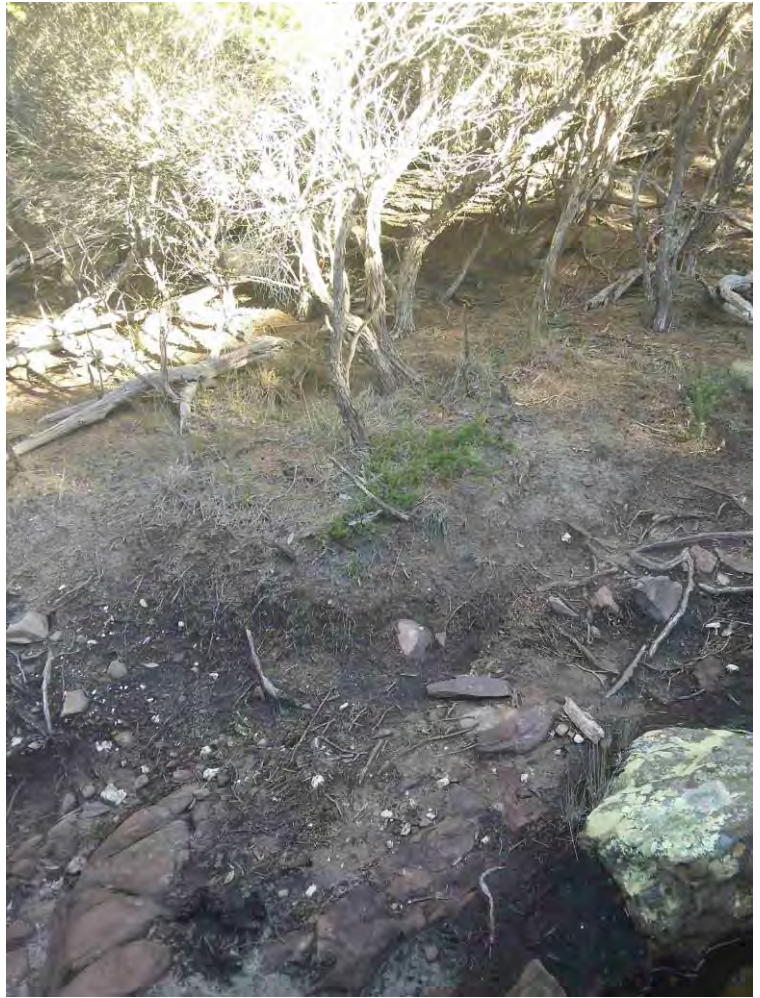
Work Section No.	3
Track Category	Recommended New Track
Length (m)	243
Cross Slope (%)	0 - 10
Vegetation	About 35% thick scrub, 65% open melaleuca.
Gradient (%)	0 - 5
Substrate	Soil with 10m section of stoney ground.
Descriptions/ Comments	Route contours around cliff-top at gentle grade with good views of coastline.
Recommended Work (Text Details)	Machine benching.
Machine benching (m)	243
Clear vegetation (Person Days)	0.5
Rehabilitate old track with soil and cleared vegetation.	Y

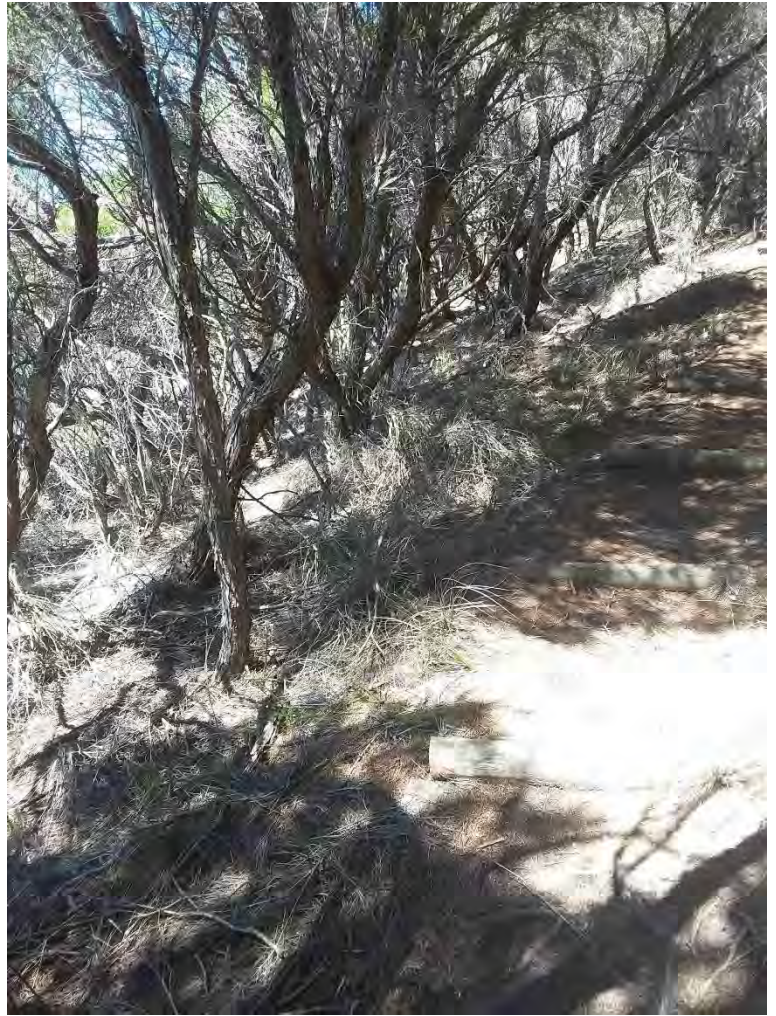
Work Section No.	4
Track Category	Recommended New Track
Length (m)	195
Cross Slope (%)	0 - 10
Vegetation	35% thick scrub, 65% medium
Gradient (%)	0 - 5
Substrate	Soil
Descriptions/ Comments	Route contours around cliff-top at gentle grade with good views of coastline.
Machine benching (m)	195
Clear vegetation (Person Days)	0.5
Rehabilitate old track with soil and cleared vegetation.	Y

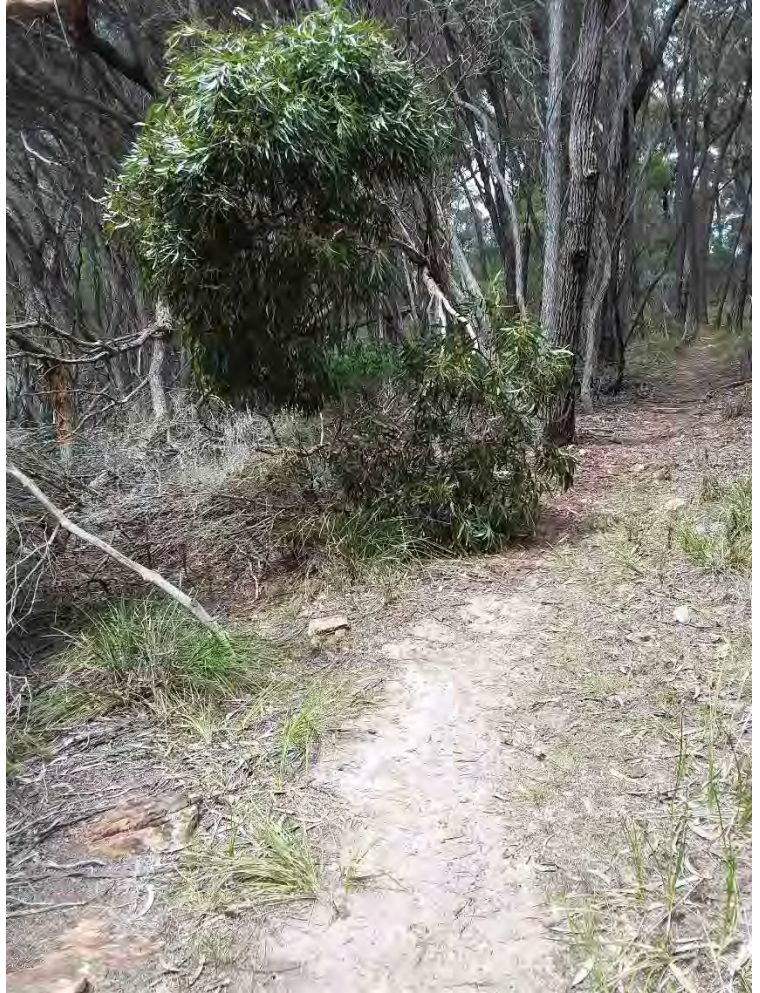
Work Section No.	5
Track Category	New Track
Length (m)	1113
Cross Slope (%)	<5 - 15, short sections of 25
Vegetation	Open woodland, open melaleuca scrub.
Gradient (%)	0 - 10
Substrate	Clay soil with occasional sandy soil. Occasional patches of rocky substrate.
Viewing/Rest points	Potential viewing point looking north up coast to Boyd tower and Red Sands Bay.
Signage	Will need markers where track crosses vehicular track (if vehicular track not closed and rehabilitated).
Descriptions/ Comments	This section leaves the existing track after it climbs up a copper log stairway from Red Sands Bay. It follows the coast and crosses a vehicle track before ending at another existing vehicular track. The new alignment has nice coastal views for much of its length.
Recommended Work (Text Details)	Machine benching. May need a climbing turn or two where grade becomes a little steep.
Machine benching (m)	1113
Clear vegetation (Person Days)	2

Rehabilitate old track with soil and cleared vegetation.	If vehicular track is to be closed - yes

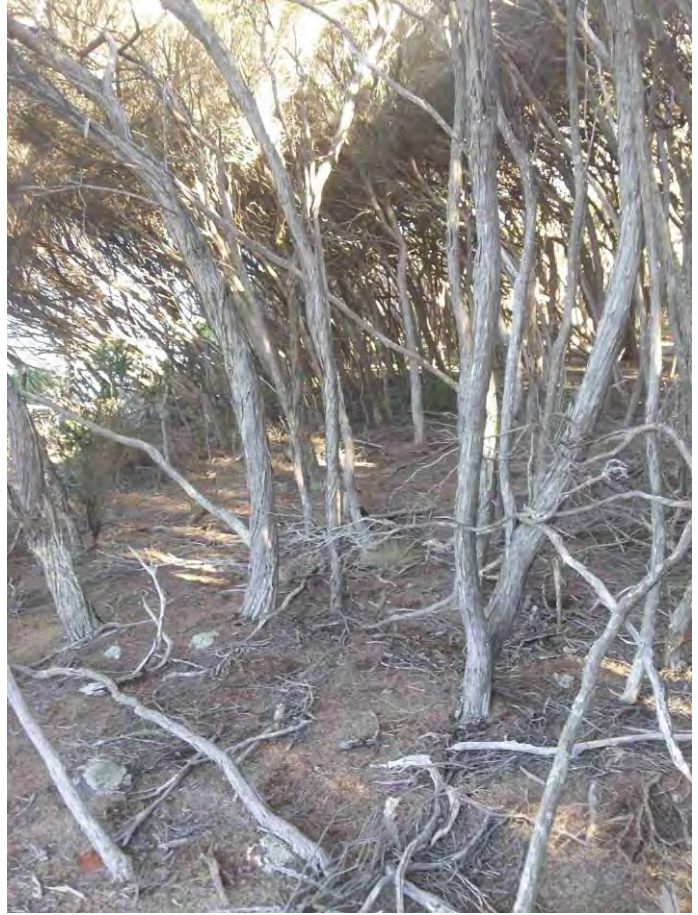
Work Section No.	6-1
Track Category	Recommended New Track
Length (m)	167
Cross Slope (%)	10
Vegetation	Open melaleuca scrub. 20% thick scrub.
Gradient (%)	0 - 10
Substrate	Soil, some short patches of stony ground.
Descriptions/ Comments	Continues contouring along cliff top.
Recommended Work (Text Details)	Machine bench.
Machine benching (m)	167
Rehabilitate old track with soil and cleared vegetation.	Y

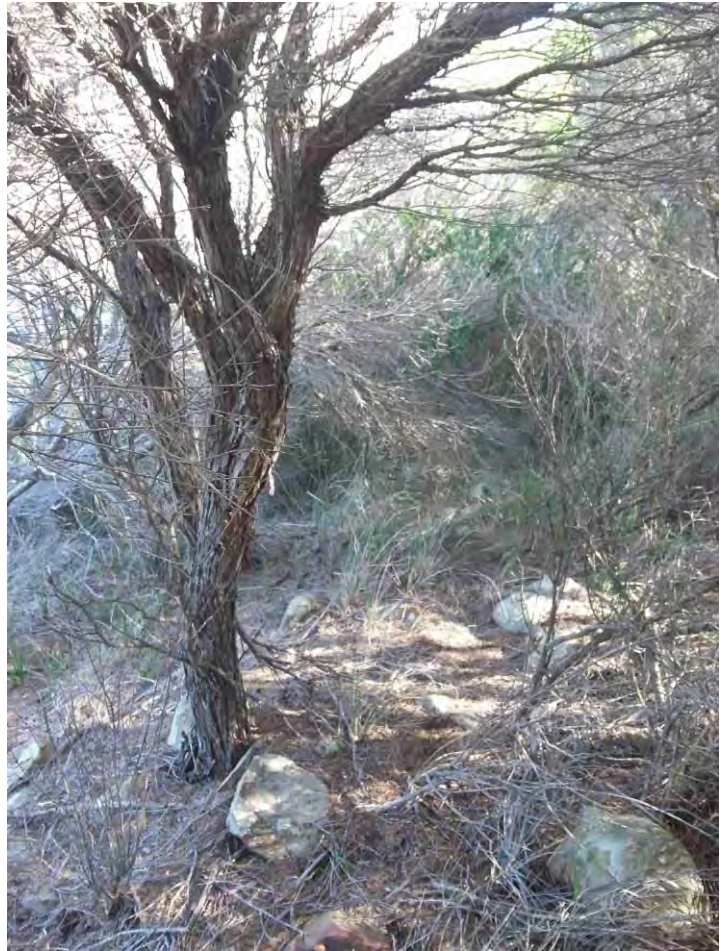
Work Section No.	6-2
Track Category	Recommended New Track
Length (m)	117
Cross Slope (%)	5 - 15
Vegetation	Medium melaleuca scrub.
Gradient (%)	10
Substrate	Rocky
Descriptions/ Comments	May need to move track inland slightly if impractical to build through rocky cliff top.
Recommended Work (Text Details)	Hand benching through stony ground.
Benching by hand (Person Days)	10
Rehabilitate old track with soil and cleared vegetation.	Y

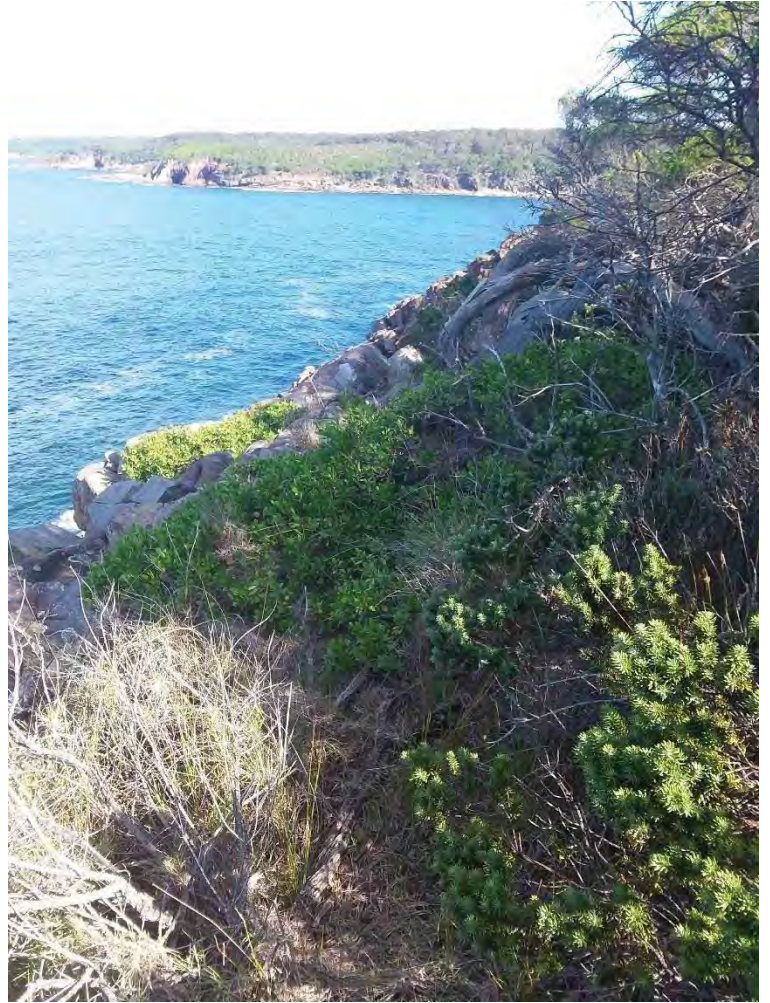
Work Section No.	6-3
Track Category	Recommended New Track
Length (m)	77
Cross Slope (%)	0 - 5
Vegetation	Bedrock with a few bushes.
Gradient (%)	<10
Substrate	Bedrock.
Viewing/Rest points	Yes, excellent views of Leatherjacket Bay.
Descriptions/ Comments	Route goes along bedrock on coast.
Recommended Work (Text Details)	Some hand clearing of stones.
Benching by hand (Person Days)	1
Clear vegetation (Person Days)	0.2

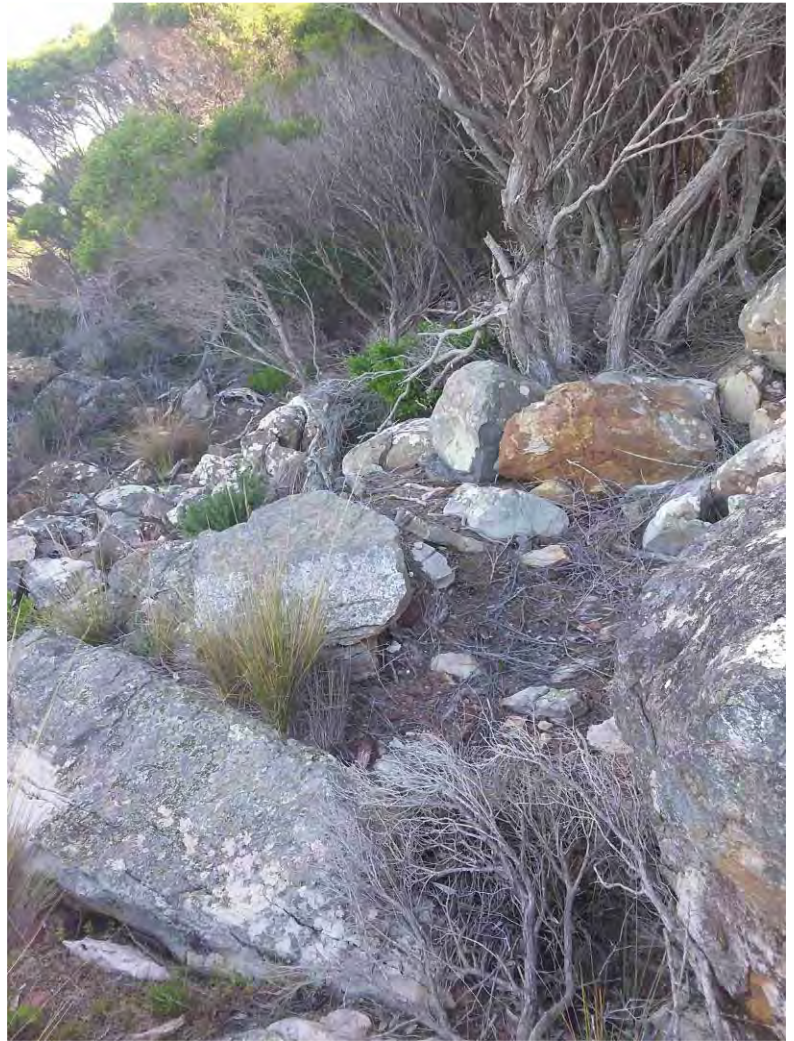
Work Section No.	6-4
Track Category	Recommended New Track
Length (m)	685
Cross Slope (%)	5 - 20
Vegetation	Open woodland, open melaleuca scrub.
Gradient (%)	0 - 13
Substrate	Soil, short stony sections.
Descriptions/ Comments	Route leaves rock shelf to contour along cliff-top then descends into Leatherjacket Bay.
Recommended Work (Text Details)	May need some hand benching and rough stone work for first 20m as there is a small boulder field to pass. Machine benching.
Benching by hand (Person Days)	2
Machine benching (m)	685
Clear vegetation (Person Days)	1.5
Rehabilitate old track with soil and cleared vegetation.	Y

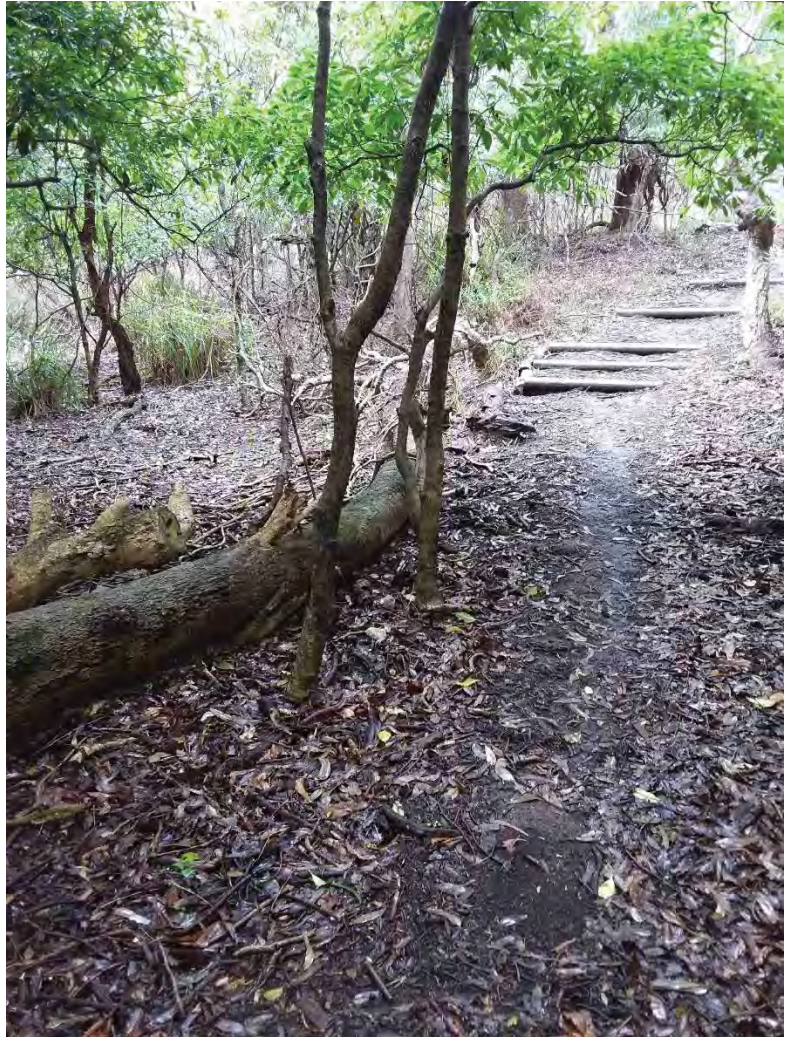
Work Section No.	7
Track Category	New Track
Length (m)	1251
Cross Slope (%)	<5 - 15
Vegetation	Open woodland and melaleuca scrub, 30% of section thick scrub.
Gradient (%)	0 - 10
Substrate	Soil with about 20% through stony ground
Descriptions/ Comments	Climbs gradually out of Leather Jacket Bay on a contoured alignment. Follows coast around before descending down to small bay.
Recommended Work (Text Details)	Machine benching. May need a couple of stepping stones where crosses drainage. Use local stone. Use material from benching and clearing vegetation to close and rehab old track.
Stone work - (Person Days)	1
Machine benching (m)	1251
Clear vegetation (Person Days)	2
Rehabilitate old track with soil and cleared vegetation.	Y

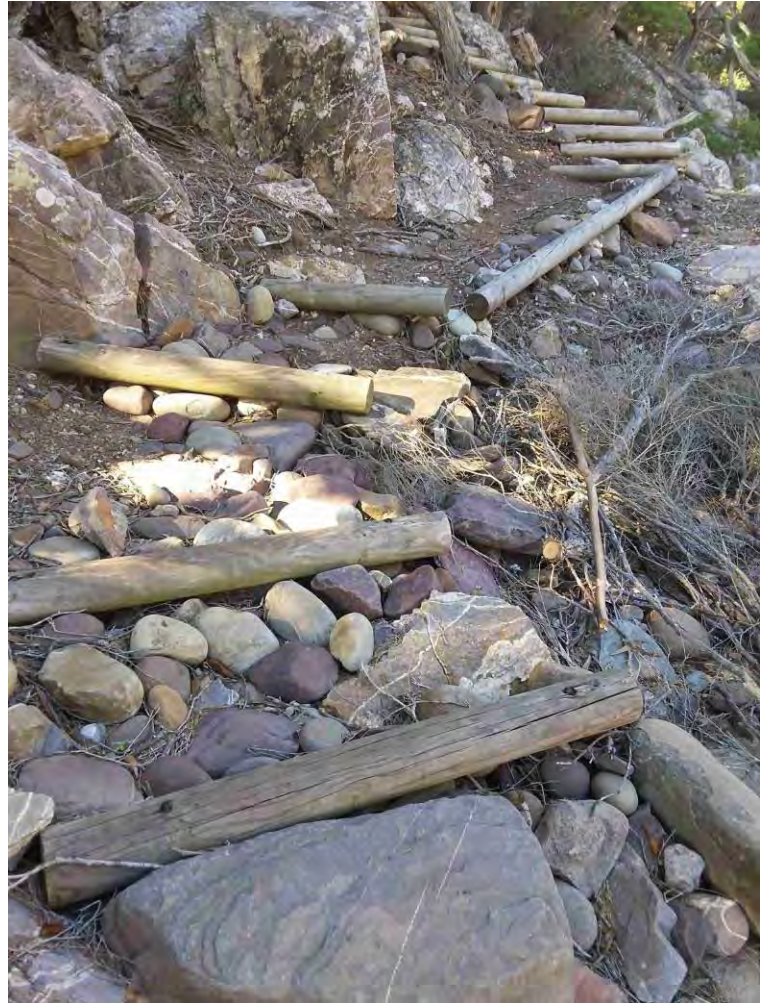
Work Section No.	Alt-1
Track Category	Existing Track
Comment	Alternative route if proposed route not to go through midden
Length (m)	120
Cross Slope (%)	0 - 40
Vegetation	Open woodland.
Gradient (%)	15 - 50
Substrate	soil, rocky soil
Descriptions/ Comments	This is an existing section of track that may have to be included because the proposed new alignment passes through a significant Aboriginal site. It leaves the small bay and climbs up the fall line. The existing copper log stairway will need to be replaced as many of the steel pegs are nearly rusted through and the logs are reaching the end of their life span.
Recommended Work (Text Details)	Remove existing steps. Dig trench. Install timber or stone steps using imported material flown in. Install returns on lower section.
Timber step (600x200mm) ea.	150
Timber return(mm) total length	50000
Galvanized steel pipe pegs(600X30mm) ea.	325
Excavate footing (m ³)	14.4

Remove existing timber/steel /FRP and pack in Heli bags (Person Days)	4

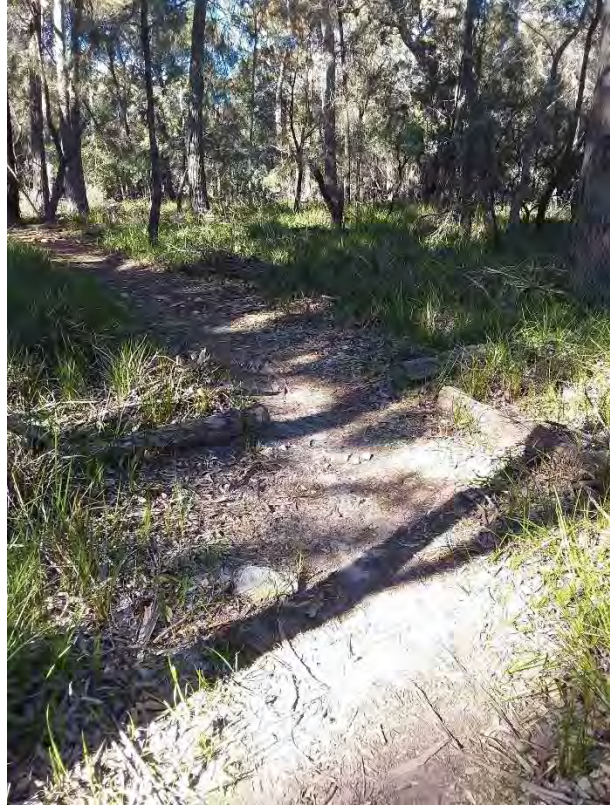
Work Section No.	Alt-2
Track Category	Existing Track
Comment	Alternative route if proposed route not to go through midden
Length (m)	206
Cross Slope (%)	0
Vegetation	Open woodland.
Gradient (%)	0 - 10
Substrate	soil, clay
Descriptions/ Comments	Existing track continues up fall line at very gentle grade.
Recommended Work (Text Details)	No work required.

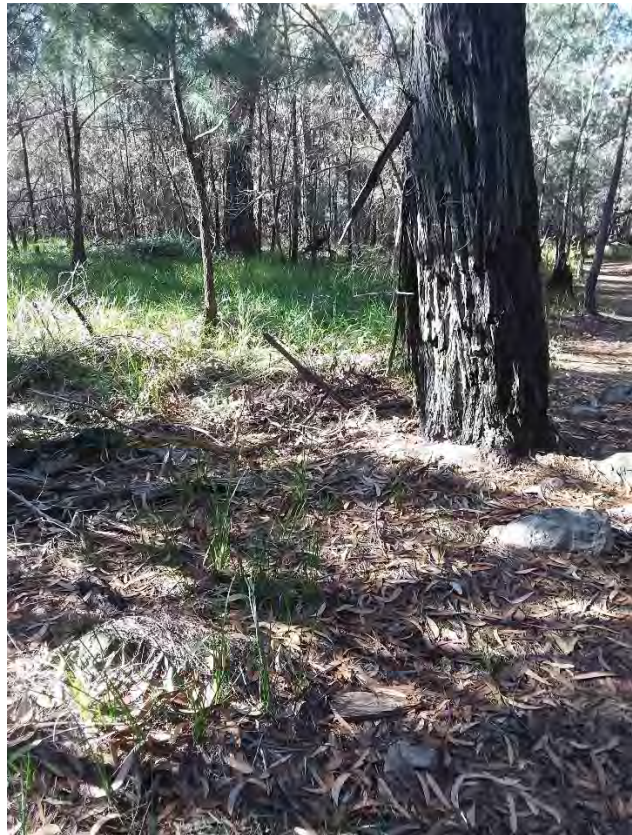
Work Section No.	Alt-3
Track Category	New Track
Comment	Alternative route if proposed route not to go through midden
Length (m)	35
Cross Slope (%)	0 - 5
Vegetation	Open woodland.
Gradient (%)	10
Substrate	soil, clay
Descriptions/ Comments	Short reroute to remove dog leg in existing track. Ends at existing 4WD track.
Recommended Work (Text Details)	Light machine benching.
Machine benching (m)	35

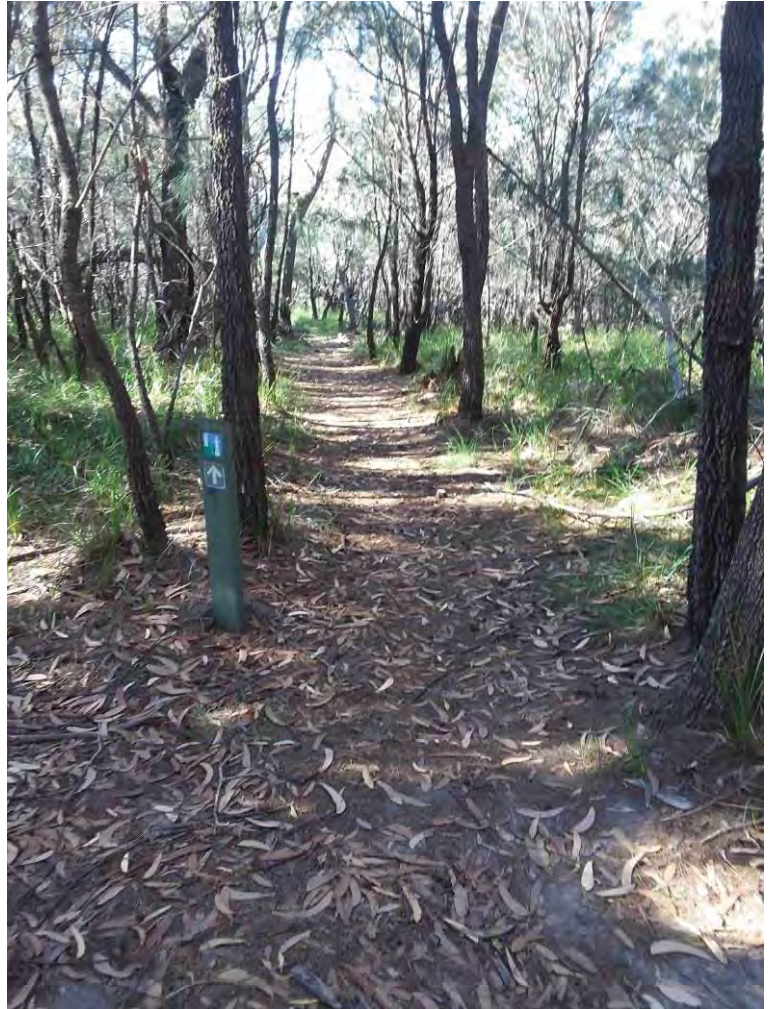
Work Section No.	Alt-4
Track Category	Existing Track
Comment	Alternative route if proposed route not to go through midden
Length (m)	153
Cross Slope (%)	5 - 10
Vegetation	Open woodland.
Gradient (%)	10 - 25
Substrate	soil, clay
Descriptions/ Comments	Existing track that starts from existing 4WD track. Descends at close to fall line. Existing timber steps could be replaced. Construct three metres of new track to link to new route, avoids needless dogleg.
Recommended Work (Text Details)	Remove existing timber steps. Install timber steps. Install grade dips. Construct three metres of new track to join with other route at southern end to straighten out
Timber step (600x200mm) ea.	50
Galvanized steel pipe pegs(600X30mm) ea.	100
Grade dip (ea.)	5

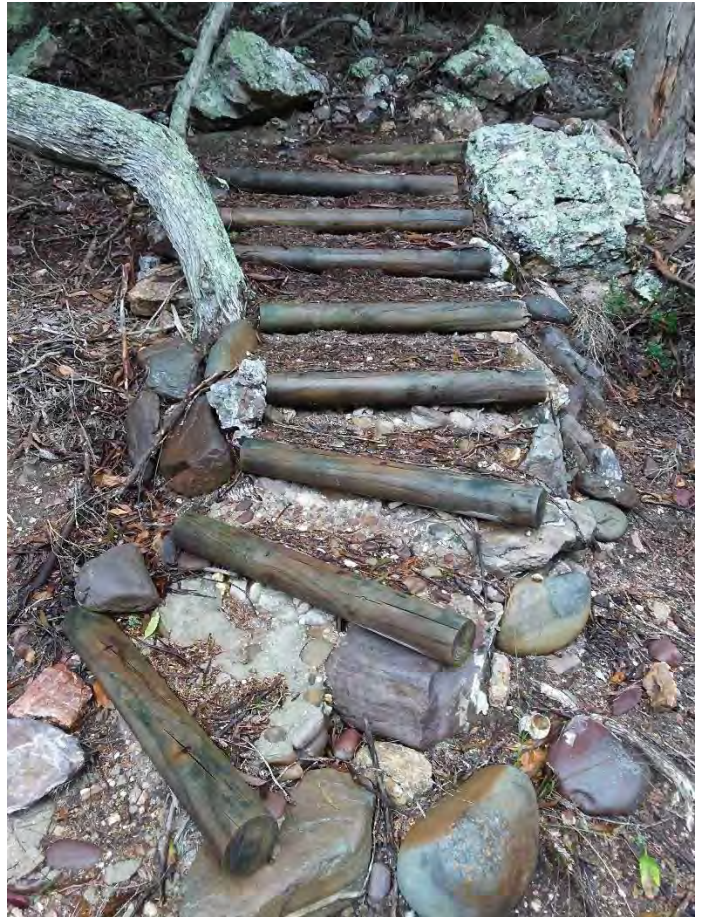
Work Section No.	8
Track Category	New Track
Length (m)	924
Cross Slope (%)	5 - 10 with short sections of 20
Vegetation	15% open woodland. 10% open melaleuca. 75% thick melaleuca scrub.
Gradient (%)	5 - 10 with 20m at start 30%.
Substrate	70% soil, 30% stony.
Descriptions/ Comments	The last two thirds of this section will be redundant if the recommended route along the coastal bedrock is used. Leaves existing track of old copper log stairway soon after climbing up from small bay. First 20m is steep and rocky, then begins to contour around coast. Towards the end, the route heads inland to contour around drainage. The existing 10m section of copper log stairway at the start of this section should be replaced with stone steps as it is in poor condition.
Recommended Work (Text Details)	Build stone stairway/steps for 20m steep section at start using local material. Machine benching for rest of section. Use cut vegetation and benched material to close old tracks if required.

Stone work - (Person Days)	16
Machine benching (m)	924
Clear vegetation (Person Days)	2
Rehabilitate old track with soil and cleared vegetation.	If vehicular tracks are to be closed - yes

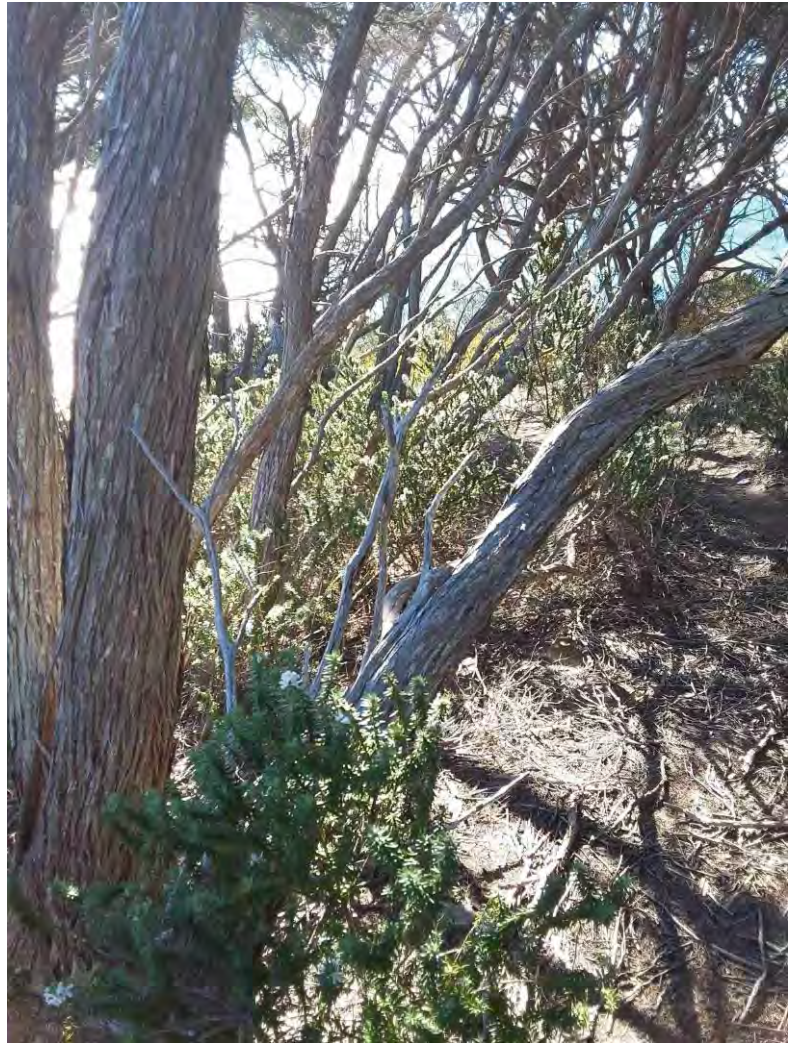
Work Section No.	9-1
Track Category	Recommended New Track
Length (m)	20
Cross Slope (%)	0 - 5
Vegetation	Light melaleuca scrub.
Gradient (%)	15
Substrate	Stoney soil.
Viewing/Rest points	Excellent views from clifftop.
Geotech Assessment Recommended	yes
Descriptions/ Comments	Short section on clifftop leading to steep descent down to coastal rock platform.
Recommended Work (Text Details)	Light machine benching. May need climbing turn to reduce grade.
Machine benching (m)	20
Clear vegetation (Person Days)	0.2

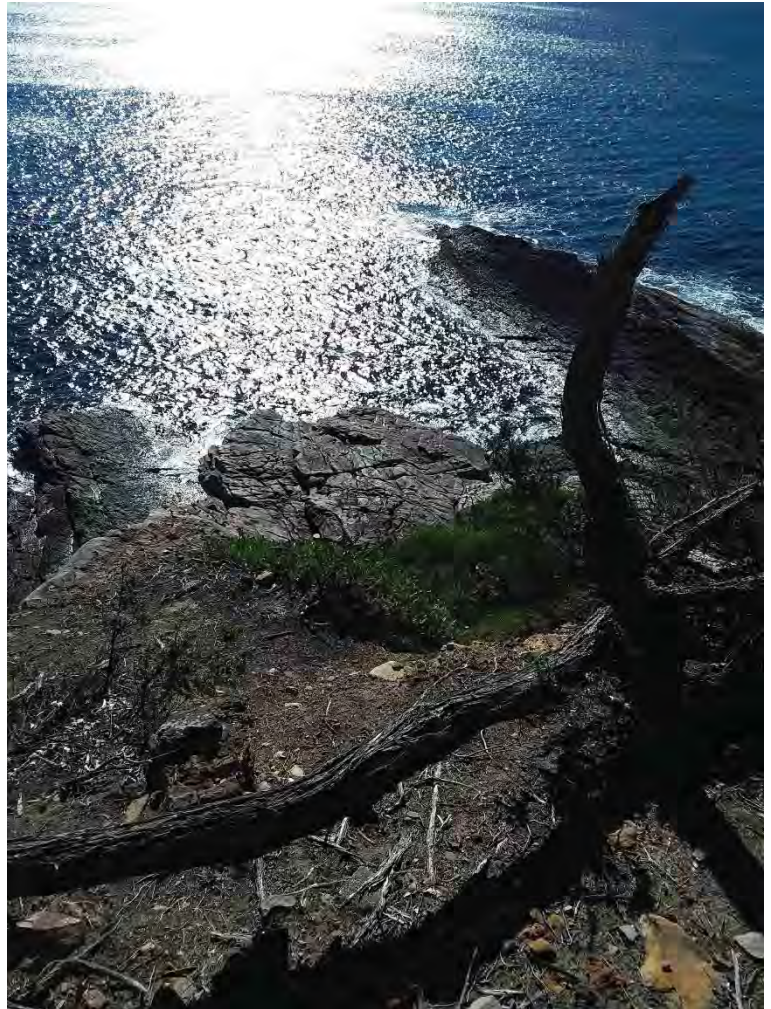
Work Section No.	9-2
Track Category	Recommended New Track
Length (m)	20
Cross Slope (%)	0 - 5
Vegetation	Melaleuca bushes
Gradient (%)	70
Substrate	Soil, crumbly bedrock
Signage	May need marker to indicate descent down to rock platform.
Geotech Assessment Recommended	yes
Descriptions/ Comments	Short steep descent down to coastal rock platform.
Recommended Work (Text Details)	Dig trench and install 26 stone steps using local stone (will need to fly up from platform). Lower stone into place with winch. About 10m of bedrock platform then natural steps (may want to chisel 3 steps to make more walker friendly). Clear boulders at base(1man day and install 3 stone steps at base using local stone
Stone work - (Person Days)	1
Stone Steps 900x200x400mm (ea.)	29
Excavate footing (m ³)	1.5
Chiselled step(900-1200x300x200mm) (ea.)	3
Chisel tread (Person Days)	1
Clear vegetation (Person Days)	0.1

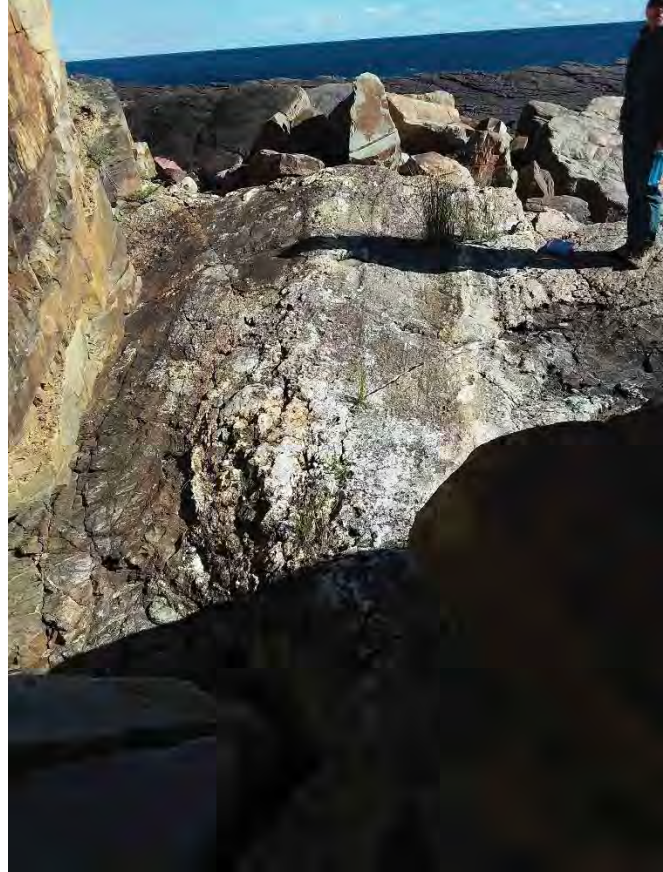
Work Section No.	9-3
Track Category	Recommended New Track
Length (m)	5
Cross Slope (%)	0 - 5
Vegetation	none
Gradient (%)	0 - 25
Substrate	bedrock
Signage	Will need some stencilled arrows on bedrock to indicate route.
Geotech Assessment Recommended	yes
Descriptions/ Comments	This route along the rock platform is possibly the most spectacular section of the whole Light to Light walk.
Recommended Work (Text Details)	none

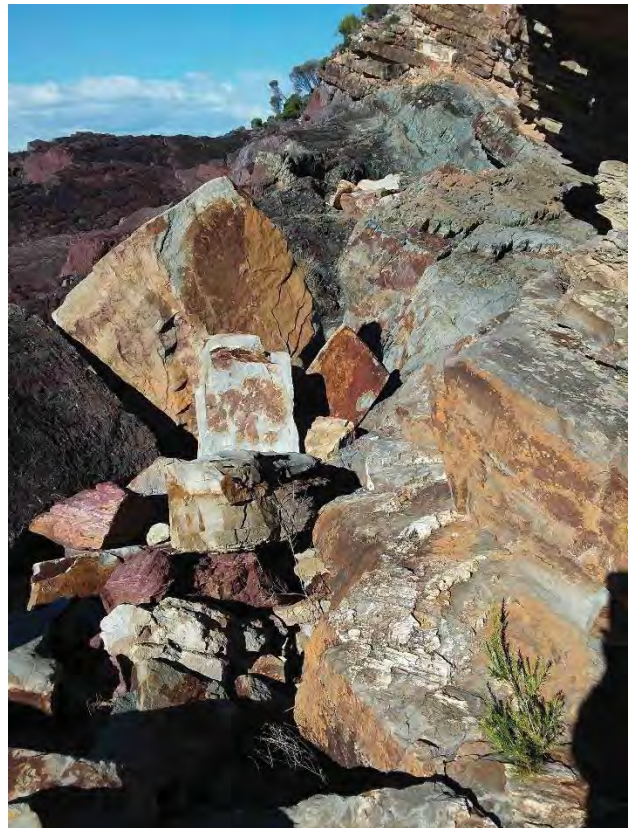
Work Section No.	9-4
Track Category	Recommended New Track
Length (m)	11
Cross Slope (%)	0 - 5
Vegetation	none
Gradient (%)	
Substrate	bedrock, large boulders
Geotech Assessment Recommended	yes
Descriptions/ Comments	Route needs to pass through boulders in order to avoid Geotech hazards closer to base of cliff.
Recommended Work (Text Details)	Drill and split boulders then clear route.
Stone work - (Person Days)	8

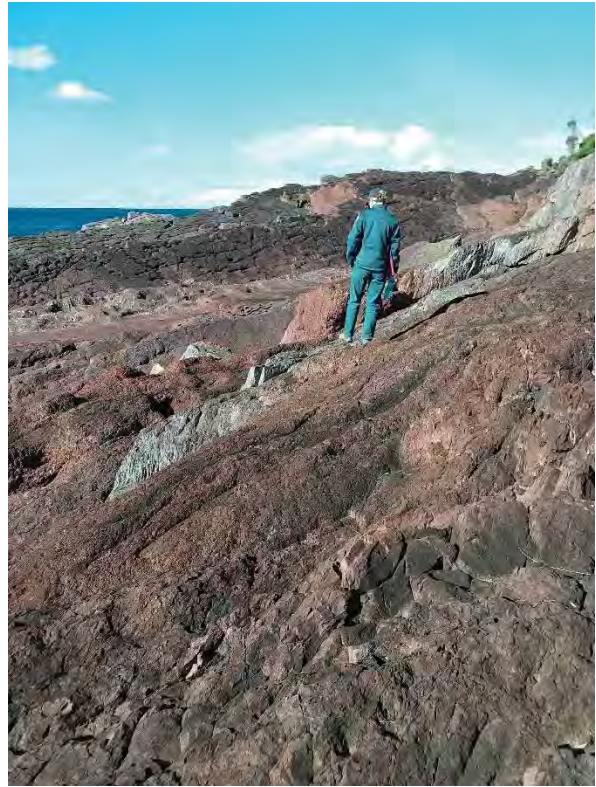
Work Section No.	9-5
Track Category	Recommended New Track
Length (m)	151
Cross Slope (%)	0 - 35
Vegetation	none
Gradient (%)	0 - 25
Substrate	bedrock
Signage	Will need some stencilled arrows on bedrock to indicate route.
Geotech Assessment Recommended	yes
Descriptions/ Comments	Route follows bedrock shelves.
Recommended Work (Text Details)	No work required apart from stencilled arrows

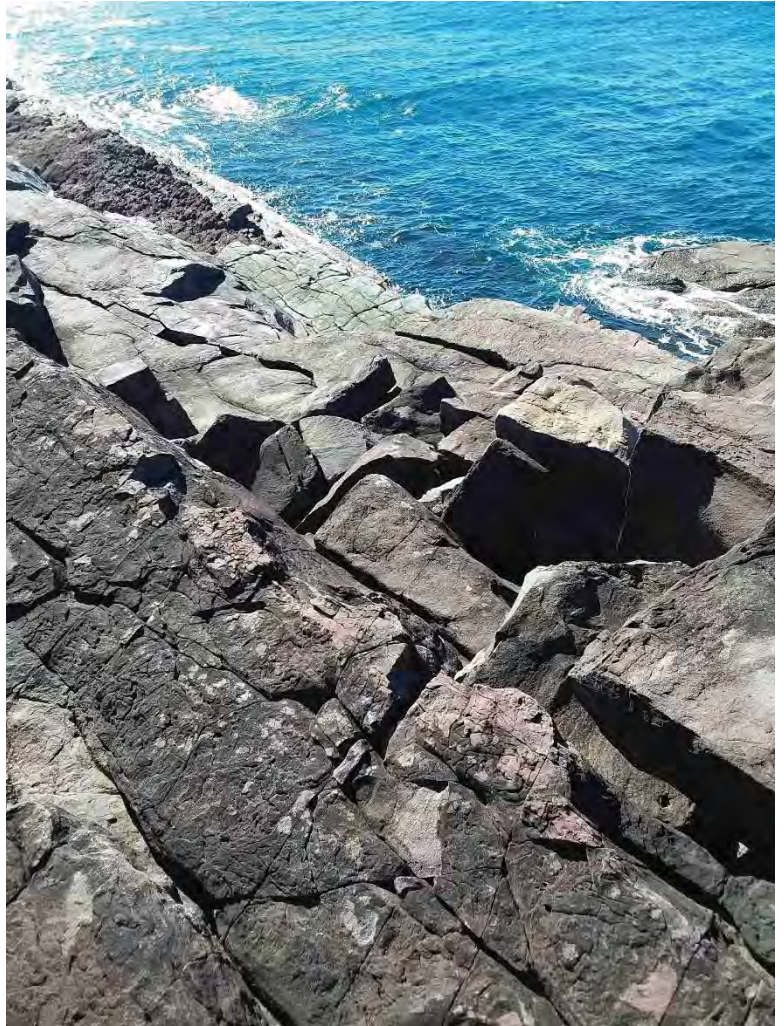
Work Section No.	9-6
Track Category	Recommended New Track
Length (m)	9
Cross Slope (%)	0 - 5
Vegetation	none
Gradient (%)	50 - 70
Substrate	bedrock
Signage	Will need marker to indicate turn and descent down to lower platform.
Geotech Assessment Recommended	yes
Descriptions/ Comments	Route turns and descends down sloping bedrock to lower platform.
Recommended Work (Text Details)	Carve 6 steps. 4 man days to rearrange boulders and install 4 steps using local stone.
Stone work - (Person Days)	4
Stone Steps 900x200x400mm (ea.)	4
Chiselled step(900-1200x300x200mm) (ea.)	6

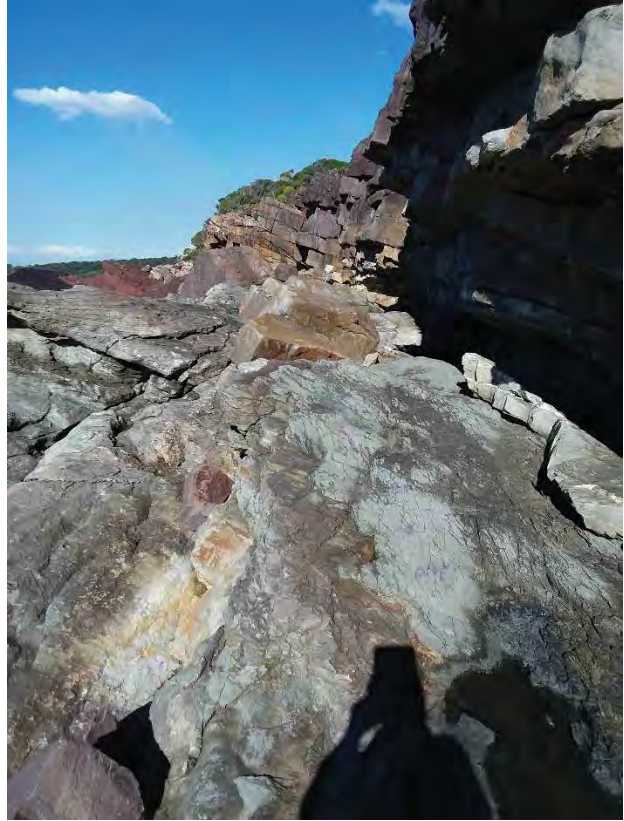
Work Section No.	9-7
Track Category	Recommended New Track
Length (m)	31
Cross Slope (%)	5 - 20
Vegetation	none
Gradient (%)	0 - 10
Substrate	bedrock
Signage	Will need some stencilled arrows on bedrock to indicate route.
Geotech Assessment Recommended	yes
Descriptions/ Comments	End of descent down bedrock to lower platform. Route follows platform.
Recommended Work (Text Details)	No work required.

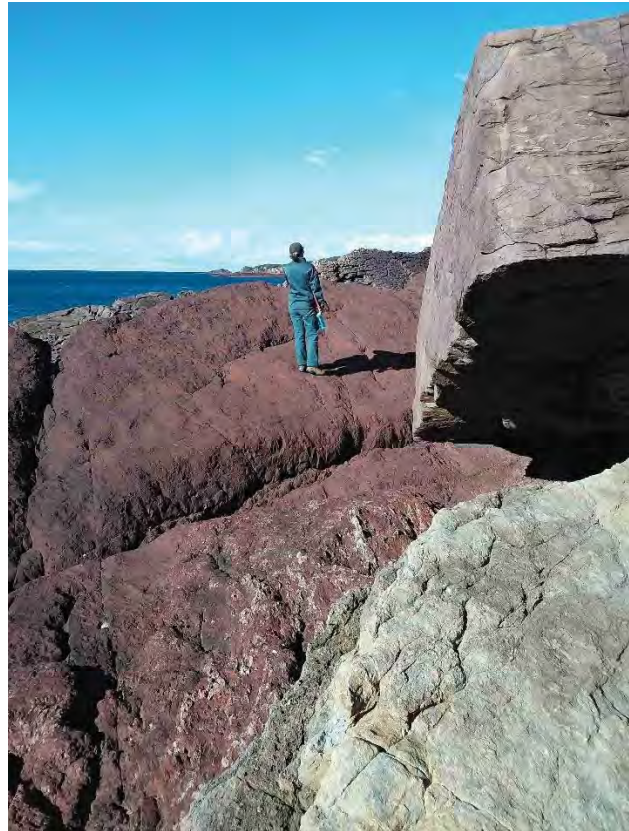
Work Section No.	9-8
Track Category	Recommended New Track
Length (m)	4
Cross Slope (%)	25
Vegetation	none
Gradient (%)	70
Substrate	bedrock
Geotech Assessment Recommended	yes
Descriptions/ Comments	Small drop off on route along platform.
Recommended Work (Text Details)	Carve 3 steps at small drop off (or install three steps using local stone).
Chiselled step(900-1200x300x200mm) (ea.)	3

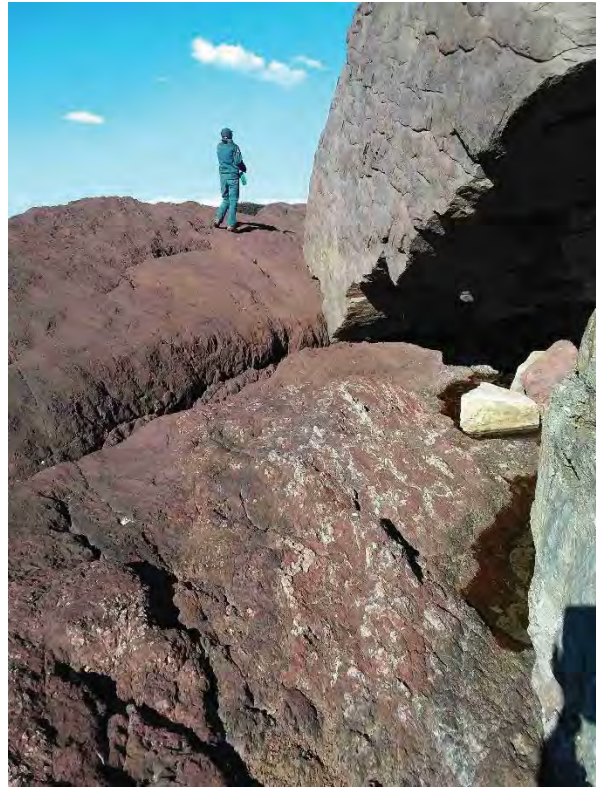
Work Section No.	9-9
Track Category	Recommended New Track
Length (m)	130
Cross Slope (%)	30
Vegetation	none
Gradient (%)	0 - 10
Substrate	bedrock
Geotech Assessment Recommended	yes
Descriptions/ Comments	Route passes large boulders that push walkers near cliff edge.
Recommended Work (Text Details)	May need to drill and slit two boulders to take walkers away from cliff edge.
Stone work - (Person Days)	4

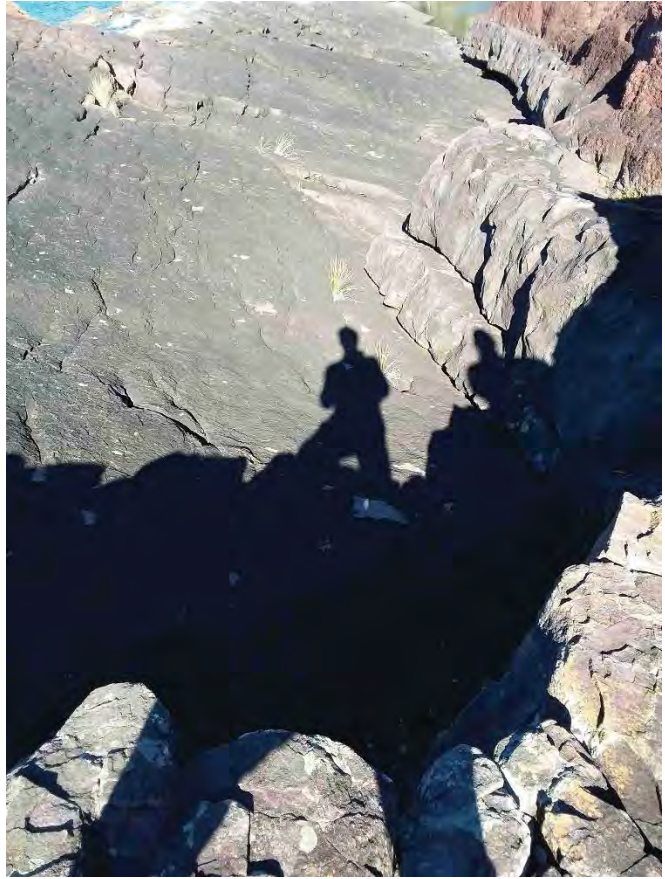
Work Section No.	9-11
Track Category	Recommended New Track
Length (m)	153
Cross Slope (%)	15
Vegetation	none
Gradient (%)	100
Substrate	bedrock
Geotech Assessment Recommended	yes
Descriptions/ Comments	1 meter drop along bedrock
Recommended Work (Text Details)	Carve 4 steps (or install 4 steps using local stone). Another alternative is to leave as is and let walkers' scramble up and down.
Chiselled step(900-1200x300x200mm) (ea.)	4

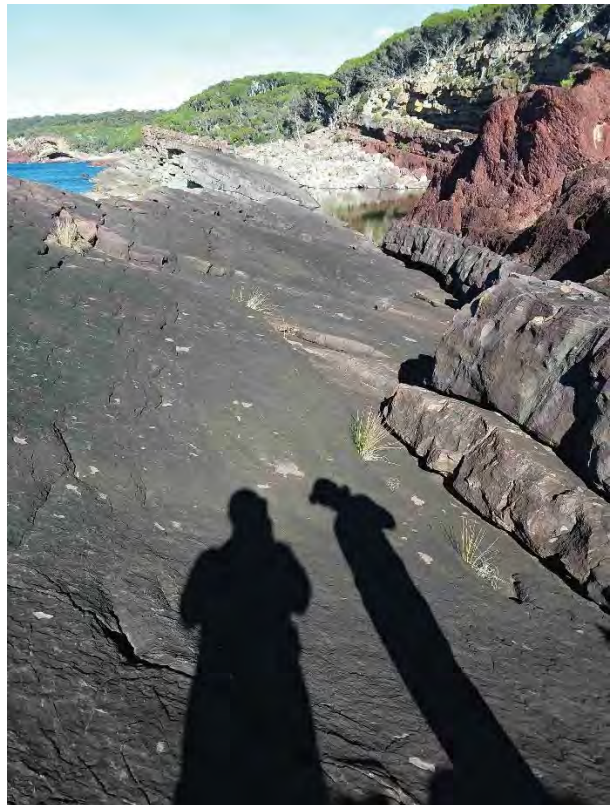
Work Section No.	9-13
Track Category	Recommended New Track
Length (m)	68
Cross Slope (%)	25
Vegetation	none
Gradient (%)	0 - 10
Substrate	bedrock
Signage	Will need some stencilled arrows on bedrock to indicate route.
Descriptions/ Comments	Route follows platform with boulders across it.
Recommended Work (Text Details)	Clear boulders off route along platform.
Stone work - (Person Days)	8

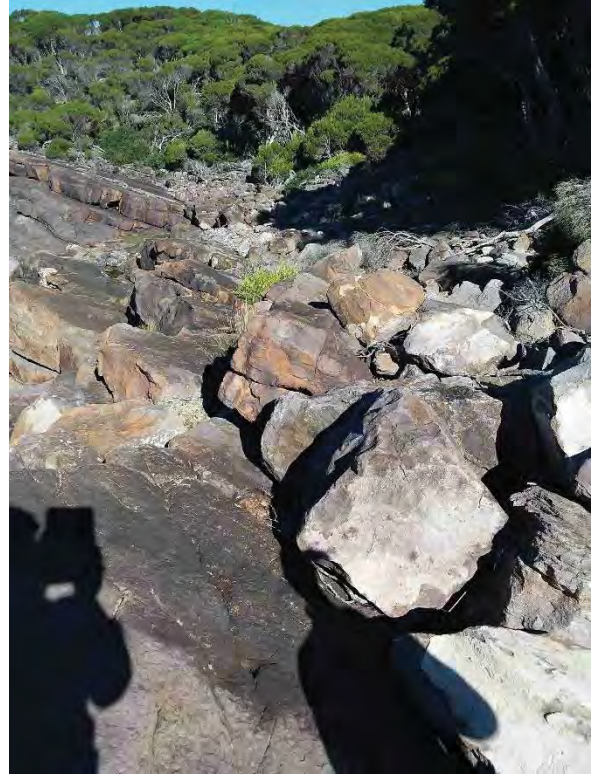
Work Section No.	9-14
Track Category	Recommended New Track
Length (m)	44
Cross Slope (%)	25
Vegetation	none
Gradient (%)	15 - 20
Substrate	bedrock
Signage	Will need some stencilled arrows on bedrock to indicate route.
Descriptions/ Comments	Route climbs up sloping bedrock slab.
Recommended Work (Text Details)	No work required.

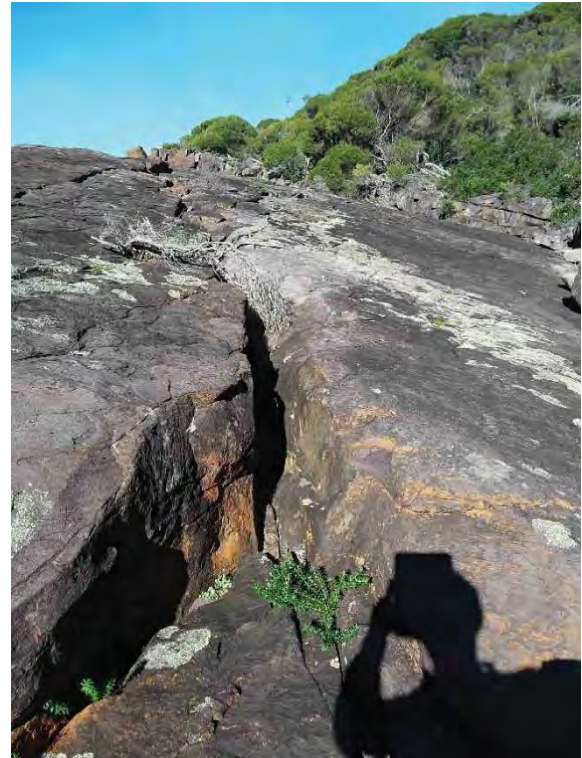
Work Section No.	9-15
Track Category	Recommended New Track
Length (m)	48
Cross Slope (%)	10
Vegetation	Melaleuca
Gradient (%)	0 - 5
Substrate	bedrock
Geotech Assessment Recommended	yes
Descriptions/ Comments	Route continues on bedrock with some melaleuca bushes.
Recommended Work (Text Details)	Clear vegetation and rocks on route.
Stone work - (Person Days)	1
Clear vegetation (Person Days)	0.2
