Ben Boyd National Park

Light to Light Walk

Recommended Alignment and Construction

TRACK AND TRAIL MANAGEMENT SERVICES PTY LTD

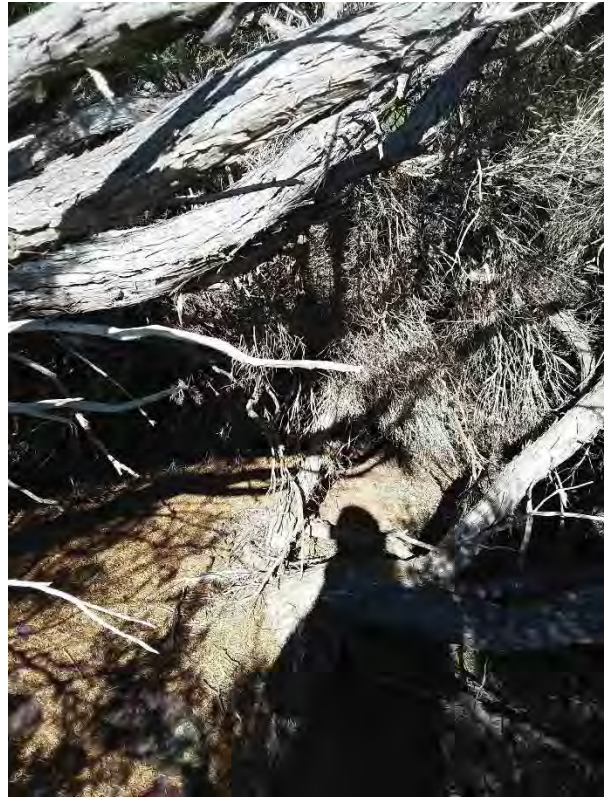
Work Section No.	9-16
Track Category	Recommended New Track
Length (m)	19
Cross Slope (%)	0 - 5
Vegetation	Some melaleuca, mostly grass patches.
Gradient (%)	0 - 5
Substrate	soil
Geotech Assessment Recommended	yes
Descriptions/ Comments	End bedrock and start of soil. Midden at this way point.
Recommended Work (Text Details)	Light hand benching.
Benching by hand (Person Days)	1

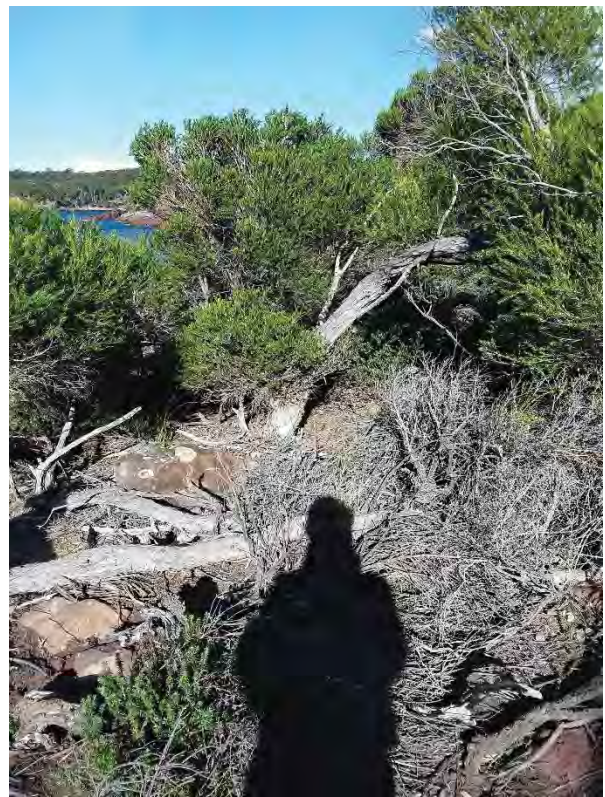
Work Section No.	9-17
Track Category	Recommended New Track
Length (m)	28
Cross Slope (%)	35
Vegetation	melaleuca bushes
Gradient (%)	40
Substrate	Soft bedrock.
Descriptions/ Comments	Start steep ascent up crumbly bedrock.
Recommended Work (Text Details)	Carve steps in soft bedrock.
Chiselled step(900-1200x300x200mm) (ea.)	14

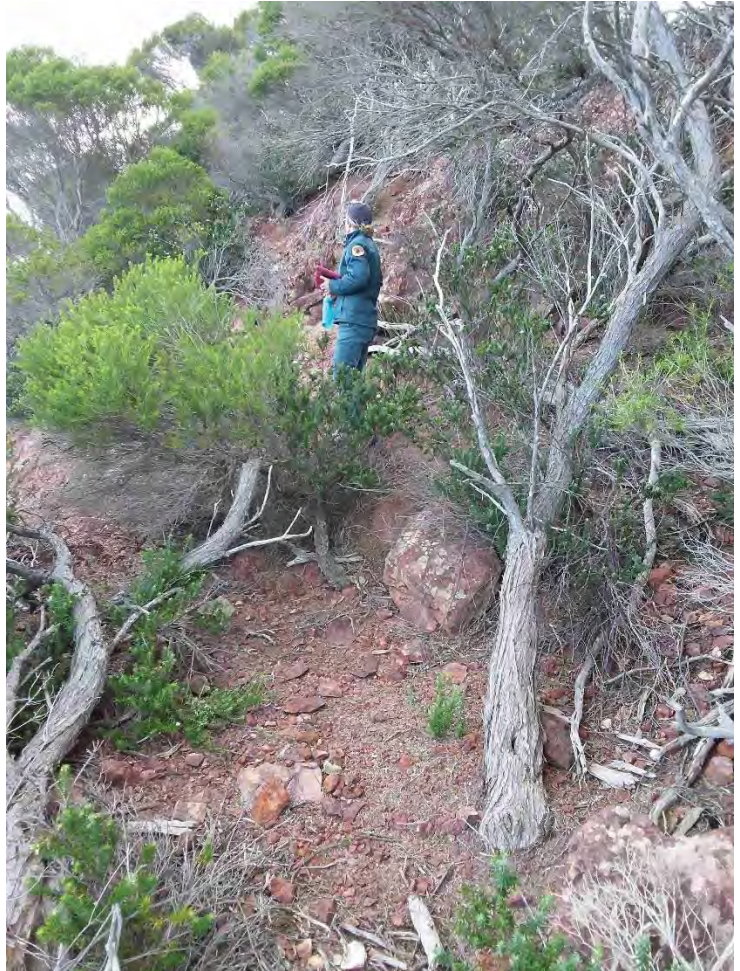
Work Section No.	10
Track Category	Recommended New Track
Length (m)	366
Cross Slope (%)	5 - 25
Vegetation	Medium melaleuca scrub
Gradient (%)	0 - 15
Substrate	Soil with some patches of stone.
Descriptions/ Comments	Route contours long cliff-top to next stony bay.
Recommended Work (Text Details)	Machine benching.
Machine benching (m)	366
Clear vegetation (Person Days)	1
Rehabilitate old track with soil and cleared vegetation.	Y

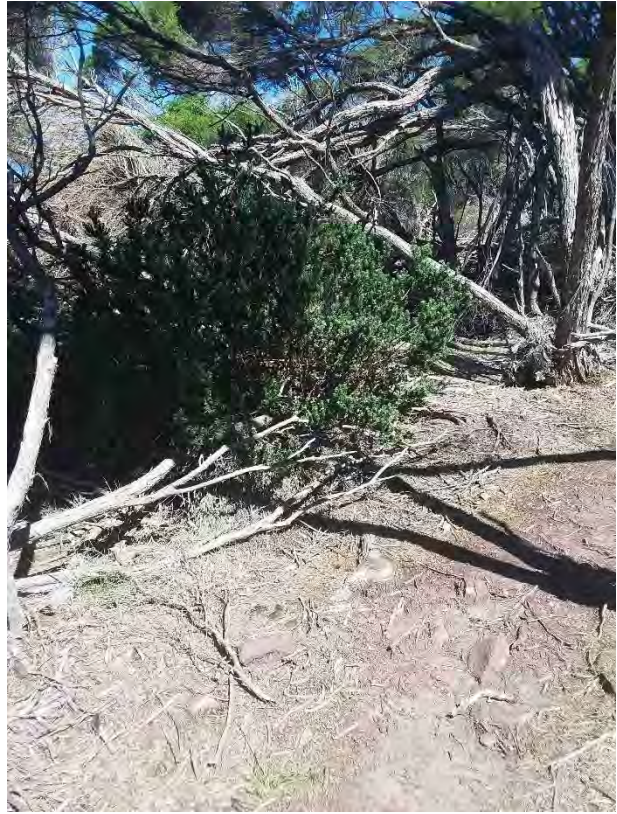
Work Section No.	10-1
Track Category	Recommended New Track
Length (m)	52
Cross Slope (%)	
Vegetation	Medium melaleuca scrub
Descriptions/ Comments	Short linking track from existing track. Will only be used if Sections 9 not used but Section 8 is used
Machine benching(m)	52
Clear vegetation - person days.	0.2

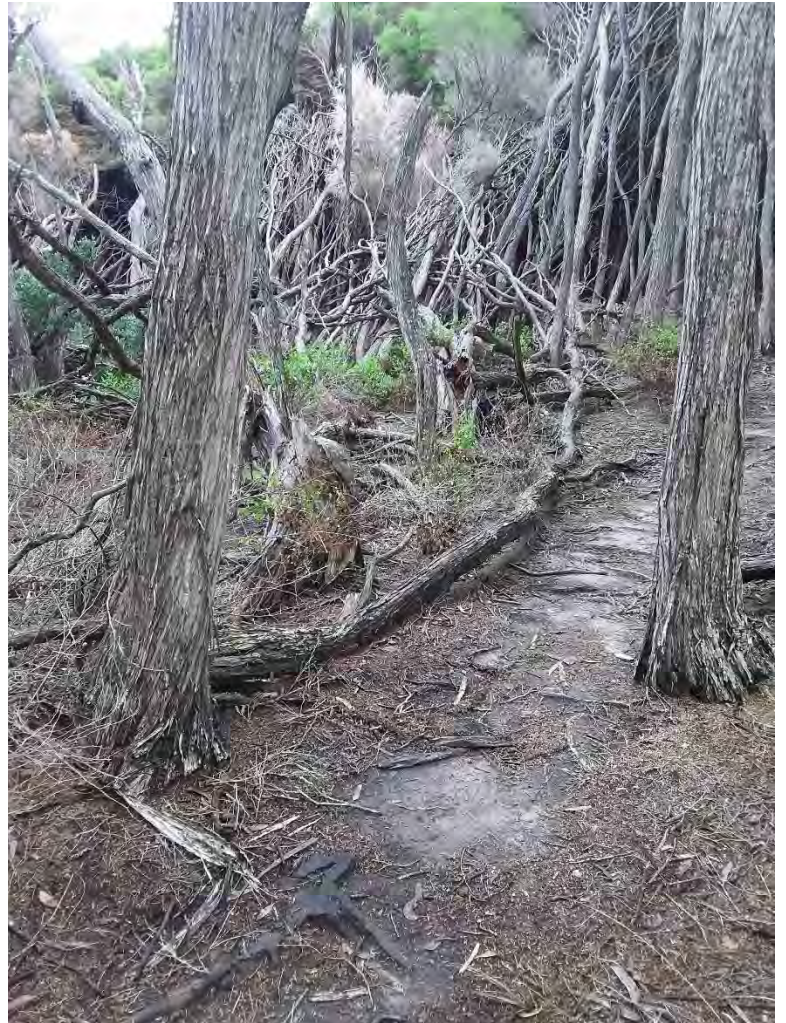
Work Section No.	12
Track Category	New Track
Length (m)	611
Cross Slope (%)	0 - 20, mostly 10 - 15, 50m section of 60
Vegetation	Open woodland, 15% thicker melaleuca scrub.
Gradient (%)	0 - 10
Substrate	Soil, one 20m rocky section.
Viewing/Rest points	Viewing point at end of section. Overlooking beach.
Signage	Will need track markers at start of section if existing track not closed.
Descriptions/ Comments	Track contours up from beach crossing two gullies. Contours out to small headland crossing historic dam wall before joining existing track. This section may need to be resurveyed by archaeologist as was altered after cultural survey done.
Recommended Work (Text Details)	Machine benching. 20m rocky section will need some jackhammering and a stone step or two. May need a climbing turn or two towards headland to maintain 10% grade. Good views along this section.
Stone work - (Person Days)	1
Machine benching (m)	420

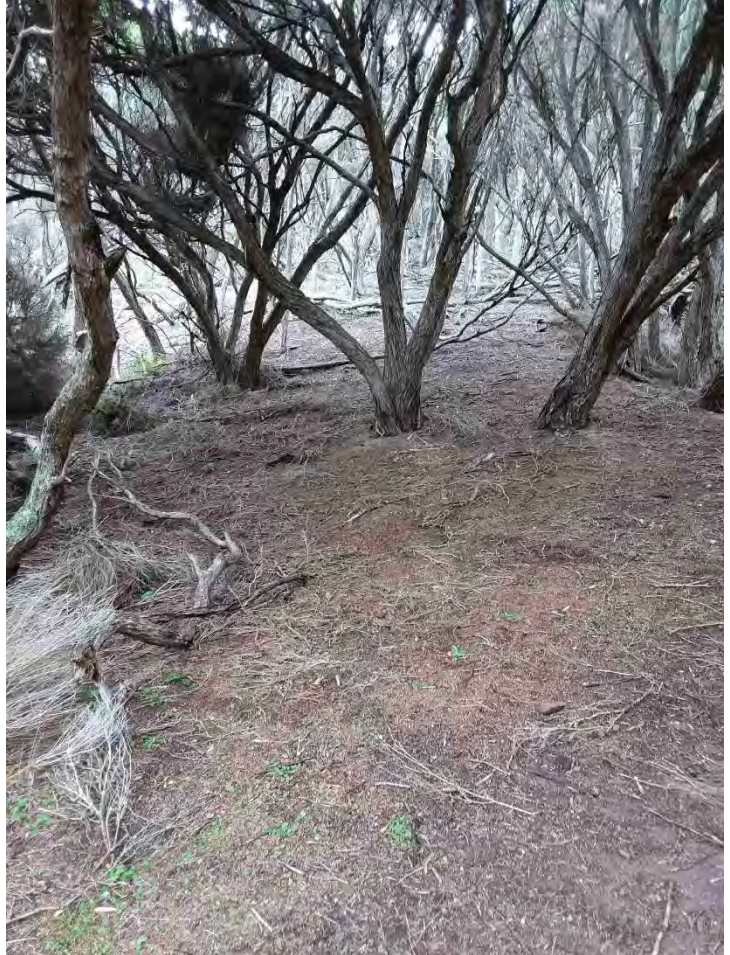
Work Section No.	13
Track Category	New Track
Length (m)	192
Cross Slope (%)	<5 - 15
Vegetation	Medium density melaleuca scrub.
Gradient (%)	0 - 10
Substrate	Soil with some rocky patches.
Signage	Will need sign indicating side route to Mowarry Point.
Descriptions/ Comments	Route leaves existing track to head out to narrow neck on headland then contours back at flat grade to rejoin existing track.
Recommended Work (Text Details)	Machine benching.
Stone work - (Person Days)	1
Machine benching (m)	187
Clear vegetation (Person Days)	0.5
Rehabilitate old track with soil and cleared vegetation.	Y

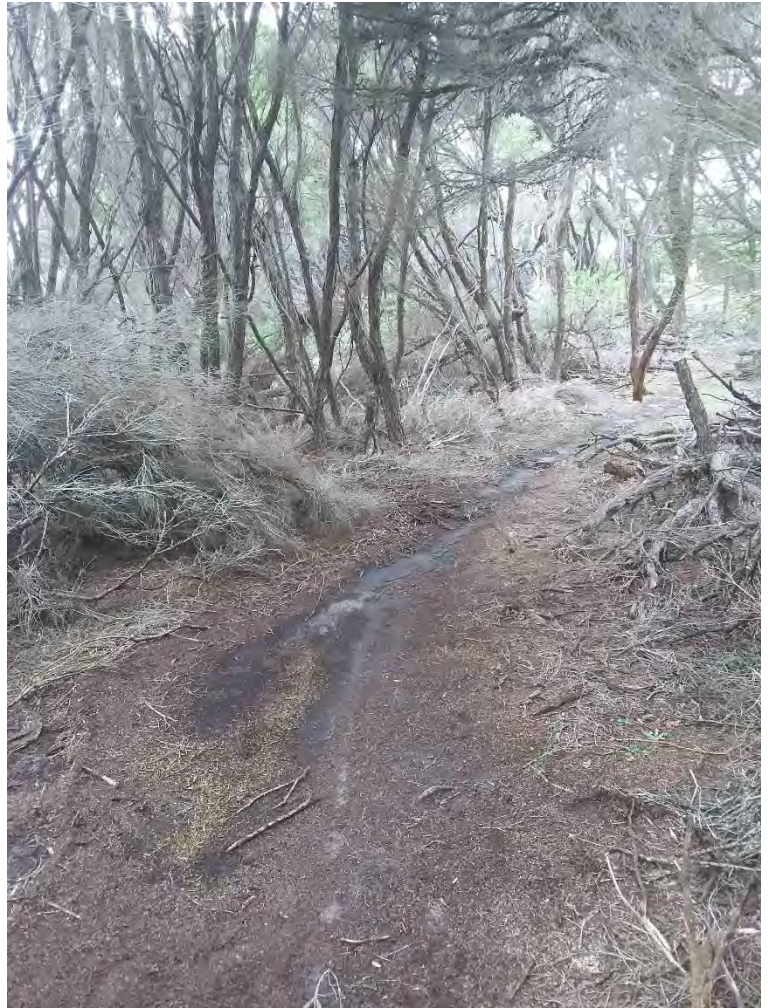
Work Section No.	14-1
Track Category	New Track
Length (m)	661
Cross Slope (%)	5 - 10, short sections at 25
Vegetation	75% thick melaleuca scrub, 25% open melaleuca.
Gradient (%)	0 - 10, short section at 15
Substrate	Rocky soil, some patches of soil.
Signage	Will need marker at start of section.
Descriptions/ Comments	Route follows cliff edge through low scrub, leave buffer around midden just before sea caves. Melaleuca becomes less dense near top of sea caves, then thickens again towards end of section. Section ends where alignment goes onto bedrock on coast.
Recommended Work (Text Details)	Machine benching. A climbing turn is needed at the start. Install climbing turns around thick vegetation if grade is exceeding 10%.
Machine benching (m)	640
Clear vegetation (Person Days)	2
Rehabilitate old track with soil and cleared vegetation.	Y

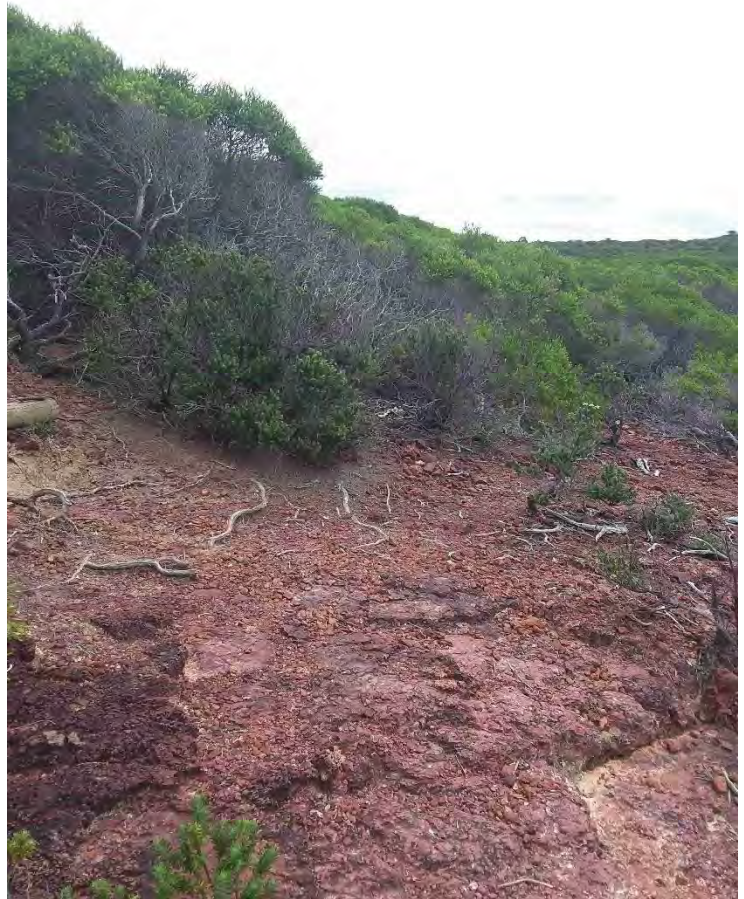
Work Section No.	14-2
Track Category	New Track
Length (m)	724
Cross Slope (%)	5-10, short sections of 20 - 30
Vegetation	25% thick scrub, 50% medium, 25% open melaleuca.
Gradient (%)	0 - 10, short sections at 15%
Substrate	Soil
Signage	Will need marker at end of section.
Descriptions/ Comments	This is the second half of the sea caves reroute. Route continues contouring along cliff-top from sea caves. There are views of the coast through the vegetation which now and then open up to more expansive views. Route ends at existing track on bedrock.
Recommended Work (Text Details)	Machine benching. Will need to install some climbing turns where alignment is greater than 10% grade.
Machine benching (m)	730
Clear vegetation (Person Days)	2
Rehabilitate old track with soil and cleared vegetation.	y

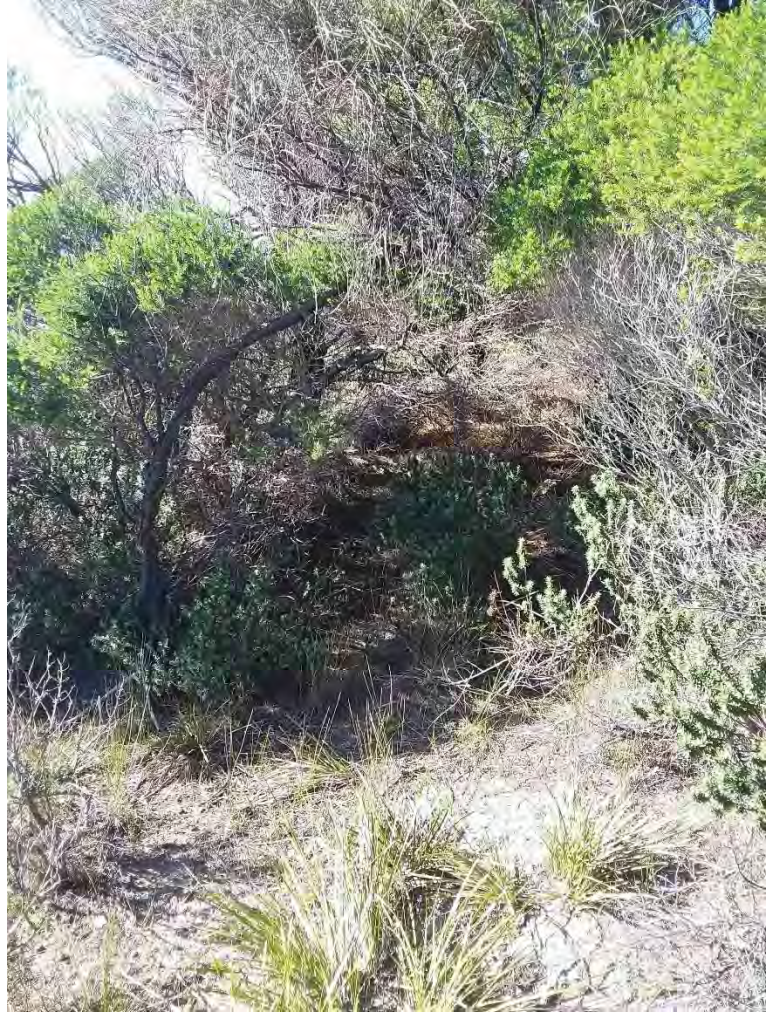
Work Section No.	15-1	No photo available
Track Category	Recommended New Track	
Length (m)	460	
Cross Slope (%)	0 - 15	
Vegetation	Thick melaleuca scrub.	
Gradient (%)	0 - 5	
Substrate	Soil	
Geotech Assessment Recommended	Route follows cliff top for part of section. Will need assessment.	
Descriptions/ Comments	Route starts where existing track on bedrock ends and heads inland. Route follows cliff top out to headland and contours around coastline. Finishes where thick melaleuca ends and open melaleuca starts.	
Recommended Work (Text Details)	Machine benching.	
Machine benching (m)	460	
Clear vegetation (Person Days)	1.5	
Rehabilitate old track with soil and cleared vegetation.	Y

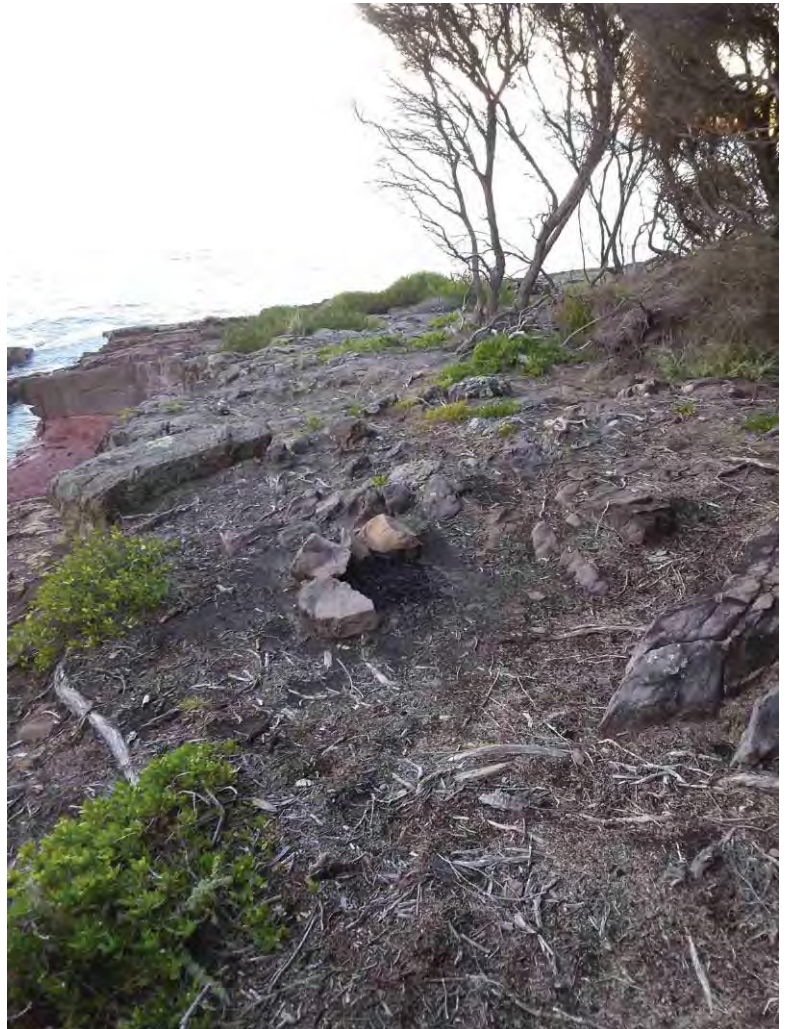
Work Section No.	16-1
Track Category	New Track
Length (m)	819
Cross Slope (%)	5 - 10, short sections at 15 - 20
Vegetation	66% thick scrub, 33% open woodland and melaleuca.
Gradient (%)	0 - 10, short sections at 15%
Substrate	Sandy soil, hard clay, one 10m rocky patch.
Signage	Will need to replace existing sign with one showing new distances and directions at start of section.
Descriptions/ Comments	This section starts from south end of Saltwater Creek Beach and contours along coastline. It ends where the route heads out onto the coastal rock platform. There are a number of midden sites on the coastline that were avoided by installing climbing turns. Although a threatened Plant Community Type (PCT) was marked on the route corridor map, it was not identified in the field by park ranger Sarah Fergusson.
Recommended Work (Text Details)	Machine benching. Install climbing turns to reduce grade on steeper sections or where midden sites present. May need some hand benching on sections with steep cross slope.

Benching by hand (Person Days)	4
Machine benching (m)	1440
Clear vegetation (Person Days)	3
Rehabilitate old track with soil and cleared vegetation.	Y

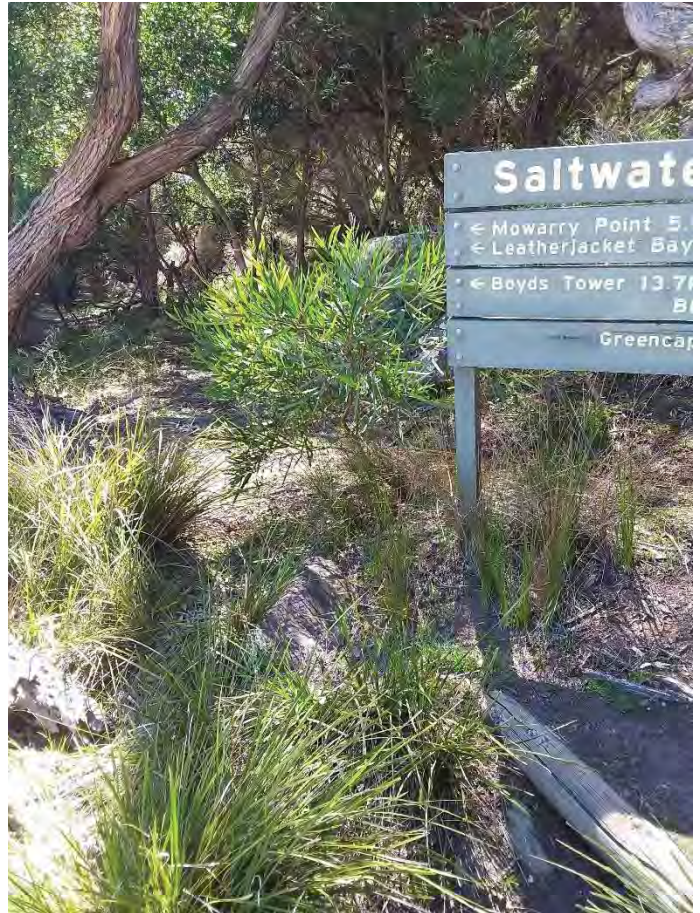
Work Section No.	16-2	No photo available
Track Category	New Track	
Length (m)	685	
Cross Slope (%)	5 - 10, short sections at 15 - 20	
Vegetation	50% thick scrub, 50% medium scrub	
Gradient (%)	0 -10	
Substrate	Sandy soil, hard clay	
Descriptions/ Comments	This section continues along top of steep slope following the coastline before heading inland to join the existing track. It will be redundant if the the preferred route along the coastal rock platform is used.	
Recommended Work (Text Details)	Machine benching.	
Machine benching (m)	685	
Clear vegetation (Person Days)	2

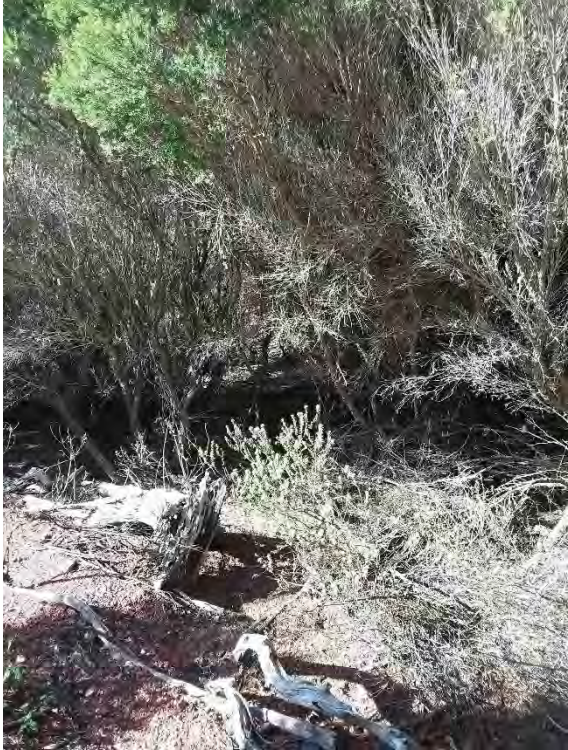
Work Section No.	17-1

Track Category	Recommended New Track	
Length (m)	16	
Cross Slope (%)	0 - 5	
Vegetation	thick scrub	
Gradient (%)	35	
Substrate	Hard clay, crumbly bedrock.	
Descriptions/ Comments	Short descent down to rock platform.	
Recommended Work (Text Details)	Install stone steps using local stone. May need to be flown from elsewhere.	
Stone Steps 900x200x400mm (ea.)	12	
Clear vegetation (Person Days)	0.1

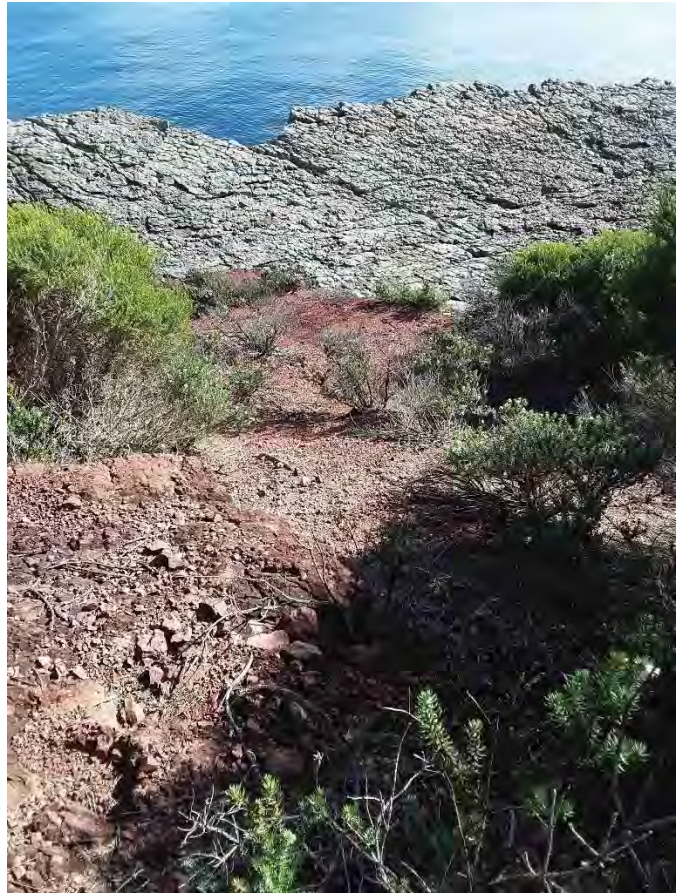
Work Section No.	17-3
Track Category	Recommended New Track
Length (m)	39
Cross Slope (%)	70
Vegetation	thick scrub
Gradient (%)	10
Substrate	Some soil, mostly soft bedrock.
Geotech Assessment Recommended	Will need assessment.
Descriptions/ Comments	Short section with very steep cross slope. Will need to be accessed for fall height issues.
Recommended Work	Full benching through soft bedrock using demo saw and jackhammer. Leave vegetation on downhill side to mitigate fall height issues.
Chisel tread (Person Days)	39
Clear vegetation (Person Days)	0.1

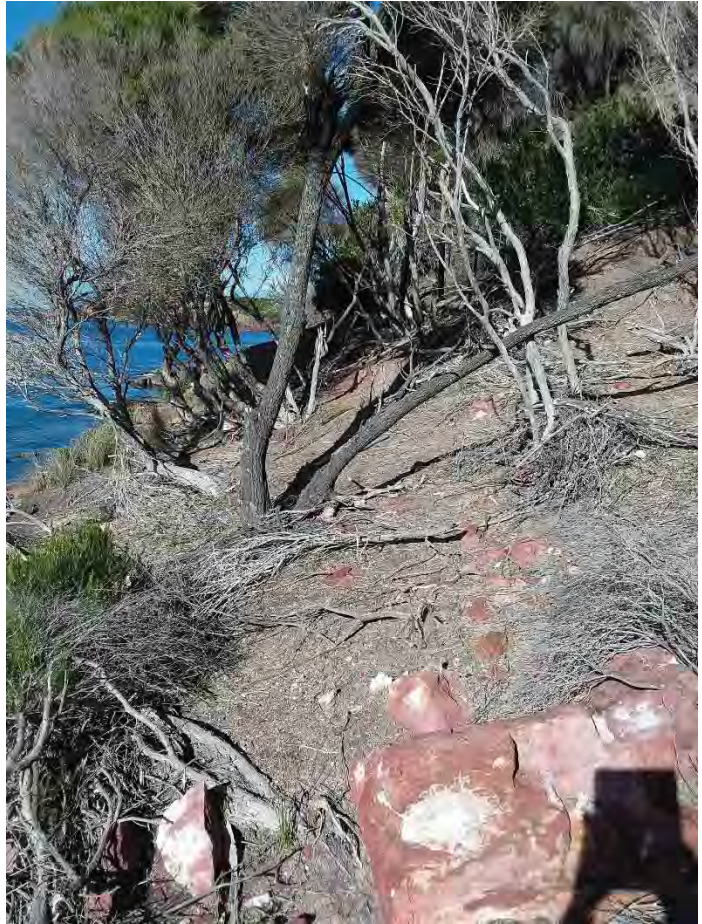
Work Section No.	17-4
Track Category	Recommended New Track
Length (m)	90
Cross Slope (%)	0 - 5
Vegetation	none
Gradient (%)	0 - 5
Substrate	Bedrock
Geotech Assessment Recommended	Will need assessment.
Descriptions/ Comments	Rock platform starts again.
Recommended Work (Text Details)	Carve to steps in bedrock at start of section.
Chiselled step(900-1200x300x200mm) (ea.)	2

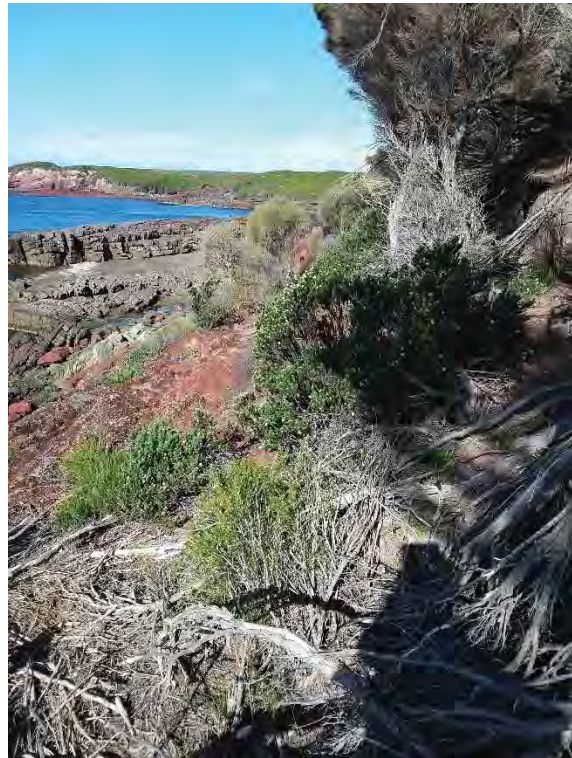
Work Section No.	17-5
Track Category	Recommended New Track
Length (m)	19
Cross Slope (%)	0 - 10
Vegetation	some grass and small bushes
Gradient (%)	0 - 5
Substrate	bedrock
Geotech Assessment Recommended	Will need assessment.
Descriptions/ Comments	Bedrock becomes rough and uneven in some spots.
Recommended Work	Chisel rough spots
Chisel tread (Person Days)	5

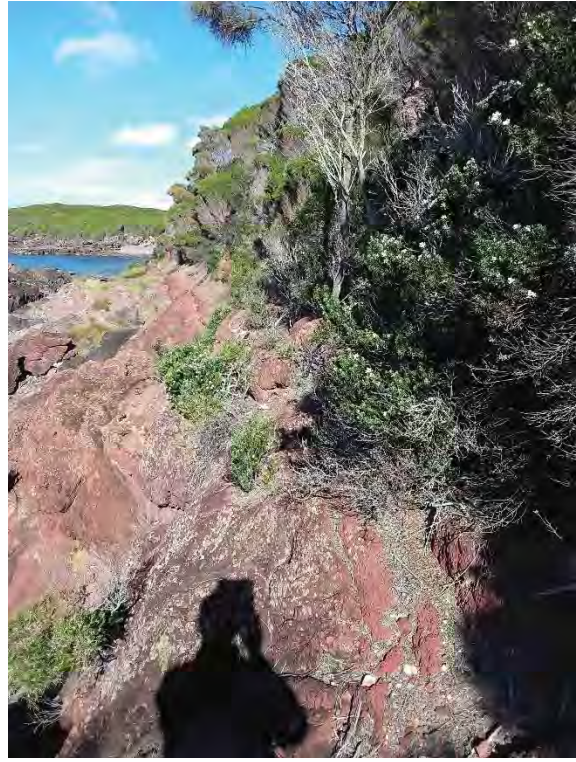
Work Section No.	17-6
Track Category	Recommended New Track
Length (m)	13
Cross Slope (%)	0 - 5
Vegetation	none
Gradient (%)	100
Substrate	bedrock
Geotech Assessment Recommended	Will need assessment.
Descriptions/ Comments	Platform ends with 4m high cliff face. To continue following rock platform will require large stone stairway.
Recommended Work (Text Details)	Install 5m long by 4m high by 1.5m wide stairway (15 cubic meters) stone stairway.
Stone work - (Person Days)	125
Set up overhead rigging - person days.	4

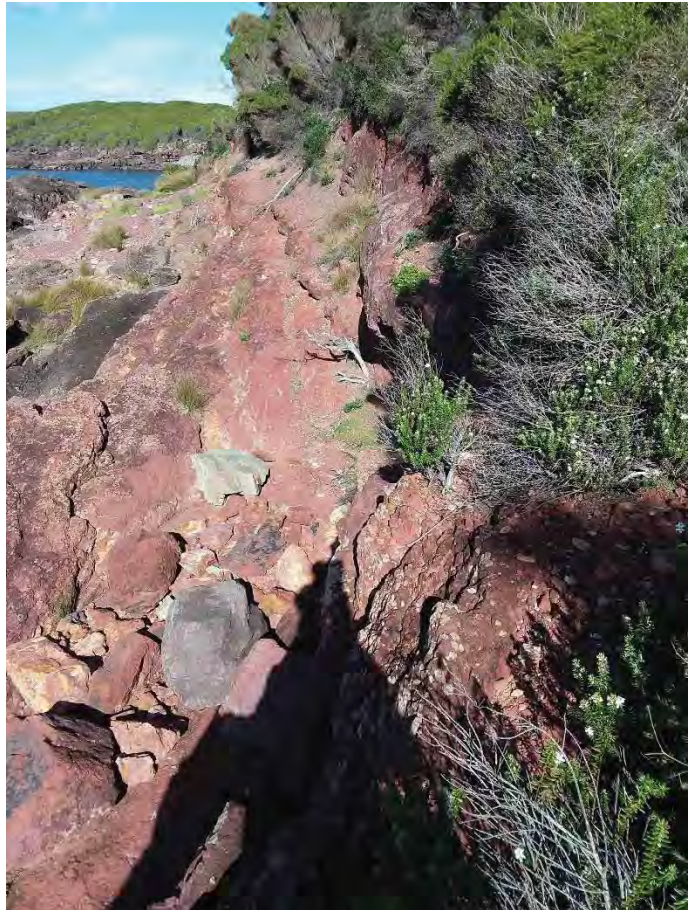
Work Section No.	17-7
Track Category	Recommended New Track
Length (m)	71
Cross Slope (%)	0 - 5
Gradient (%)	0 - 10
Substrate	bedrock
Descriptions/ Comments	Route follows bedrock.
Recommended Work (Text Details)	No work needed.

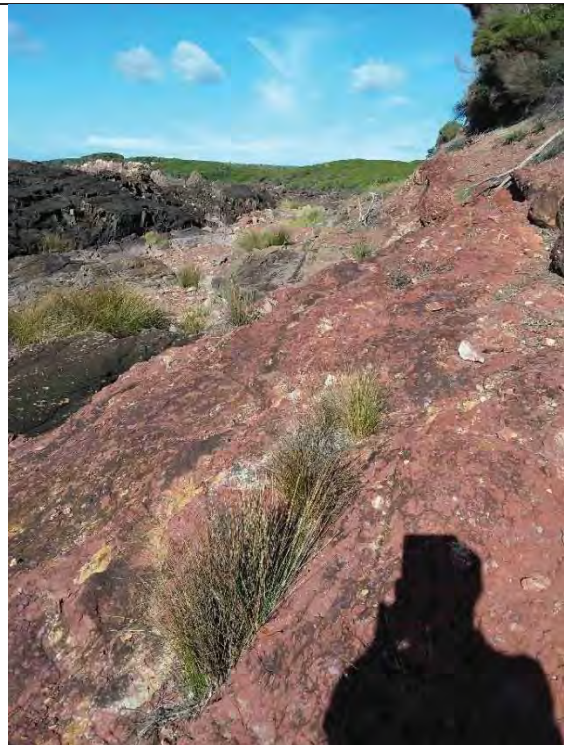
Work Section No.	17-8
Track Category	Recommended New Track
Length (m)	8
Cross Slope (%)	0 - 20
Vegetation	none
Gradient (%)	5 -30
Substrate	large boulders
Geotech Assessment Recommended	Will need assessment.
Descriptions/ Comments	Bedrock ends with crossing over large boulders that form natural causeway.
Recommended Work (Text Details)	Boulders can be maneuvered to make easier to cross causeway. Boulders and rough wall can be added to make more walker friendly.
Stone work - (Person Days)	12

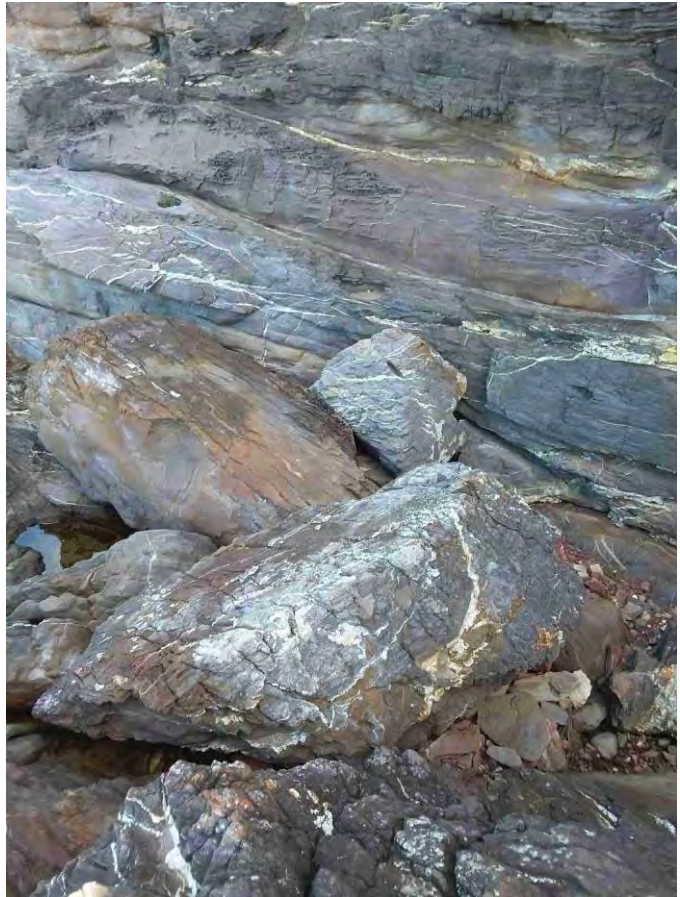
Work Section No.	17-9
Track Category	Recommended New Track
Length (m)	3
Cross Slope (%)	0 - 15
Vegetation	none
Gradient (%)	70
Substrate	bedrock
Geotech Assessment Recommended	Will need assessment.
Descriptions/ Comments	Route climbs up small escarpment.
Recommended Work (Text Details)	Chisel bedrock to reduce cross slope. Chisel steps into bedrock.
Chiselled step(900-1200x300x200mm) (ea.)	12
Chisel tread (Person Days)	1

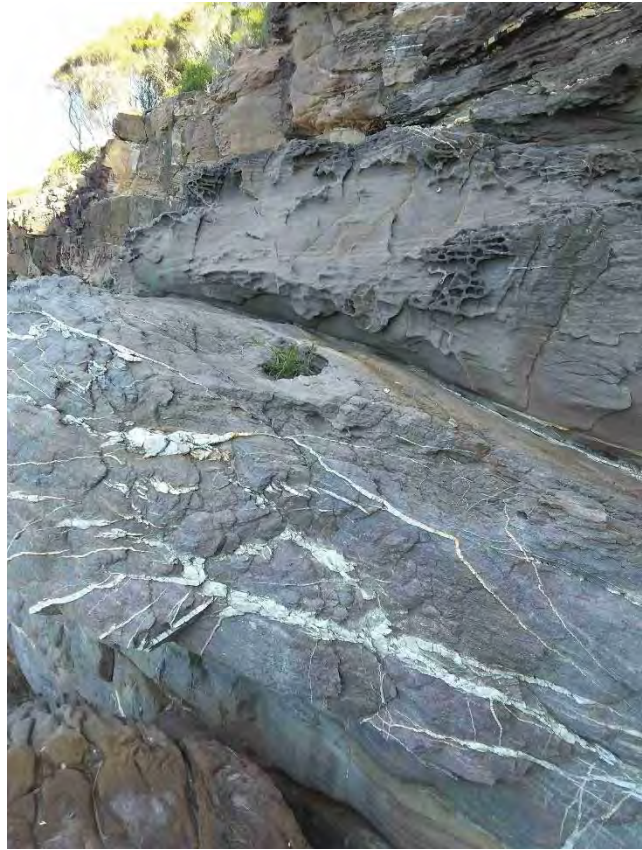
Work Section No.	17-10
Track Category	Recommended New Track
Length (m)	21
Cross Slope (%)	0 - 5
Vegetation	some bushes
Gradient (%)	0 - 5
Substrate	Crumbly bedrock
Geotech Assessment Recommended	Will need assessment.
Descriptions/ Comments	Route follows rough bedrock.
Recommended Work (Text Details)	Rough bedrock will need some chiselling and sledge hammering to make more walker friendly.
Chisel tread (Person Days)	3

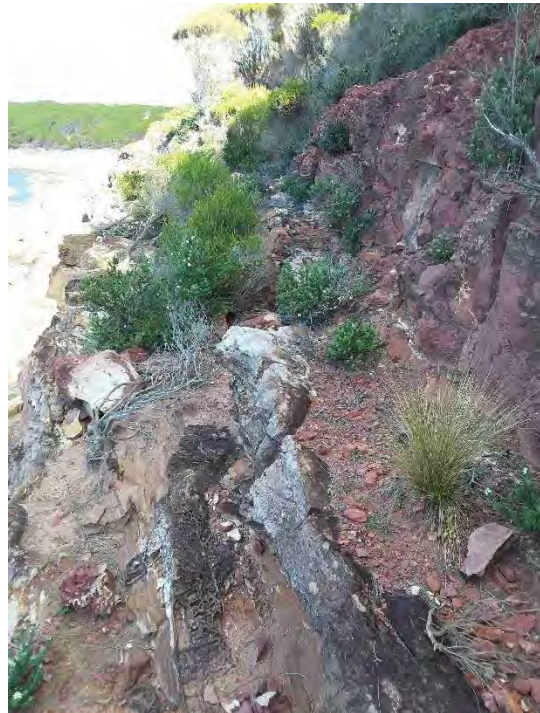
Work Section No.	17-11
Track Category	Recommended New Track
Length (m)	10
Cross Slope (%)	0 - 5
Vegetation	some
Gradient (%)	40
Substrate	Crumbly bedrock
Descriptions/ Comments	Short climb up crumbly bedrock slope then benching in crumbly bedrock.
Recommended Work (Text Details)	Carve 5 steps then full bench in crumbly bedrock. Bench in bedrock for 5m.
Chiselled step(900-1200x300x200mm) (ea.)	5
Chisel tread (Person Days)	2

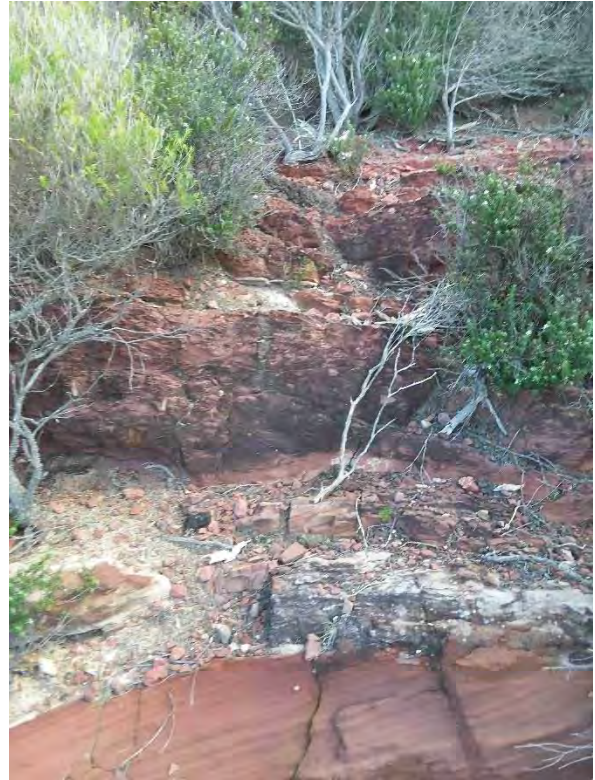
Work Section No.	17-12
Track Category	Recommended New Track
Length (m)	54
Cross Slope (%)	5 - 25
Vegetation	melaleuca scrub
Gradient (%)	0 - 10
Substrate	soil
Geotech Assessment Recommended	Will need assessment.
Descriptions/ Comments	Route contours at gentle grade to pass small coastal ravine. Contours back down onto bedrock once passed head of ravine.
Recommended Work (Text Details)	Hand benching - not worth flying in machine for such a short easy section.
Benching by hand (Person Days)	1.5
Clear vegetation (Person Days)	0.1

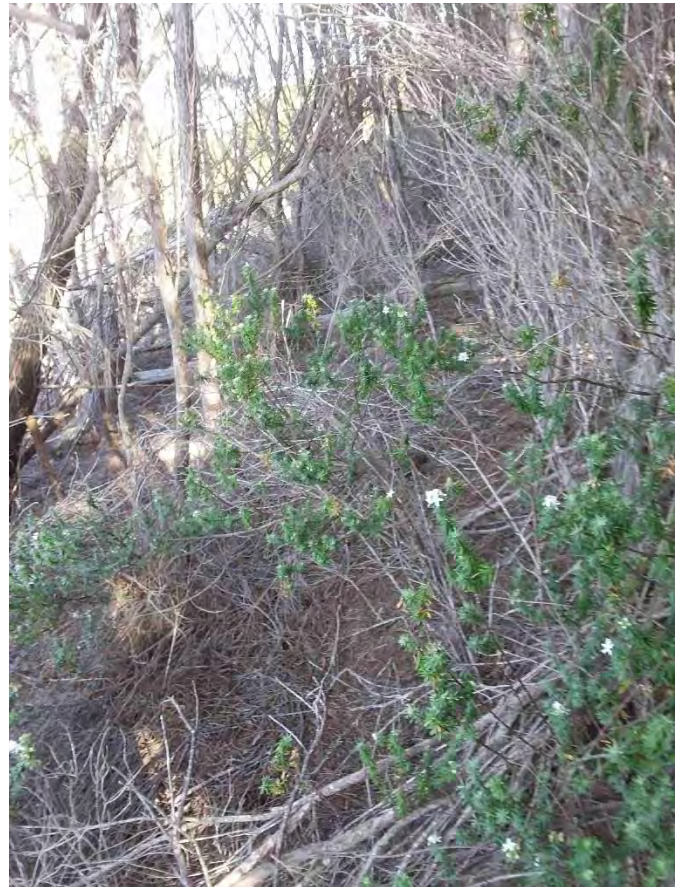
Work Section No.	17-13
Track Category	Recommended New Track
Length (m)	112
Cross Slope (%)	0 - 5
Vegetation	Some low bushes.
Gradient (%)	0 - 10
Substrate	Bedrock.
Geotech Assessment Recommended	Will need assessment.
Descriptions/ Comments	Route goes along rough uneven bedrock to cobbled beach.
Recommended Work (Text Details)	Will need some clearing of loose rock and chiselling of uneven patches.
Chisel tread (Person Days)	5

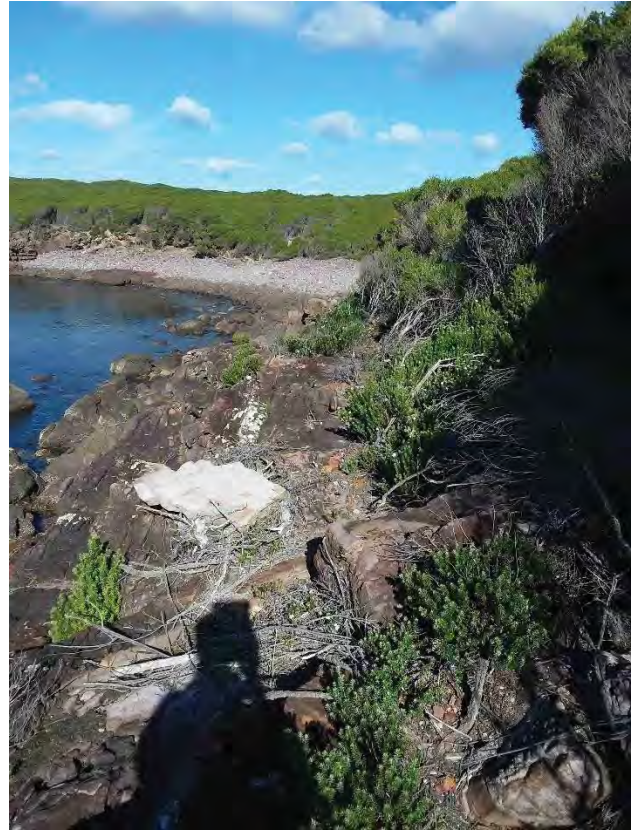
Work Section No.	18
Track Category	New Track
Length (m)	1593
Cross Slope (%)	70% at <10, 25% at 10 - 25, 5% at 30 - 50
Vegetation	10% thick scrub, 10% medium scrub, 80% Open woodland and melaleuca.
Gradient (%)	0 - 10
Substrate	Soil, some patches of clay, 50m section of very rocky ground.
Viewing/Rest points	Yes
Descriptions/ Comments	Route leaves existing track to contour at gentle grade to cliff top then contours into gully to cross at small bridge on existing track. The route then contours back towards coast and follows cliff top into Bittangabee Bay to rejoin existing track at creek crossing. Two middens were avoided but one will need an AHIP to build over. Most of the threatened heathland was avoided by taking route along cliff top but a 10m section will need to be built through.
Recommended Work (Text Details)	Machine benching. A steep 100m rocky section may need to be benched by hand.
Timber return(mm) total length

Benching by hand (Person Days)	5
Machine benching (m)	1480
Clear vegetation (Person Days)	2
Rehabilitate old track with soil and cleared vegetation.	Y

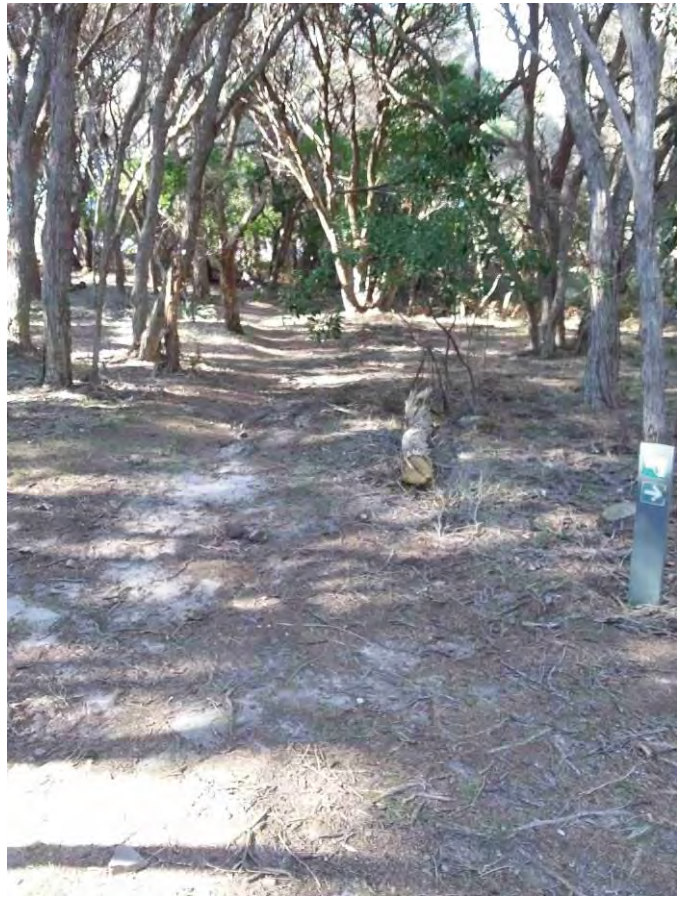
Work Section No.	19
Track Category	New Track
Length (m)	100
Cross Slope (%)	0 - 5
Vegetation	open melaleuca
Gradient (%)	10 - 20
Substrate	soil
Signage	This is where the route leaves the camp ground. Signs with distances etc. will be needed.
Descriptions/ Comments	Route leaves campground area and heads to shoreline.
Recommended Work (Text Details)	Light machine benching. May need a climbing turn to keep grade below 10%.
Machine benching (m)	100
Clear vegetation (Person Days)	0.1

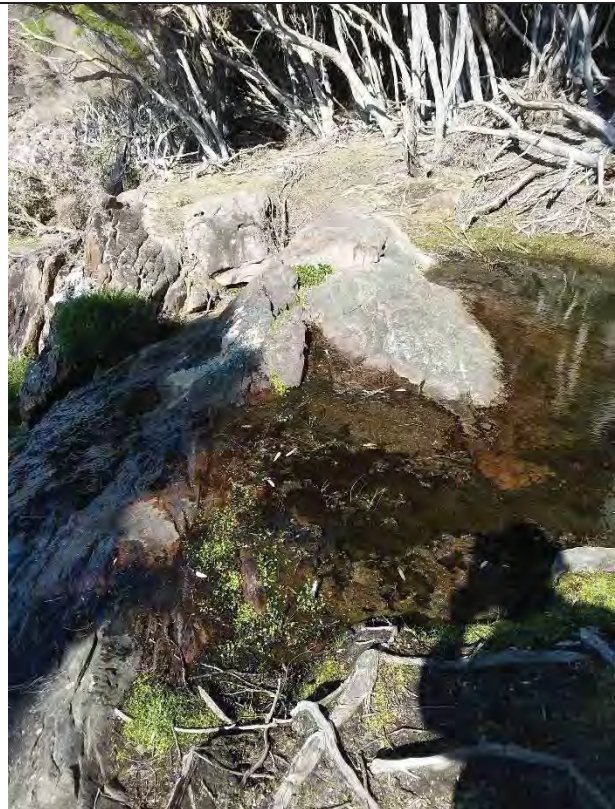
Work Section No.	20
Track Category	New Track
Length (m)	3
Cross Slope (%)	
Vegetation	none
Gradient (%)	0
Substrate	bedrock
Descriptions/ Comments	Stream crossing over bedrock.
Recommended Work (Text Details)	Insert two stepping stones. Use local stone.
Stepping stones 1000x400x400mm (ea.)	2

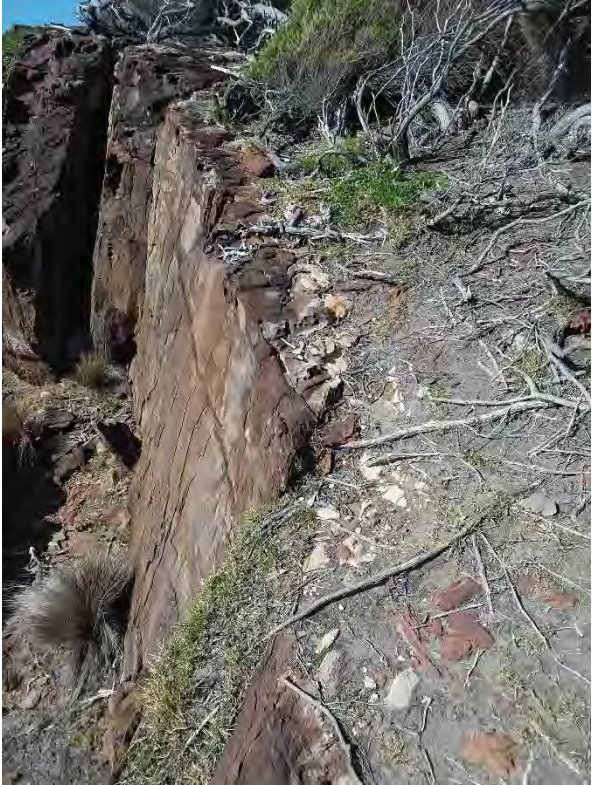
Work Section No.	22

Track Category	New Track	
Length (m)	1473	
Cross Slope (%)	5 - 20	
Vegetation	Melaleuca scrub.	
Gradient (%)	0 - 15	
Substrate	soil	
Descriptions/ Comments	Route leaves bedrock and follows clifftop through melaleuca scrub. Occasionally heads inland to avoid middens.	
Recommended Work (Text Details)	May need to switchback inland to avoid fall hieght at start and keep grade below 10%. Machine benching.	
Machine benching(m)	1473	
Clear vegetation - person days.	3

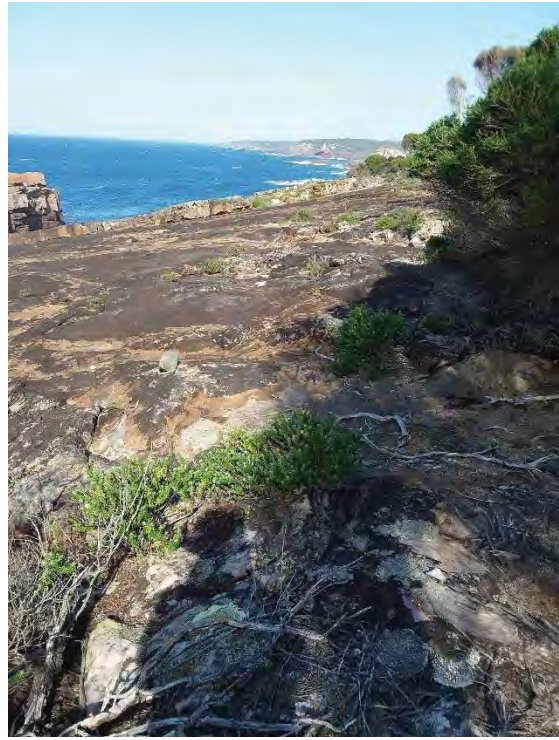
Work Section No.	23
Track Category	New Track
Length (m)	101
Cross Slope (%)	0 - 20
Vegetation	none
Gradient (%)	0 - 15
Substrate	bedrock
Signage	Will need some stencilled arrows on bedrock to indicate route.
Descriptions/ Comments	Route follows coastal bedrock.
Recommended Work (Text Details)	No work required.

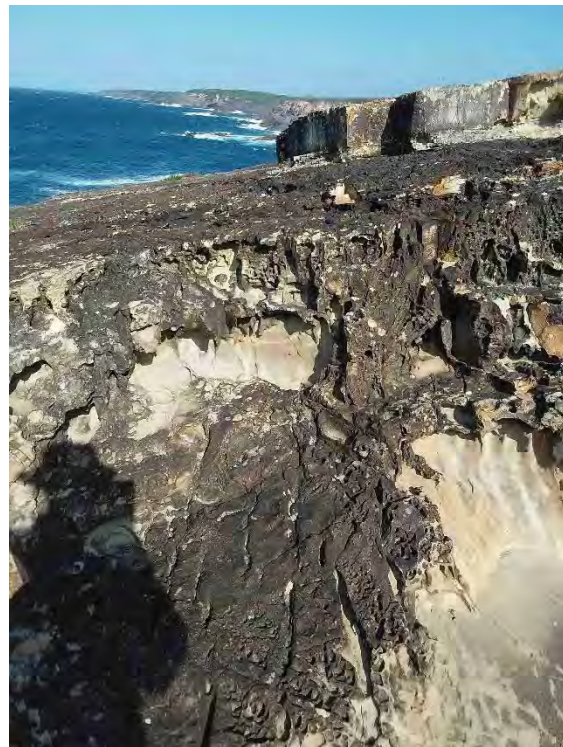
Work Section No.	24
Track Category	New Track
Length (m)	1
Cross Slope (%)	0 - 10
Vegetation	none
Gradient (%)	0 - 10
Substrate	bedrock
Signage	Will need some stencilled arrows on bedrock to indicate route.
Descriptions/ Comments	Route passes along uneven bedrock with some boulders.
Recommended Work (Text Details)	Clear boulders off route chisel bedrock.
Stone work - (Person Days)	2

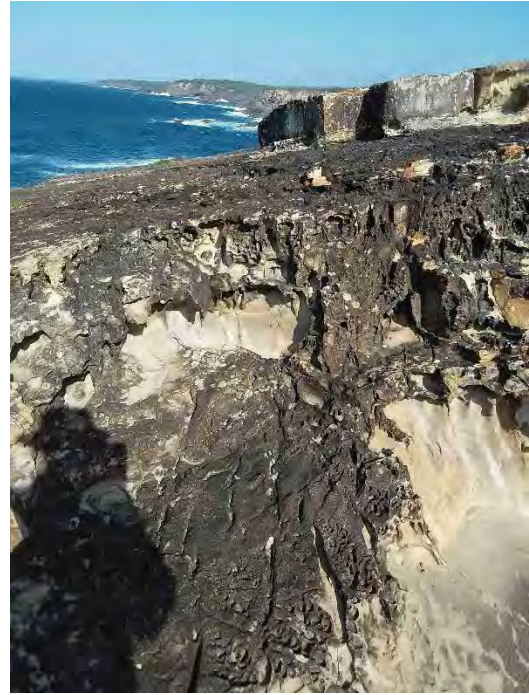
Work Section No.	25
Track Category	New Track
Length (m)	200
Cross Slope (%)	0 - 10
Vegetation	none
Gradient (%)	0 - 10
Substrate	bedrock
Signage	Will need some stencilled arrows on bedrock to indicate route.
Descriptions/ Comments	Route follows coastal bedrock.
Recommended Work (Text Details)	No work required.

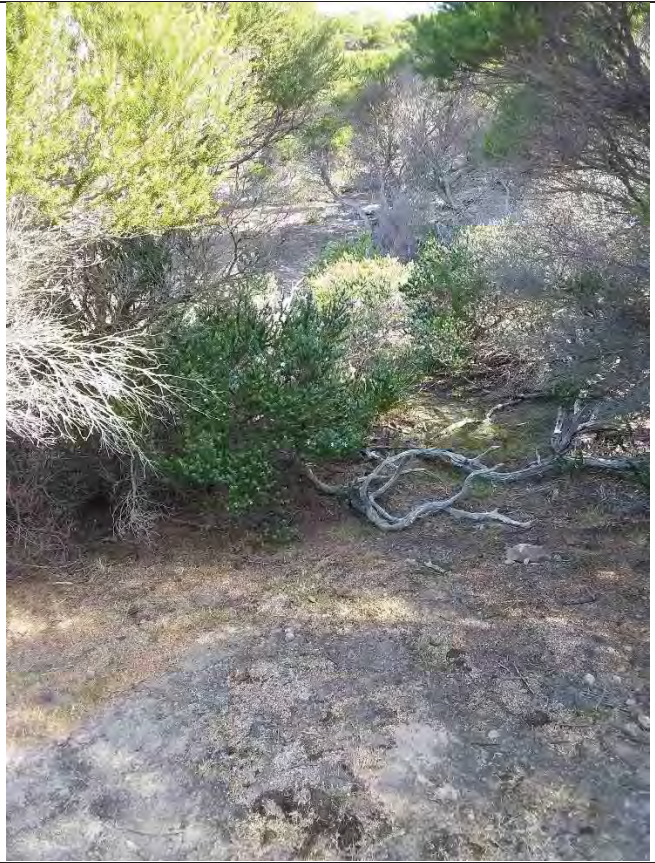
Work Section No.	26
Track Category	New Track
Length (m)	9
Cross Slope (%)	<5
Vegetation	melaleuca bushes
Gradient (%)	<5
Substrate	soil
Descriptions/ Comments	Route goes through patch of melaleuca with soil substrate.
Recommended Work (Text Details)	Light hand benching.
Chisel tread (Person Days)	
Benching by hand (Person Days)	0.3
Clear vegetation (Person Days)	0.2

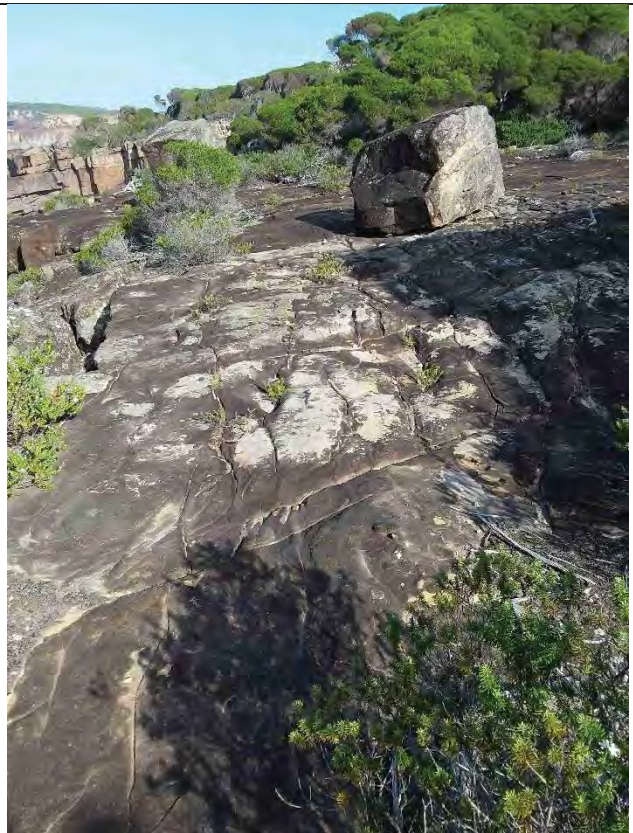
Work Section No.	27
Track Category	New Track
Length (m)	37
Cross Slope (%)	5
Vegetation	none
Gradient (%)	5
Substrate	bedrock
Signage	Will need some stencilled arrows on bedrock to indicate route.
Descriptions/ Comments	Route passes along bedrock.
Recommended Work (Text Details)	No work required.
