Ben Boyd National Park

Light to Light Walk

Recommended Alignment and Construction

TRACK AND TRAIL MANAGEMENT SERVICES PTY LTD

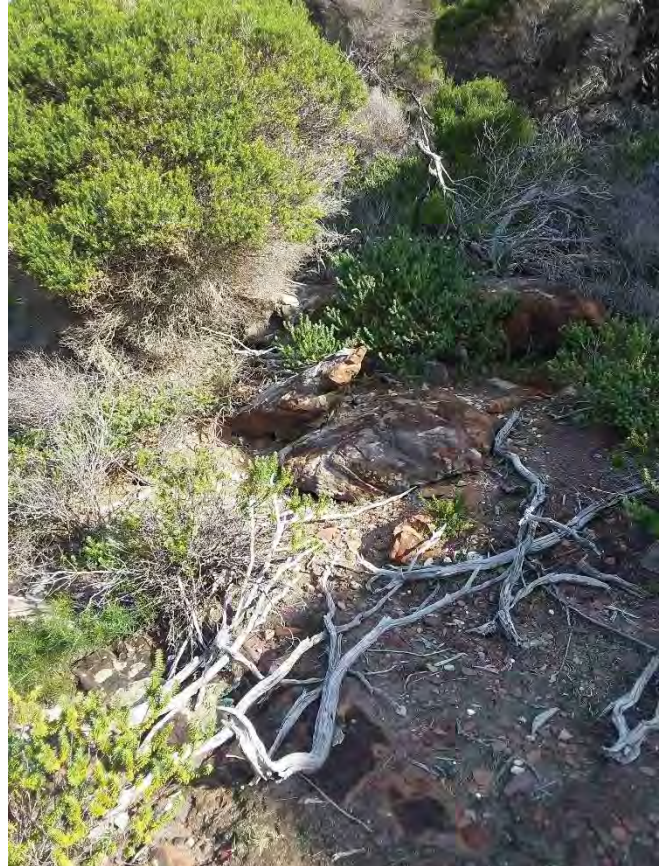
Work Section No.	28
Track Category	New Track
Length (m)	23
Cross Slope (%)	<5
Vegetation	melaleuca scrub
Gradient (%)	5
Substrate	bedrock with patches of soil and stones on top
Descriptions/ Comments	Start of bedrock mixed with patches soil and stones on top with melaleuca scrub.
Recommended Work (Text Details)	Will need some clearing of vegetation. Light hand benching.
Benching by hand (Person Days)	0.3
Clear vegetation (Person Days)	0.2

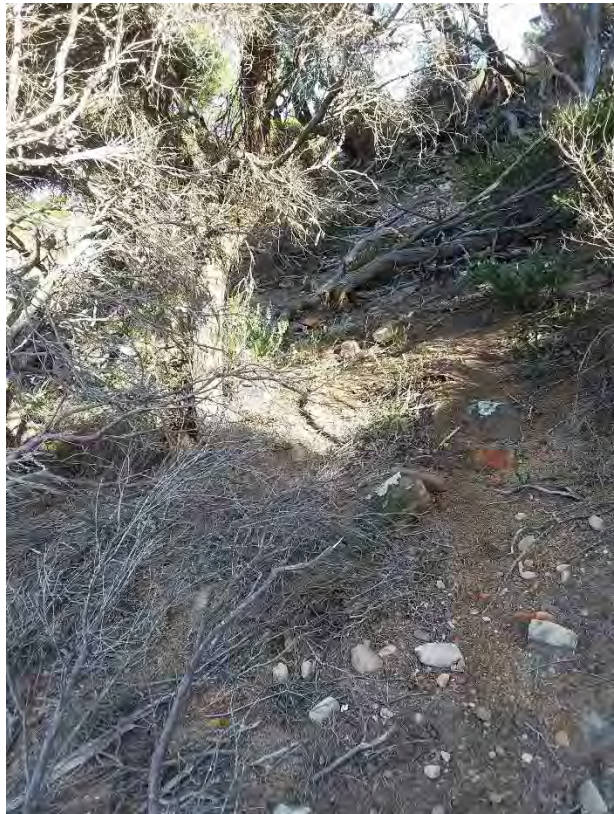
Work Section No.	29
Track Category	New Track
Length (m)	114
Cross Slope (%)	5 - 20
Vegetation	melaleuca scrub
Gradient (%)	0 - 10
Substrate	Stoney soil
Descriptions/ Comments	Route leaves bedrock and starts climbing and contouring around cliff top before returning to bedrock.
Recommended Work (Text Details)	Hand benching (not worth bring in machine for this short section.
Benching by hand (Person Days)	3
Clear vegetation (Person Days)	1

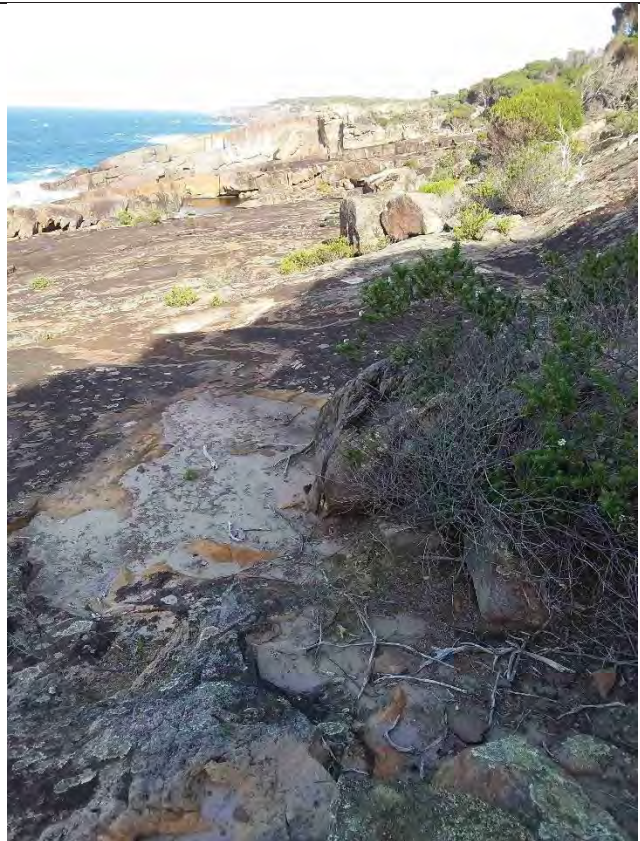
Work Section No.	30
Track Category	New Track
Length (m)	194
Cross Slope (%)	5
Vegetation	none
Gradient (%)	5 - 10
Substrate	bedrock
Signage	Will need some stencilled arrows on bedrock to indicate route.
Descriptions/ Comments	Route follows bedrock.
Recommended Work (Text Details)	No work required.

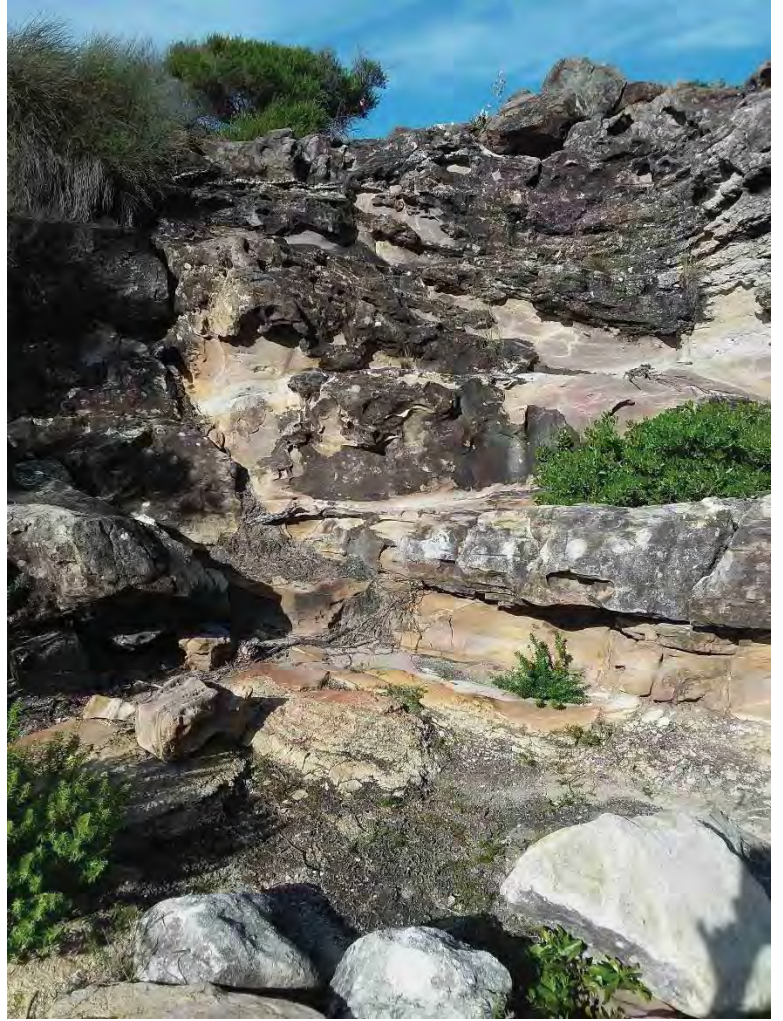
Work Section No.	31
Track Category	New Track
Length (m)	15
Cross Slope (%)	0
Vegetation	none
Gradient (%)	50 - 60
Substrate	bedrock
Signage	Will need some stencilled arrows on bedrock to indicate route.
Descriptions/ Comments	Rugged bedrock section. This section is passable as is but could install small carved steps and install three stone step using local stone to make more walker friendly. 8 man days
Recommended Work (Text Details)	Chisel small carved steps. Install stone steps using local stone.
Stone Steps 900x200x400mm (ea.)	3
Chiselled step(900- 1200x300x200mm) (ea.)	7

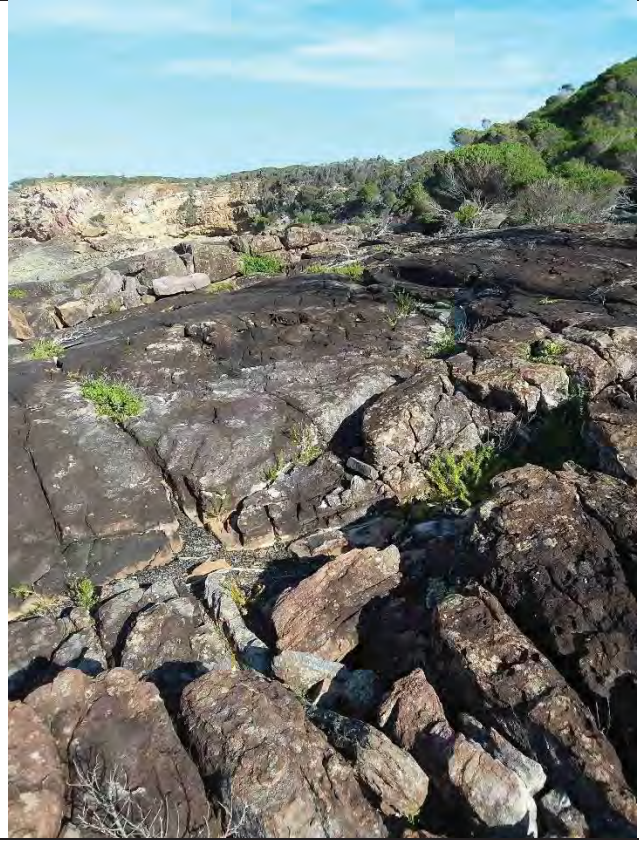
Work Section No.	32
Track Category	New Track
Length (m)	101
Cross Slope (%)	5 - 20
Vegetation	none
Gradient (%)	0 - 10
Substrate	bedrock
Signage	Will need some stencilled arrows on bedrock to indicate route.
Descriptions/ Comments	Route follows bedrock.
Recommended Work (Text Details)	No work required.

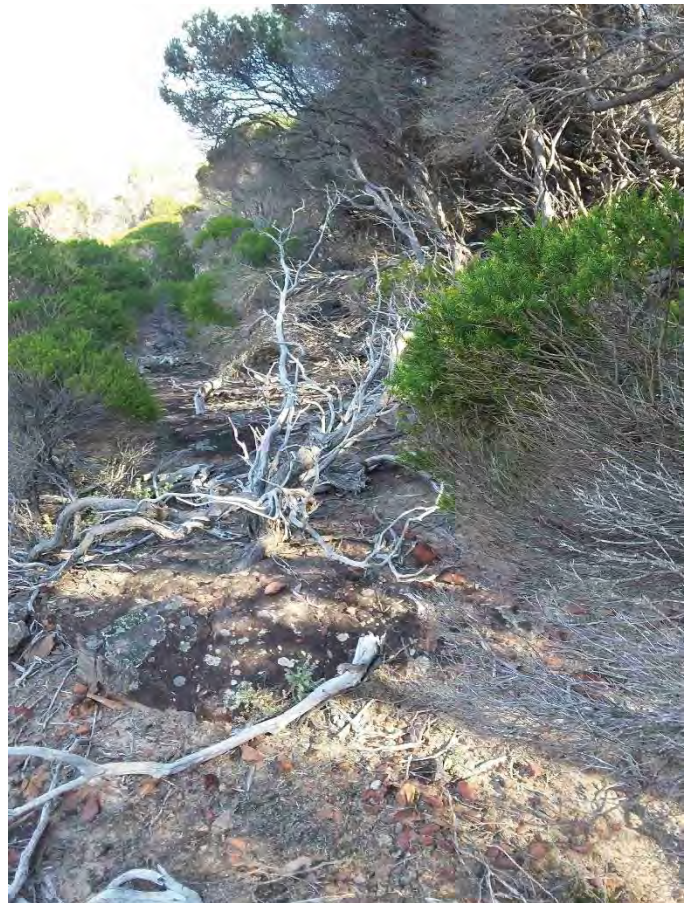
Work Section No.	33
Track Category	New Track
Length (m)	348
Cross Slope (%)	5 - 10
Vegetation	melaleuca scrub
Gradient (%)	0 - 10
Substrate	soil, stoney soil
Signage	Will need marker or sign to show where route leaves bedrock.
Descriptions/ Comments	Route leaves bedrock and contours around cliff top. May need to leave bedrock earlier to keep grade below 10%.
Recommended Work (Text Details)	Machine benching.
Machine benching (m)	348
Clear vegetation (Person Days)	2

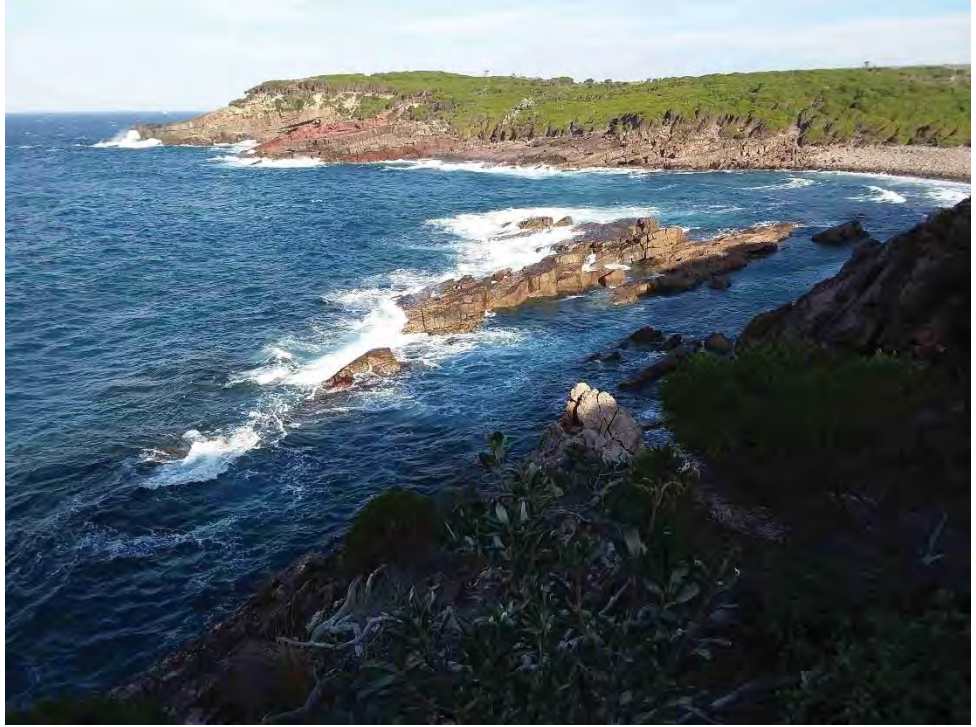
Work Section No.	35

Track Category	New Track	
Length (m)	207	
Cross Slope (%)	5 - 15	
Vegetation	melaleuca scrub	
Gradient (%)	0 - 10	
Substrate	soil	
Descriptions/ Comments	Route continues contouring around cliff top. Maintain 0% grade (do not start descending) till pasted control point before cobbled beach.	
Recommended Work (Text Details)	Machine benching.	
Machine benching (m)	207	
Clear vegetation (Person Days)	1

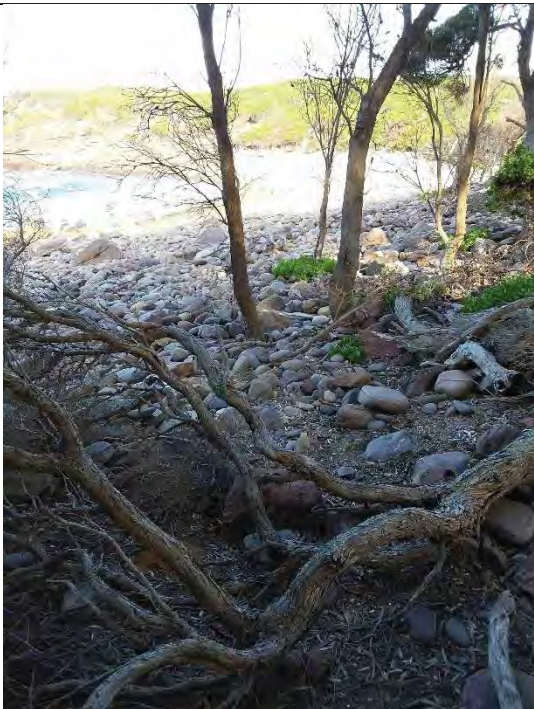
Work Section No.	36

Track Category	New Track	
Length (m)	147	
Cross Slope (%)	10	
Vegetation	none	
Substrate	beach cobbles	
Signage	Will need marker at both ends of beach.	
Descriptions/ Comments	Route goes along beach.	
Recommended Work (Text Details)	No work required.

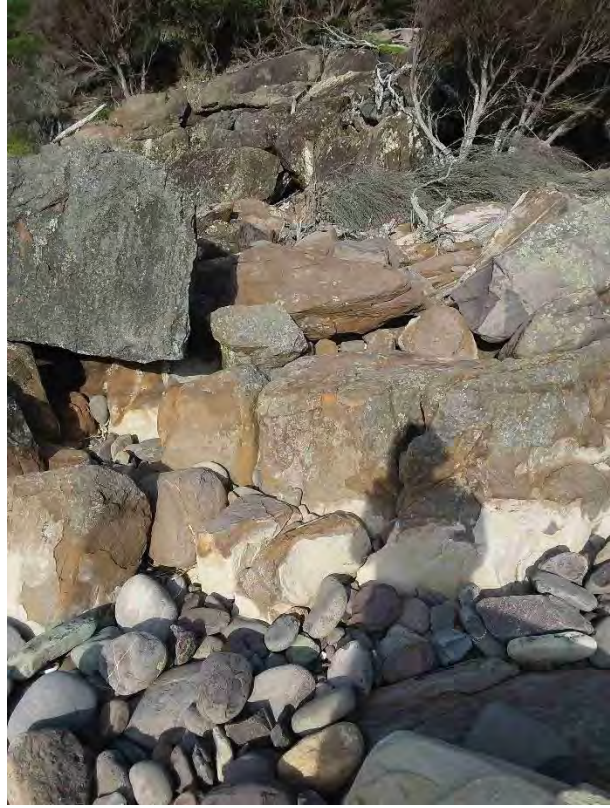
Work Section No.	37
Track Category	New Track
Length (m)	32
Cross Slope (%)	
Vegetation	none
Gradient (%)	
Substrate	bedrock
Descriptions/ Comments	Exit off cobbled beach onto rugged bedrock with boulders.
Recommended Work (Text Details)	Install steps using local stone. Rearrange boulders to make more walker friendly.
Stone work - (Person Days)	1
Stone Steps 900x200x400mm (ea.)	2

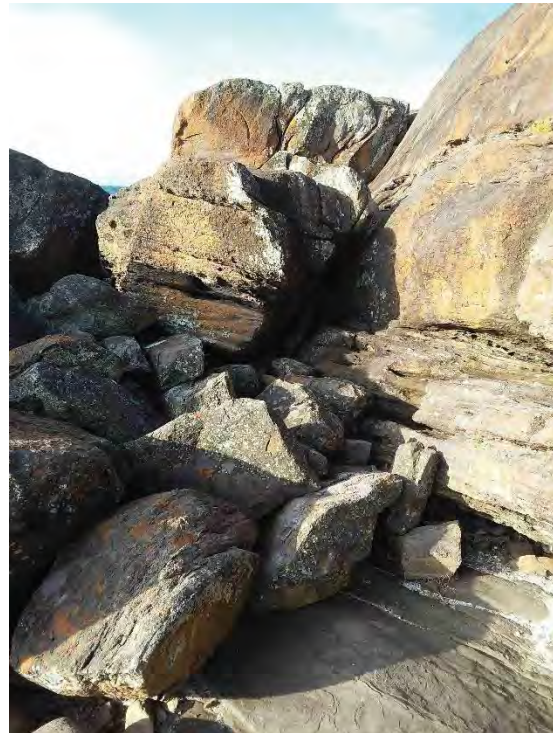
Work Section No.	38
Track Category	New Track
Length (m)	6
Cross Slope (%)	0
Vegetation	none
Substrate	bedrock
Descriptions/ Comments	End rugged bedrock. Route goes up small cliff.
Recommended Work (Text Details)	Construct stairway using local stone and carved steps.
Stone Steps 900x200x400mm (ea.)	6
Chiselled step(900-1200x300x200mm) (ea.)	2

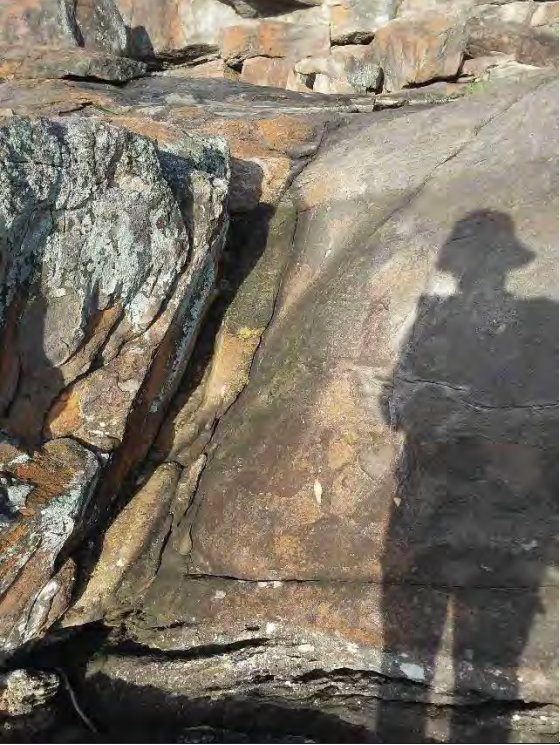
Work Section No.	39

Track Category	New Track	
Length (m)	6	
Cross Slope (%)	0	
Vegetation	none	
Gradient (%)	90	
Substrate	bedrock	
Descriptions/ Comments	Route goes up small cliff.	
Recommended Work (Text Details)	Carve steps in bedrock.	
Chiselled step(900-1200x300x200mm) (ea.)	7

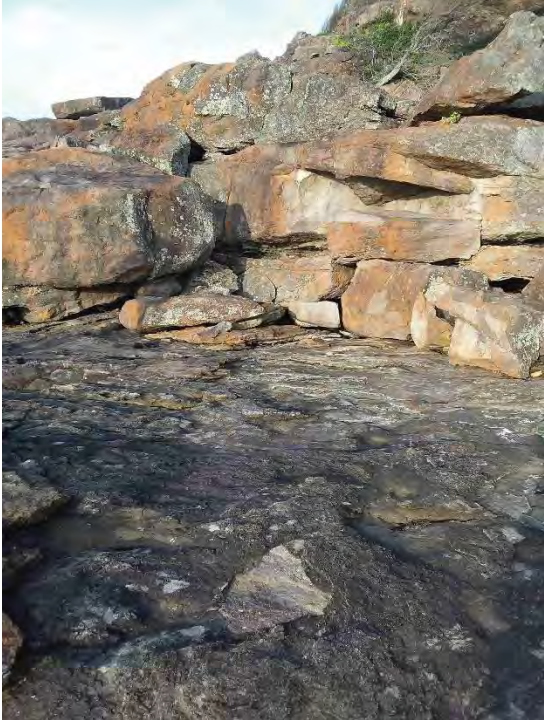
Work Section No.	40

Track Category	New Track	
Length (m)	4	
Cross Slope (%)	0	
Vegetation	none	
Gradient (%)	0	
Substrate	bedrock	
Descriptions/ Comments	End stairway, start short section of bedrock.	
Recommended Work (Text Details)	No work required.

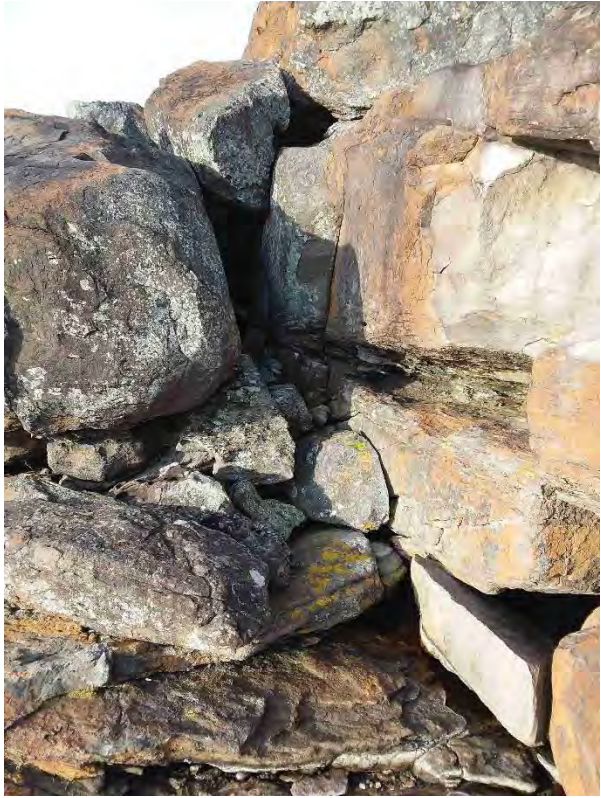
Work Section No.	41
Track Category	New Track
Length (m)	3
Cross Slope (%)	0
Vegetation	none
Gradient (%)	70
Substrate	bedrock, boulders
Descriptions/ Comments	Route goes up small rise.
Recommended Work (Text Details)	Construct stairway - install steps using local split boulders. May need to move boulders to create barrier and remove fall hazard.
Stone work - (Person Days)	4
Stone Steps 900x200x400mm (ea.)	10

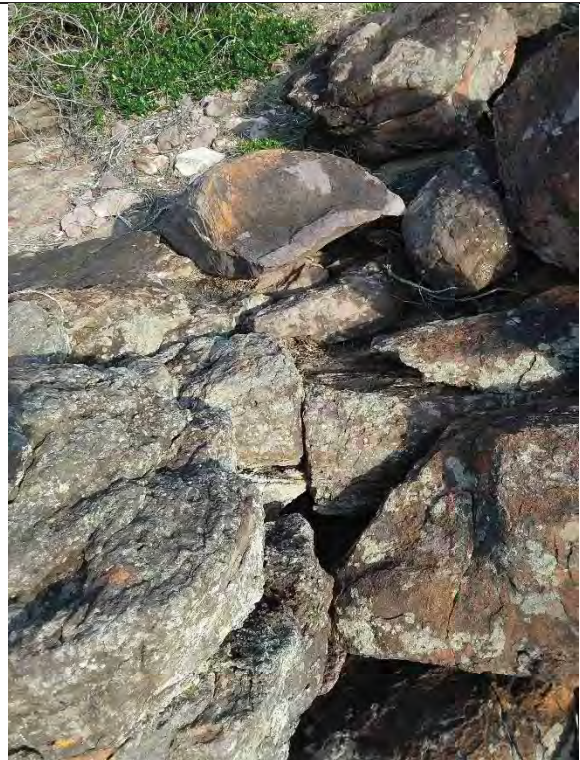
Work Section No.	42
Track Category	New Track
Length (m)	16
Cross Slope (%)	0
Vegetation	none
Gradient (%)	0
Substrate	bedrock
Descriptions/ Comments	End stairway. Start short section of bedrock.
Recommended Work (Text Details)	No work required.

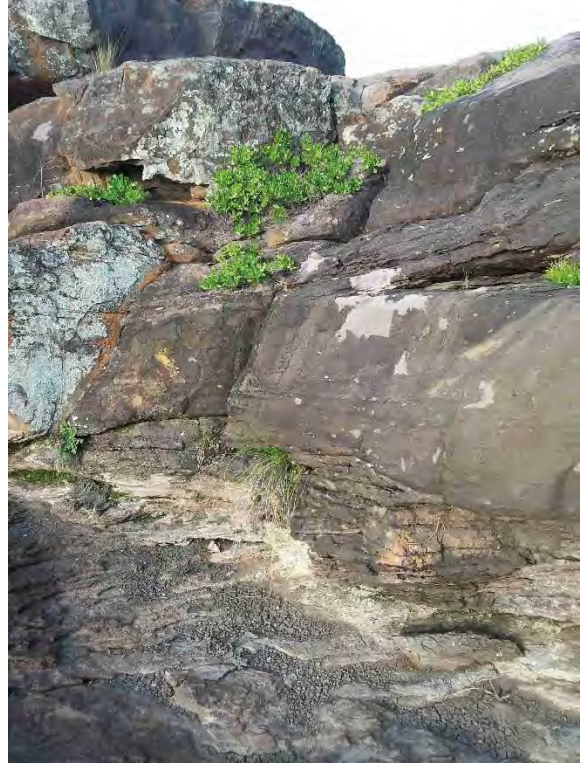
Work Section No.	43
Track Category	New Track
Length (m)	3
Cross Slope (%)	0
Vegetation	none
Gradient (%)	80
Substrate	bedrock
Descriptions/ Comments	End bedrock, start stairway.
Recommended Work (Text Details)	Install 6 steps from local split boulders. Carve upper steps from bedrock.
Stone Steps 900x200x400mm (ea.)	6
Chiselled step(900-1200x300x200mm) (ea.)	5

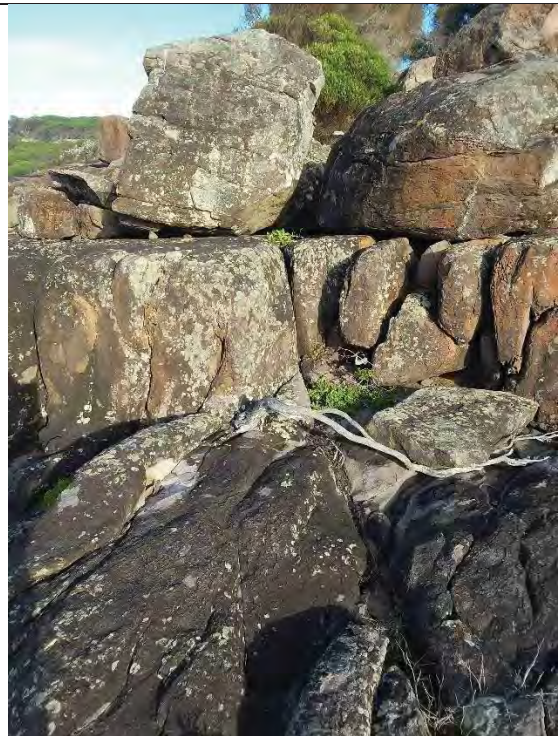
Work Section No.	44
Track Category	New Track
Length (m)	3
Cross Slope (%)	0
Vegetation	none
Gradient (%)	0
Substrate	bedrock
Descriptions/ Comments	End stairway. Short section of bedrock.
Recommended Work (Text Details)	No work required.

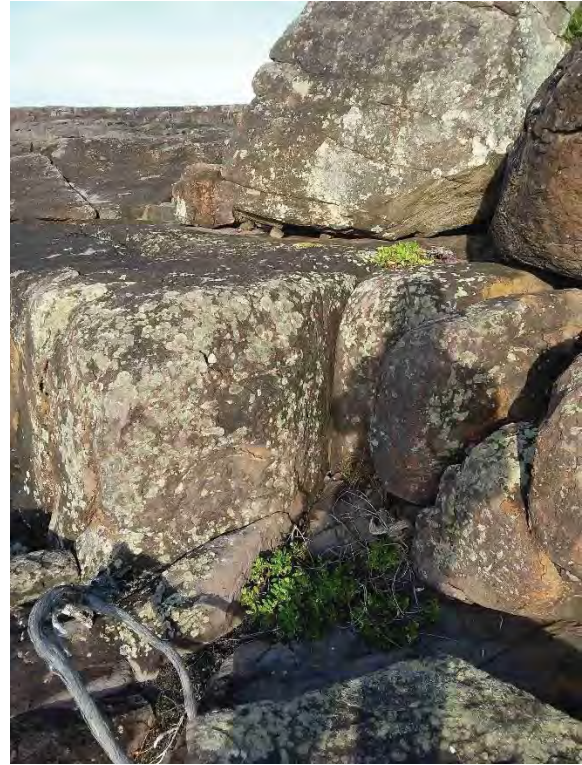
Work Section No.	45
Track Category	New Track
Length (m)	2
Cross Slope (%)	0
Vegetation	none
Gradient (%)	50
Substrate	bedrock
Descriptions/ Comments	Small rise.
Recommended Work (Text Details)	Install 3 stone steps made from split boulders. Carve 1 step (upper step).
Stone Steps 900x200x400mm (ea.)	3
Chiselled step(900- 1200x300x200mm) (ea.)	1

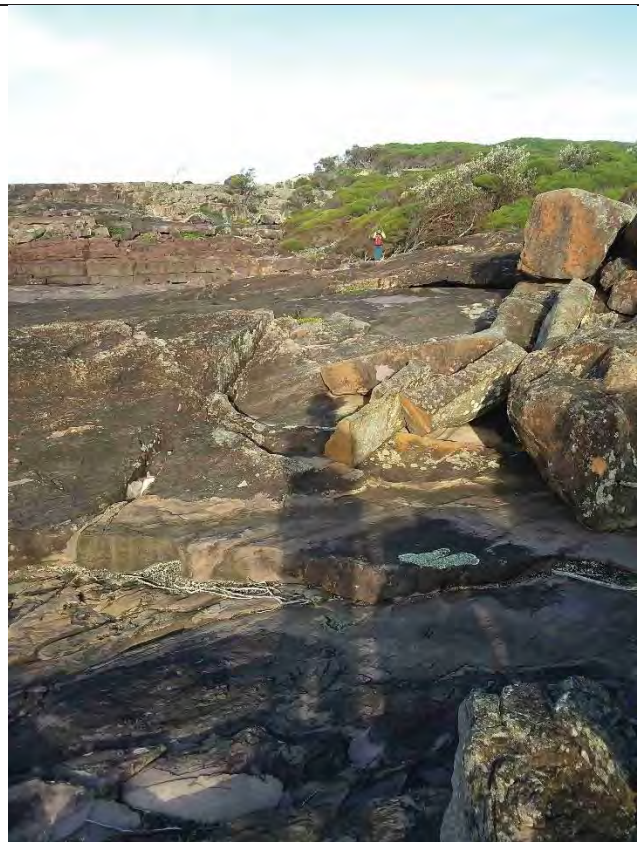
Work Section No.	46
Track Category	New Track
Length (m)	64
Cross Slope (%)	0 - 10
Vegetation	none
Gradient (%)	0 - 10
Substrate	bedrock
Descriptions/ Comments	Route follows bedrock. Passes near midden site.
Recommended Work (Text Details)	No work required.

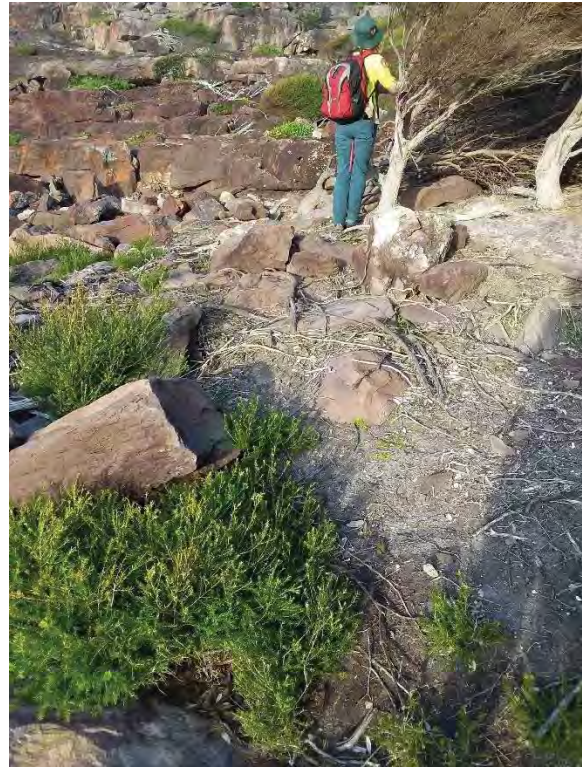
Work Section No.	47
Track Category	New Track
Length (m)	11
Cross Slope (%)	10
Vegetation	some bushes
Gradient (%)	10
Substrate	soil and rocks
Descriptions/ Comments	End bedrock. start short section of soil and rock
Recommended Work (Text Details)	Hand benching
Benching by hand (Person Days)	0.2
Machine benching (m)	
Clear vegetation (Person Days)	0.1

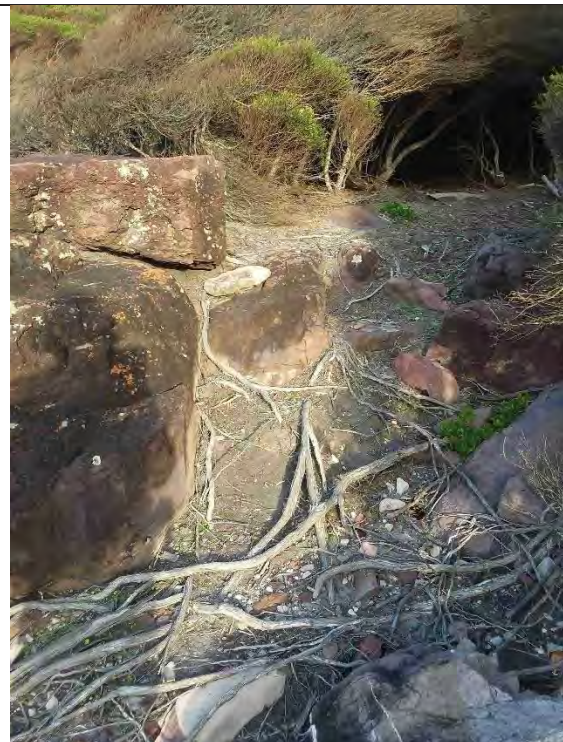
Work Section No.	48
Track Category	New Track
Length (m)	5
Cross Slope (%)	0
Vegetation	none
Gradient (%)	60
Substrate	soil and rocks
Descriptions/ Comments	Small rise to get onto bedrock platform.
Recommended Work (Text Details)	Install stone steps using local stone.
Stone Steps 900x200x400mm (ea.)	5

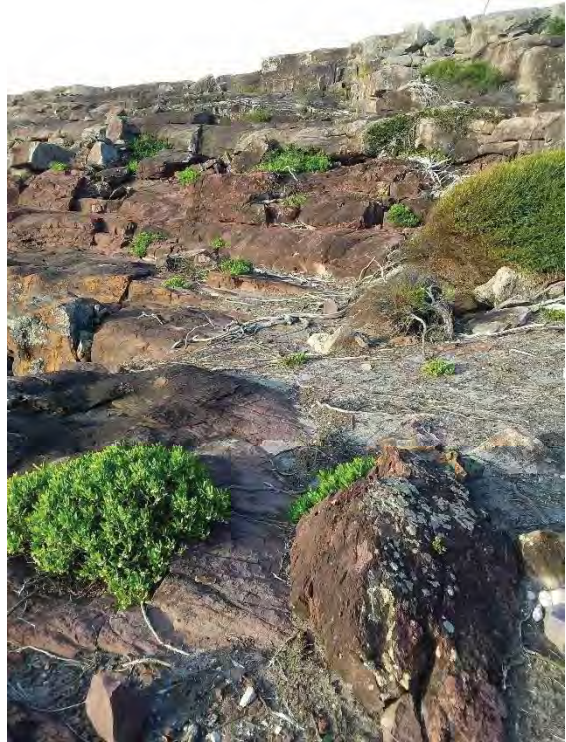
Work Section No.	49
Track Category	New Track
Length (m)	11
Cross Slope (%)	0
Vegetation	none
Gradient (%)	5
Substrate	bedrock
Signage	Will need some stencilled arrows on bedrock to indicate route.
Descriptions/ Comments	Route follows flat bedrock for short distance.
Recommended Work (Text Details)	No work required.

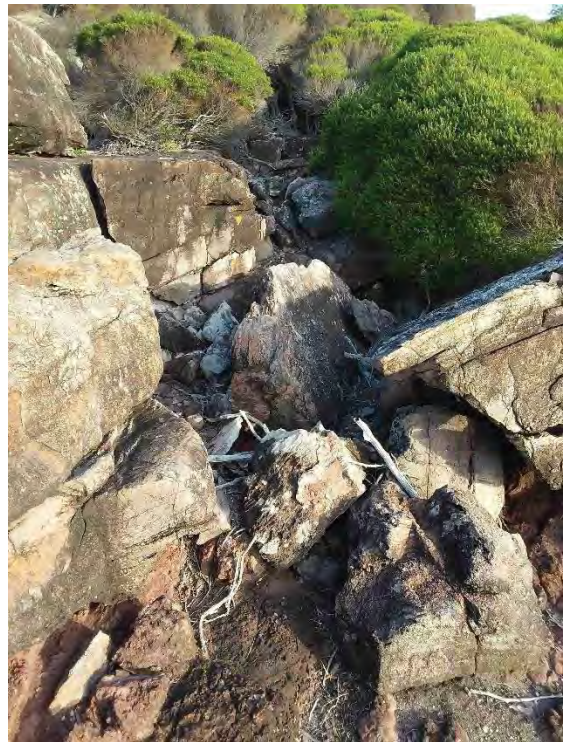
Work Section No.	50
Track Category	New Track
Length (m)	4
Cross Slope (%)	0
Vegetation	none
Gradient (%)	30
Substrate	bedrock
Descriptions/ Comments	Route goes through rugged bedrock section.
Recommended Work (Text Details)	Move stones to make move walker friendly install steps with local stone.
Stone work - (Person Days)	1
Stone Steps 900x200x400mm (ea.)	2

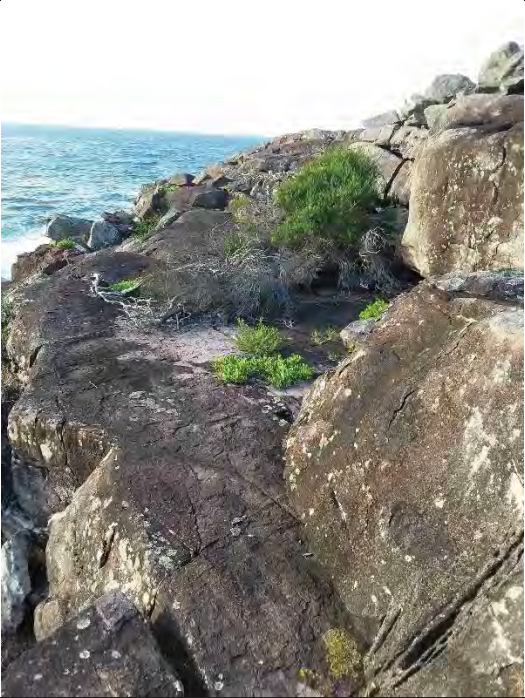
Work Section No.	51

Track Category	New Track	
Length (m)	94	
Cross Slope (%)	0	
Vegetation	one bush	
Gradient (%)	30	
Substrate	bedrock	
Signage	Will need some stencilled arrows on bedrock to indicate route.	
Descriptions/ Comments	Route follows bedrock.	
Recommended Work (Text Details)	No work required.

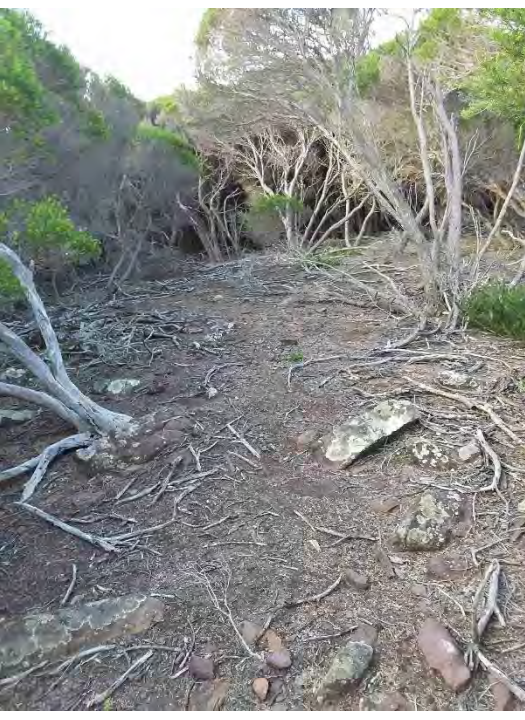
Work Section No.	52

Track Category	New Track	
Length (m)	176	
Cross Slope (%)		
Vegetation	melaleuca bushes	
Descriptions/ Comments	Bedrock ends, route contours along cliff top. May need climbing turn or two to keep grade at 10%. Head inland slightly to avoid midden.	
Recommended Work (Text Details)	Machine benching.	
Machine benching (m)	176	
Clear vegetation (Person Days)	0.3

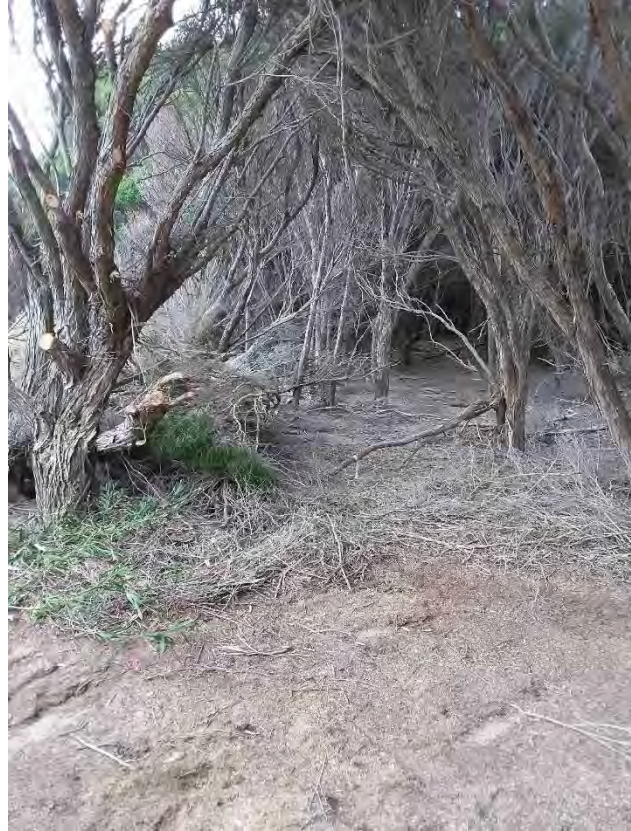
Work Section No.	53
Track Category	New Track
Length (m)	117
Cross Slope (%)	0 - 5
Vegetation	melaleuca scrub
Gradient (%)	5
Substrate	Stoney soil
Signage	Route leaves from Pulpit Rock. Will need sign with distances etc.
Descriptions/ Comments	Route starts from Pulpit Rock and heads along clifftop.
Recommended Work (Text Details)	Light machine benching.
Machine benching (m)	117
Clear vegetation (Person Days)	0.3

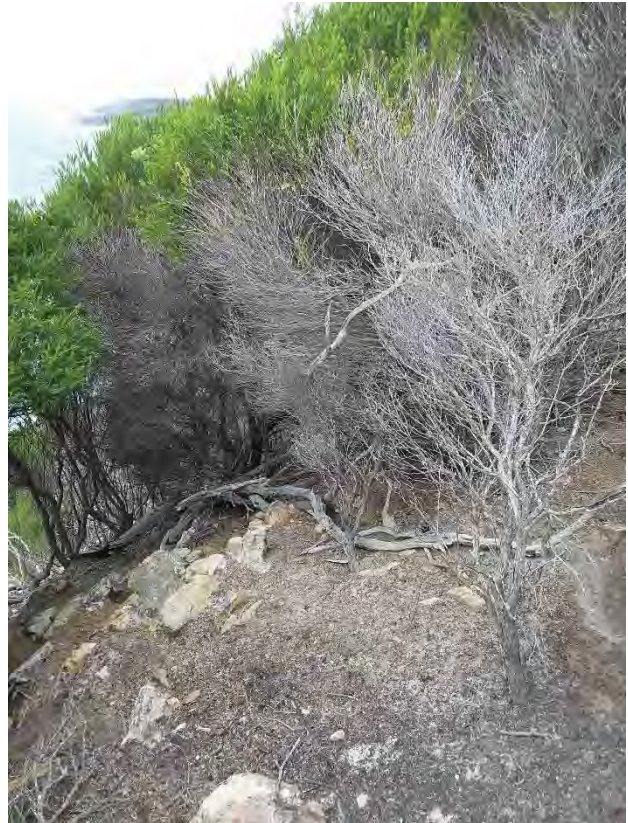
Work Section No.	54
Track Category	New Track
Length (m)	25
Cross Slope (%)	60
Vegetation	melaleuca scrub
Gradient (%)	15
Substrate	Crumbly bedrock
Descriptions/ Comments	Route leaves clifftop and contours down bank with steep cross slope to coastal rock platform.
Recommended Work (Text Details)	Chisel bench out of crumbly bedrock. Will need to do by hand as bank too steep for machine.
Stone work - (Person Days)	6
Clear vegetation (Person Days)	0.2

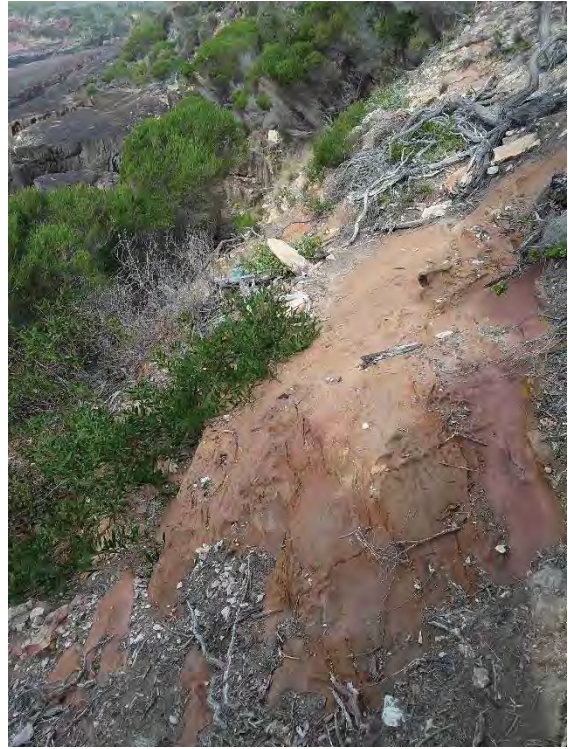
Work Section No.	55
Track Category	New Track
Length (m)	12
Cross Slope (%)	55
Vegetation	light
Gradient (%)	20
Substrate	bedrock
Descriptions/ Comments	End crumbly bedrock. Start bedrock. Route continues descending to rock platform.
Recommended Work (Text Details)	Cut and chisel bench.
Chisel tread (Person Days)	8

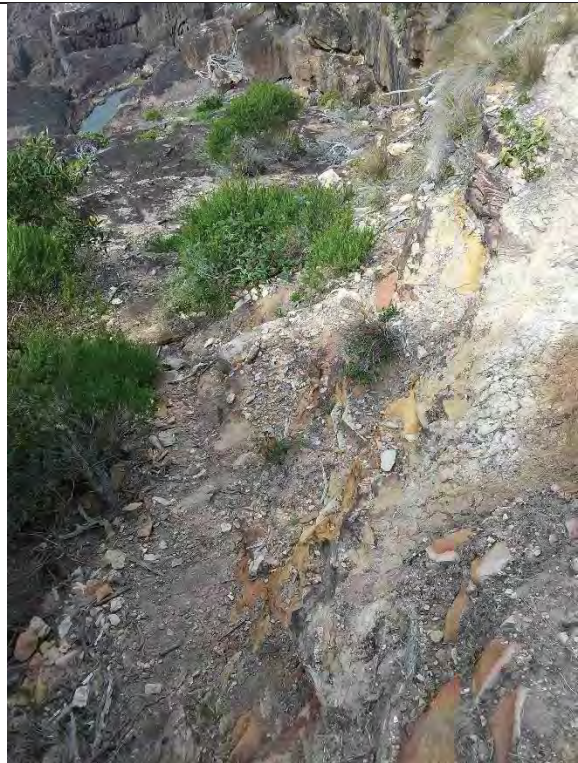
Work Section No.	56
Track Category	New Track
Length (m)	7
Cross Slope (%)	50
Vegetation	light
Gradient (%)	35
Substrate	Crumbly bedrock
Descriptions/ Comments	Route continues descending to rock platform.
Recommended Work (Text Details)	Carve bench or chisel steps into crumbly bedrock.
Stone work - (Person Days)	4

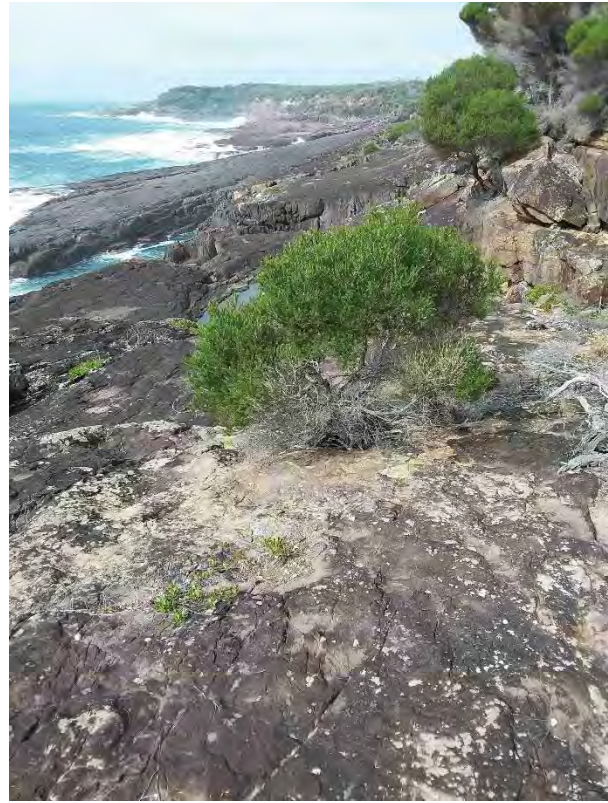
Work Section No.	57
Track Category	New Track
Length (m)	137
Cross Slope (%)	0 - 10
Vegetation	none
Gradient (%)	10
Substrate	bedrock
Signage	Will need some stencilled arrows on bedrock to indicate route.
Geotech Assessment Recommended	yes
Descriptions/ Comments	Route follows bedrock platform.
Recommended Work (Text Details)	No work required.

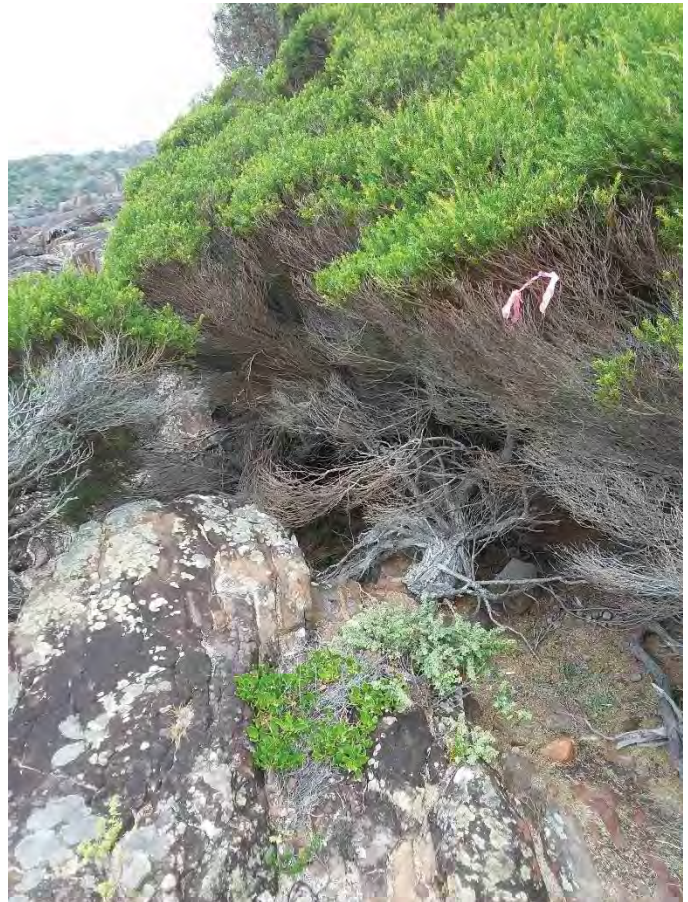
Work Section No.	58
Track Category	New Track
Length (m)	7
Cross Slope (%)	0
Vegetation	thick melaleuca
Gradient (%)	80
Substrate	bedrock
Signage	Will need some stencilled arrows on bedrock to indicate route.
Descriptions/ Comments	Short section of melaleuca with small drop on bedrock.
Recommended Work (Text Details)	Install stone steps using local stone.
Stone Steps 900x200x400mm (ea.)	2
Clear vegetation (Person Days)	0.1

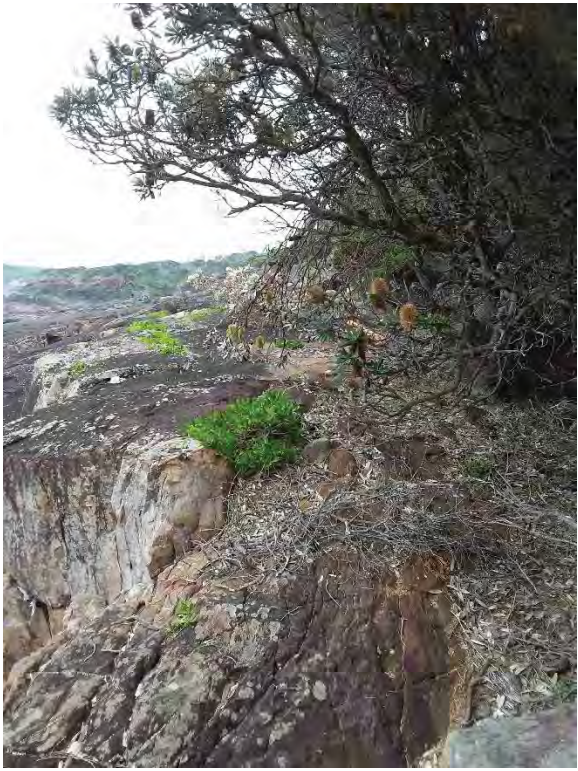
Work Section No.	59

Track Category	New Track	
Length (m)	143	
Cross Slope (%)	5 - 25	
Vegetation	none	
Gradient (%)	0 - 10	
Substrate	bedrock	
Signage	Will need some stencilled arrows on bedrock to indicate route.	
Geotech Assessment Recommended	yes	
Descriptions/ Comments	Route follows bedrock. Great views.	
Recommended Work (Text Details)	No work required.

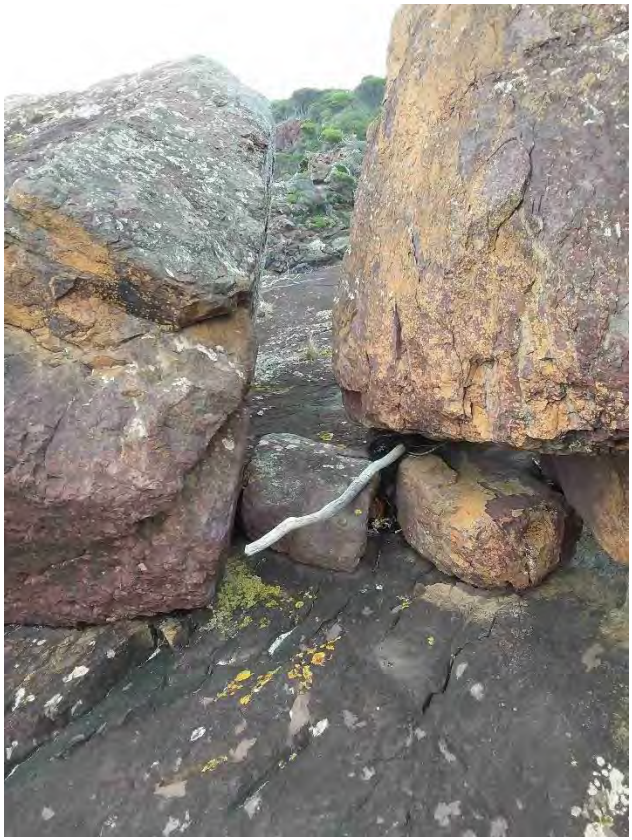
Work Section No.	60

Track Category	New Track	
Length (m)	3	
Cross Slope (%)	5	
Vegetation	none	
Gradient (%)	0	
Substrate	bedrock	
Signage	Will need some stencilled arrows on bedrock to indicate route.	
Descriptions/ Comments	Tight squeeze through two large boulders.	
Recommended Work (Text Details)	Cleave large flake off boulder with rifting hammer and sledge hammer along existing fault line to make wider. Avoid using jackhammer or small hand tools as 'natural' face is desirable.	
Stone work - person days	1

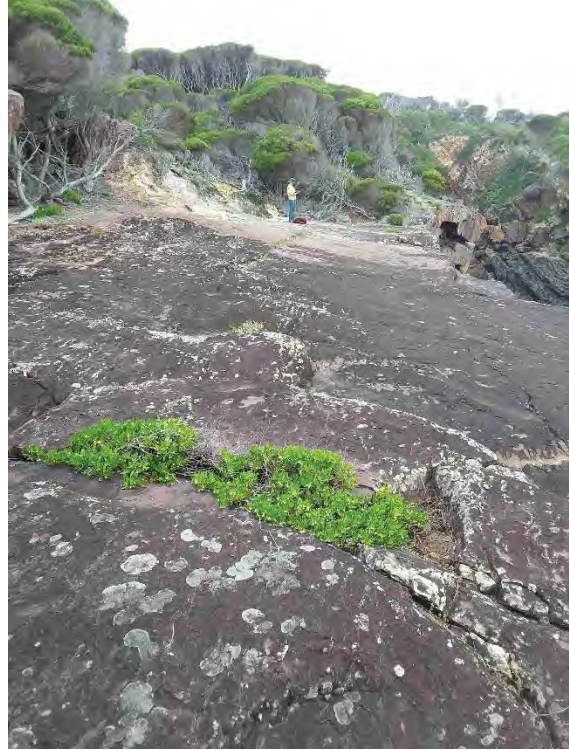
Work Section No.	62
Track Category	New Track
Length (m)	19
Cross Slope (%)	0
Vegetation	light
Gradient (%)	30
Substrate	bedrock
Signage	Will need marker to indicate leaving platform.
Descriptions/ Comments	End coastal platform. Start following sloped bedrock up water coarse.
Recommended Work (Text Details)	Trim back vegetation.
Clear vegetation (Person Days)	0.1

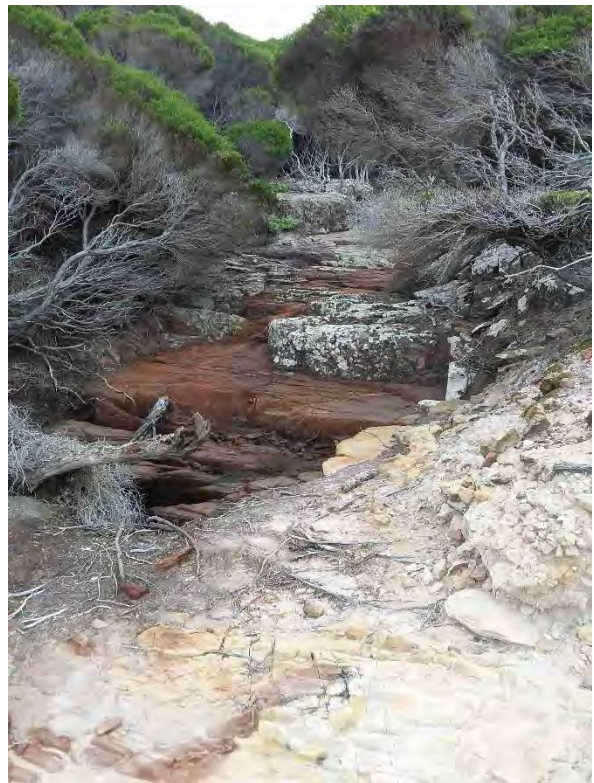
Work Section No.	63
Track Category	New Track
Length (m)	101
Cross Slope (%)	5 - 20
Vegetation	melaleuca scrub
Gradient (%)	0 - 10
Substrate	soil
Descriptions/ Comments	Route leaves bedrock water coarse and starts start contouring through melaleuca scrub to head of ravine.
Recommended Work (Text Details)	Hand bench (not worth bring machine in for short section). Install climbing turn or two to maintain grade below 10%.
Benching by hand (Person Days)	3
Clear vegetation - person days.	0.5

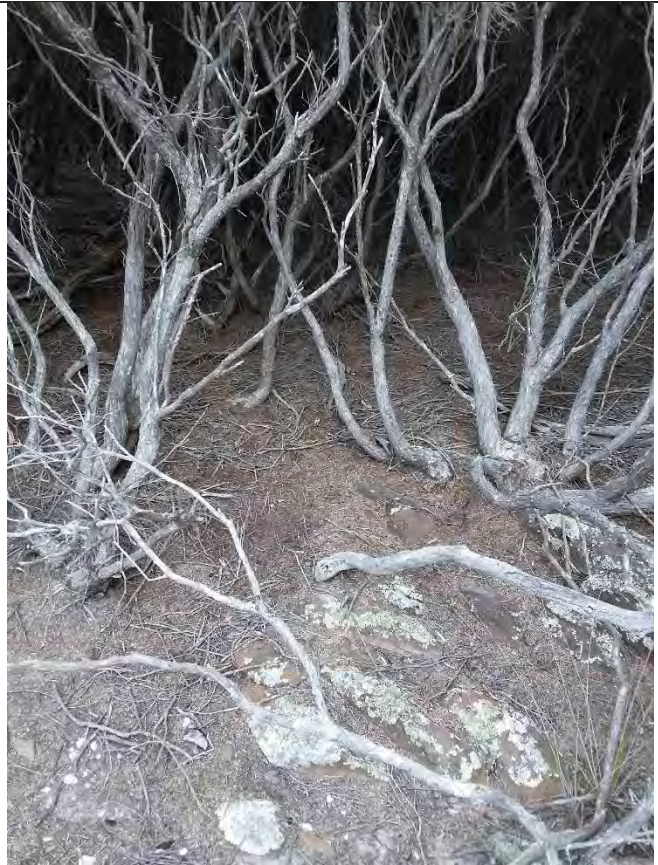
Work Section No.	64
Track Category	New Track
Length (m)	57
Cross Slope (%)	0 - 20
Vegetation	thick scrub
Gradient (%)	10 - 30
Substrate	soil
Descriptions/ Comments	From near head of costal ravine route heads down towards coastal rock platform. To get to platform below, route must go through midden. AHIP is being sort.
Recommended Work (Text Details)	Hand bench (not worth bring machine in for short section). Install climbing turn or two to maintain grade below 10%.
Benching by hand (Person Days)	0.5
Clear vegetation (Person Days)	0.3

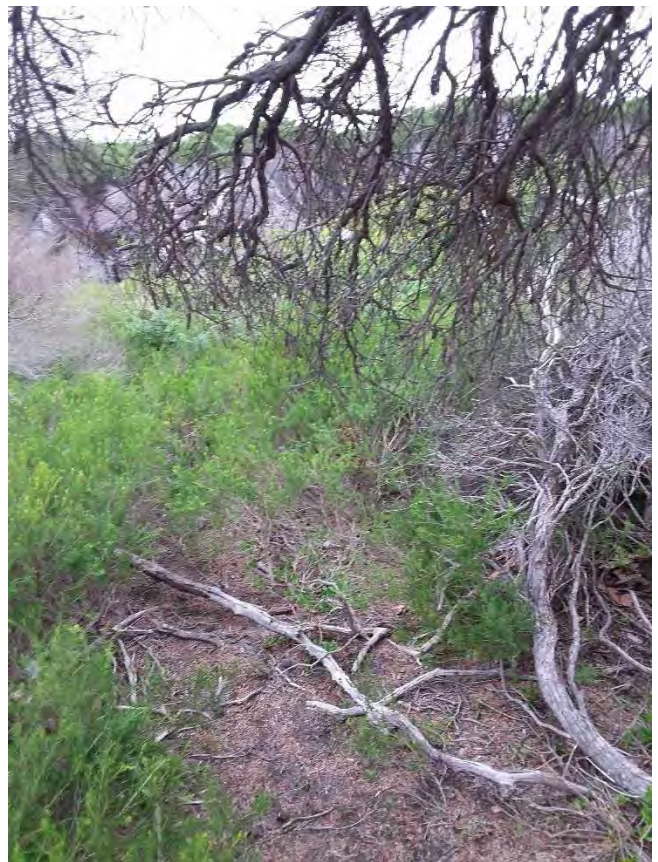
Work Section No.	65
Track Category	New Track
Length (m)	9
Cross Slope (%)	0
Vegetation	light
Gradient (%)	50
Substrate	crumbly bedrock
Geotech Assessment Recommended	yes
Descriptions/ Comments	Route goes through pinch point continuing down to platform through midden.
Recommended Work (Text Details)	Carve steps into crumbly bedrock. Keep route away from cliff edge to avoid fall height issues.
Chiselled step(900-1200x300x200mm) (ea.)	5

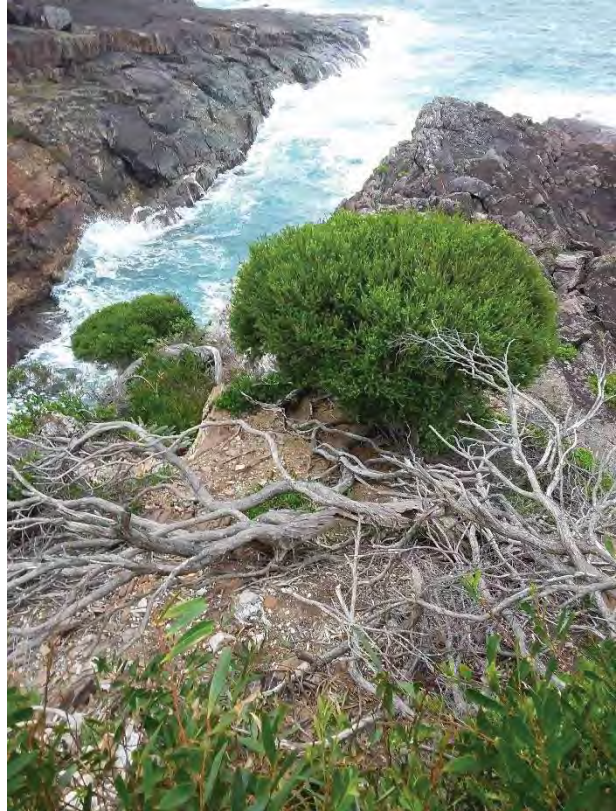
Work Section No.	66
Track Category	New Track
Length (m)	6
Cross Slope (%)	0
Vegetation	light
Gradient (%)	40
Substrate	soil, rocks, crumbly bedrock
Geotech Assessment Recommended	yes
Descriptions/ Comments	Route continues through midden and pinch point and ends at rock platform. Install 10 steps using local rock.
Recommended Work (Text Details)	Install steps using local stone.
Stone Steps 900x200x400mm (ea.)	10

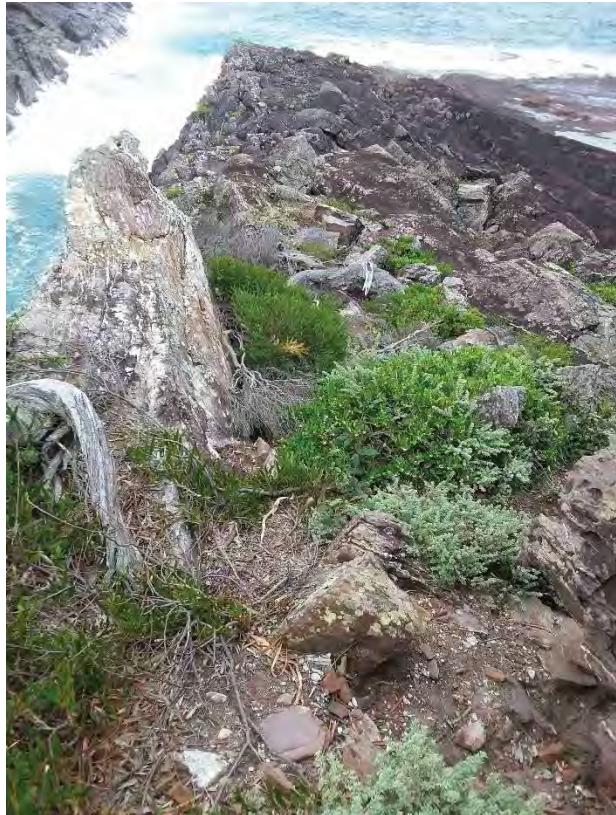
Work Section No.	67
Track Category	New Track
Length (m)	45
Cross Slope (%)	0 - 10
Vegetation	none
Gradient (%)	5 - 30
Signage	Will need some stencilled arrows on bedrock to indicate route.
Descriptions/ Comments	Route follows bedrock.
Recommended Work (Text Details)	No work required.
