Ben Boyd National Park

Light to Light Walk

Recommended Alignment and Construction

TRACK AND TRAIL MANAGEMENT SERVICES PTY LTD

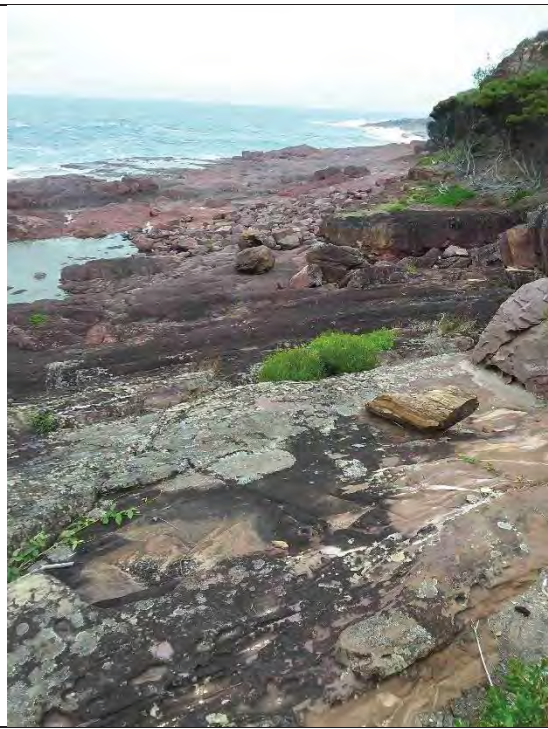
Work Section No.	68
Track Category	New Track
Length (m)	29
Cross Slope (%)	0
Vegetation	none
Gradient (%)	0
Substrate	Large boulders on bedrock.
Signage	Will need some stencilled arrows on bedrock to indicate route.
Descriptions/ Comments	Start boulder field.
Recommended Work (Text Details)	Make more walker friendly by rearranging boulders.
Stone work - (Person Days)	8

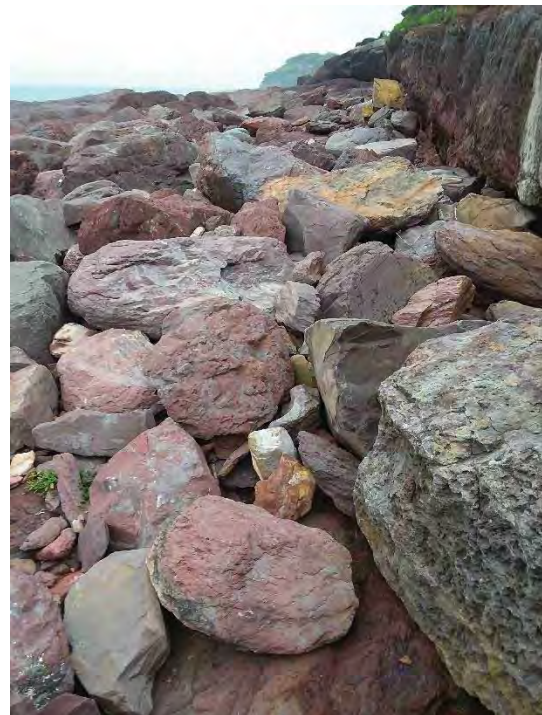
Work Section No.	69
Track Category	New Track
Length (m)	188
Cross Slope (%)	0 - 10
Vegetation	none
Gradient (%)	0
Substrate	bedrock
Signage	Will need some stencilled arrows on bedrock to indicate route.
Descriptions/ Comments	Route follows rock platform.
Recommended Work (Text Details)	No work required.

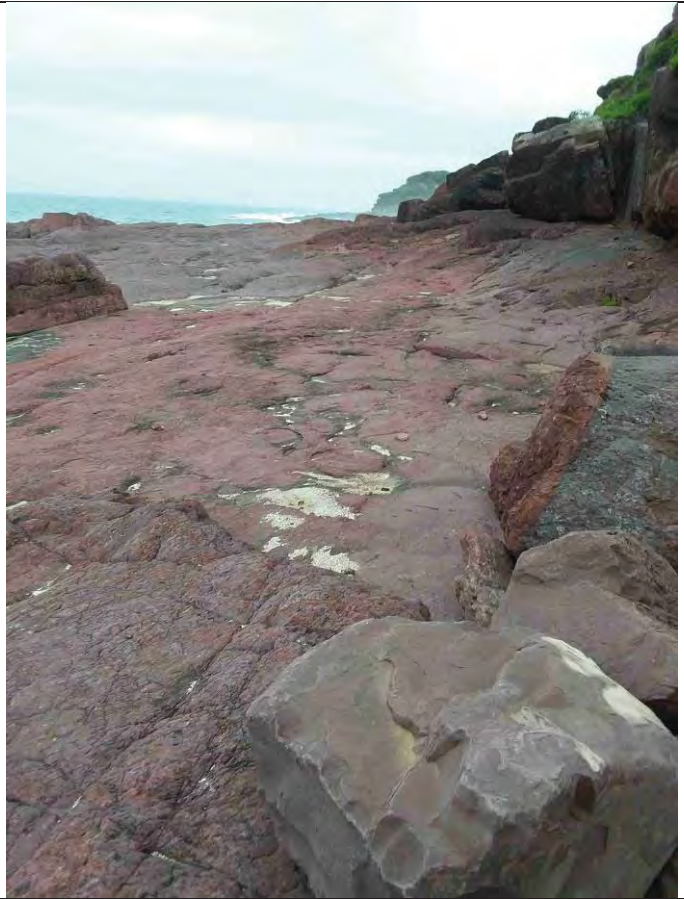
Work Section No.	70
Track Category	New Track
Length (m)	20
Cross Slope (%)	50
Vegetation	none
Gradient (%)	35
Substrate	bedrock
Signage	Will need some stencilled arrows on bedrock to indicate route.
Descriptions/ Comments	Bedrock becomes steep with strong cross slope. Take route slightly inland to avoid high tide hazards.
Recommended Work (Text Details)	Carve bench. Carve steps in bedrock at end of section.
Chiselled step(900-1200x300x200mm) (ea.)	5
Chisel tread (Person Days)	8

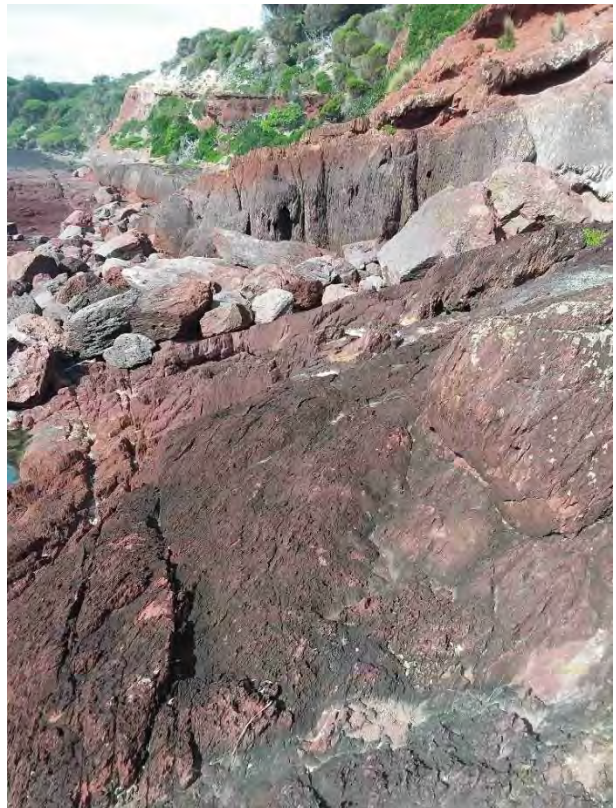
Work Section No.	71
Track Category	New Track
Length (m)	47
Cross Slope (%)	
Vegetation	none
Substrate	Large boulders on bedrock.
Signage	Will need some stencilled arrows on bedrock to indicate route.
Descriptions/ Comments	Start large boulders, needed to raise track level and guide walkers away from high tide hazards.
Recommended Work (Text Details)	Rearrange boulders and build rough causeway where needed to raise track level.
Stone work - (Person Days)	16

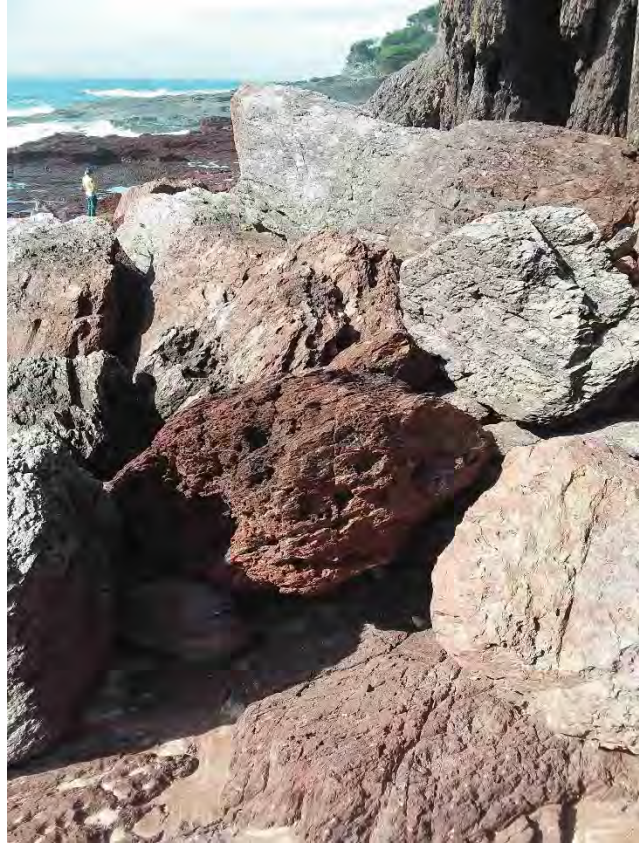
Work Section No.	72
Track Category	New Track
Length (m)	102
Cross Slope (%)	0
Vegetation	none
Gradient (%)	0
Signage	Will need some stencilled arrows on bedrock to indicate route.
Descriptions/ Comments	Route follows bedrock.
Recommended Work (Text Details)	No work required.

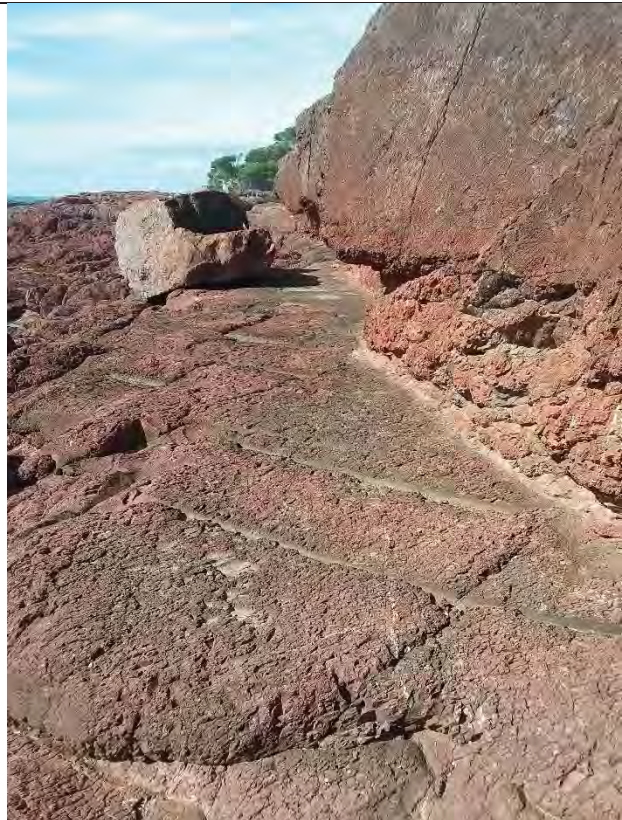
Work Section No.	73
Track Category	New Track
Length (m)	1
Cross Slope (%)	0
Vegetation	none
Gradient (%)	90
Substrate	bedrock
Signage	Will need some stencilled arrows on bedrock to indicate route.
Descriptions/ Comments	Small drop in bedrock.
Recommended Work (Text Details)	Install steps using local stone.
Stone Steps 900x200x400mm (ea.)	2

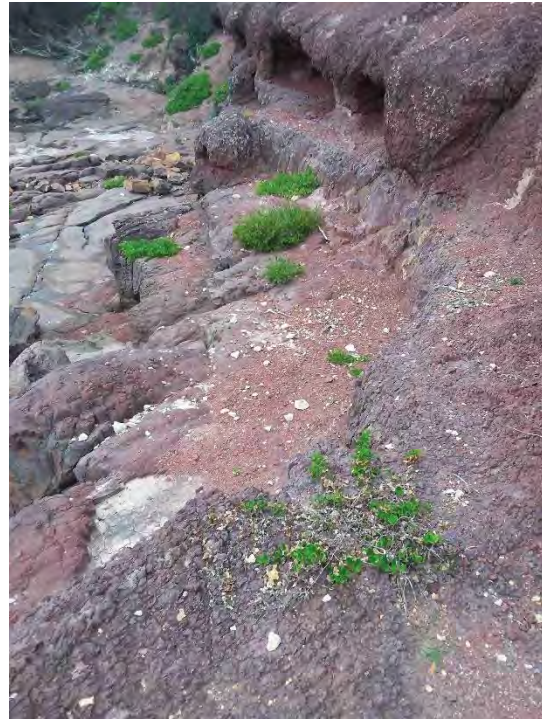
Work Section No.	74
Track Category	New Track
Length (m)	64
Cross Slope (%)	0
Vegetation	none
Gradient (%)	0
Substrate	bedrock
Signage	Will need some stencilled arrows on bedrock to indicate route.
Descriptions/ Comments	Route continues along bedrock.
Recommended Work (Text Details)	No work required.

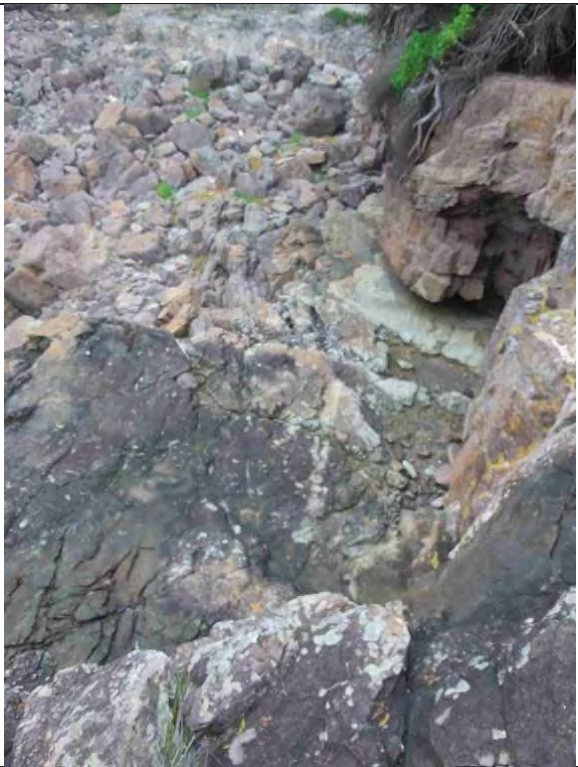
Work Section No.	75

Track Category	New Track	
Length (m)	3	
Cross Slope (%)	0	
Vegetation	none	
Gradient (%)	100	
Substrate	bedrock	
Descriptions/ Comments	Drop in bedrock.	
Recommended Work (Text Details)	Carve steps.	
Chiselled step(900- 1200x300x200mm) (ea.)	2

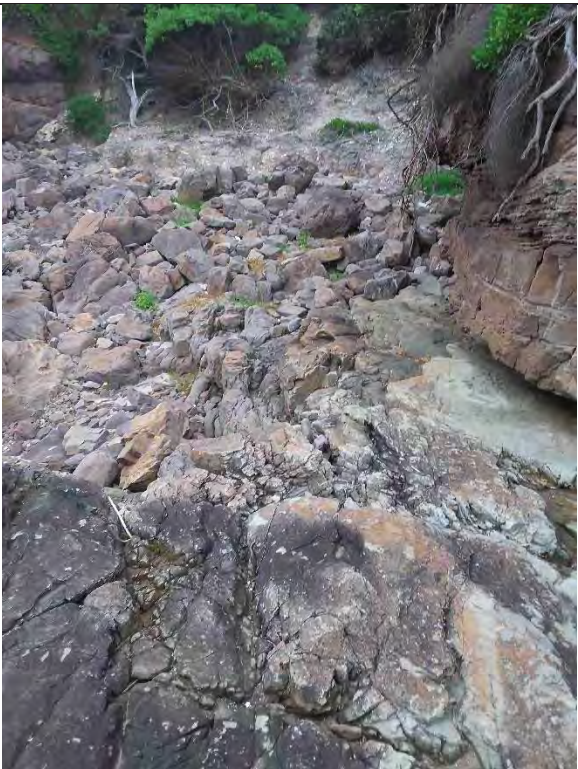
Work Section No.	76

Track Category	New Track	
Length (m)	5	
Cross Slope (%)	10	
Vegetation	none	
Gradient (%)	10	
Substrate	bedrock	
Geotech Assessment Recommended	yes	
Descriptions/ Comments	Route continues along bedrock.	
Recommended Work (Text Details)	No work required.

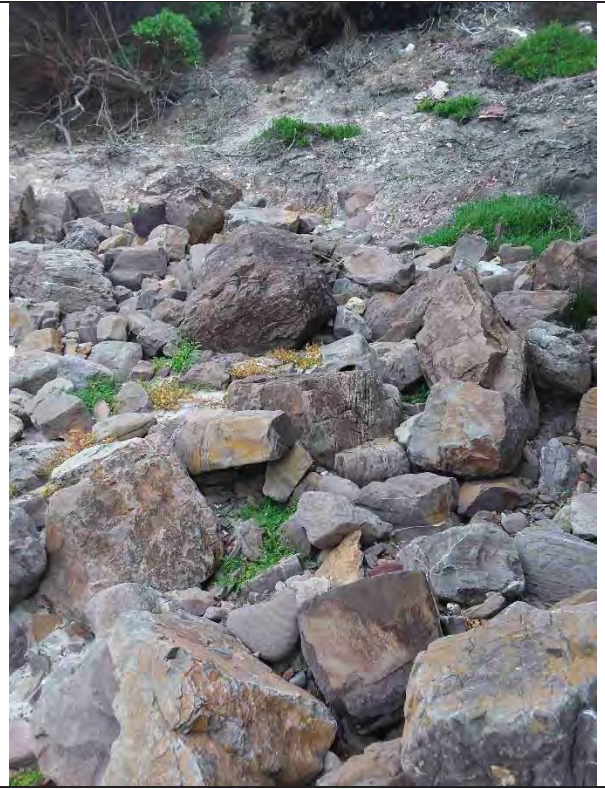
Work Section No.	78
Track Category	New Track
Length (m)	13
Cross Slope (%)	10
Vegetation	none
Gradient (%)	100
Substrate	rocks, boulders
Geotech Assessment Recommended	yes
Descriptions/ Comments	Route needs to ascend 3 meter cliff face as alternative route is hazardous at high tide and/or with rough seas.
Recommended Work (Text Details)	Install 7m x 3m x 0.5m retaining wall with steps using local stone.
Stone Steps 900x200x400mm (ea.)	15
Retaining wall/causeway rock (m ³)	5.5
Excavate footing (m ³)	2.1
Set up overhead rigging (Person Days)	4

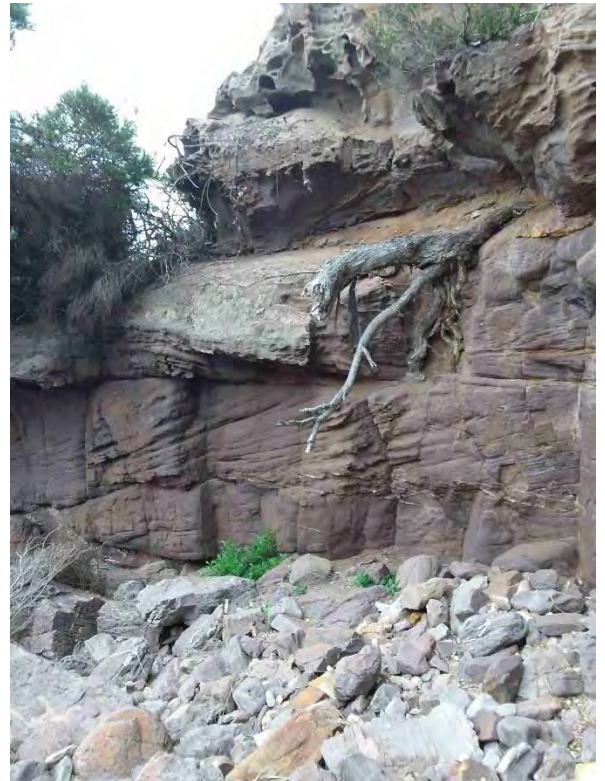
Work Section No.	79
Track Category	New Track
Length (m)	7
Cross Slope (%)	0
Vegetation	light
Gradient (%)	0 - 35
Substrate	bedrock
Signage	Will need marker.
Geotech Assessment Recommended	yes
Descriptions/ Comments	Route descends down rock platform to boulder field.
Recommended Work (Text Details)	No work required.

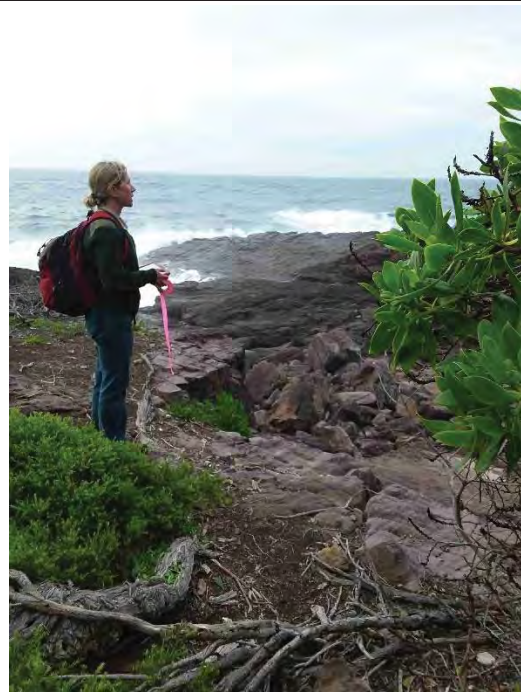
Work Section No.	80
Track Category	New Track
Length (m)	16
Cross Slope (%)	5 - 15
Vegetation	very light
Gradient (%)	10
Substrate	boulders, soil
Signage	Will need some stencilled arrows on boulders to indicate route.
Descriptions/ Comments	Route goes through boulder field.
Recommended Work (Text Details)	Rearrange boulders to make more walker friendly.
Stone work - (Person Days)	4

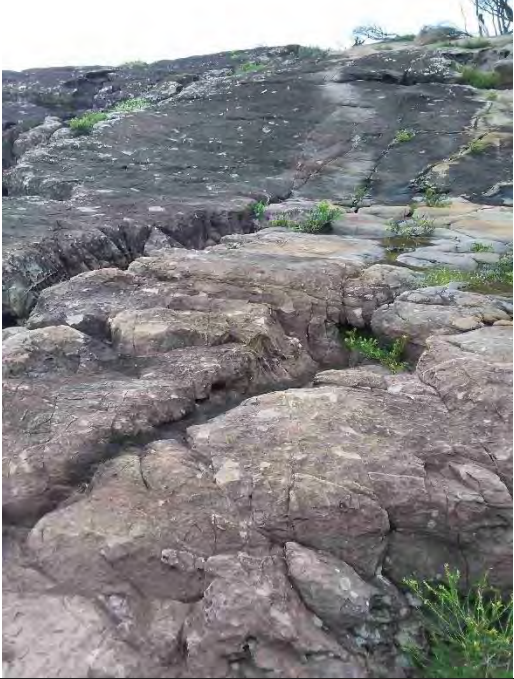
Work Section No.	81

Track Category	New Track	
Length (m)	11	
Cross Slope (%)	5	
Vegetation	none	
Gradient (%)	10 - 35	
Substrate	bedrock	
Signage	Will need some stencilled arrows on bedrock to indicate route.	
Descriptions/ Comments	Route climbs up sloping bedrock.	
Recommended Work (Text Details)	No work required.

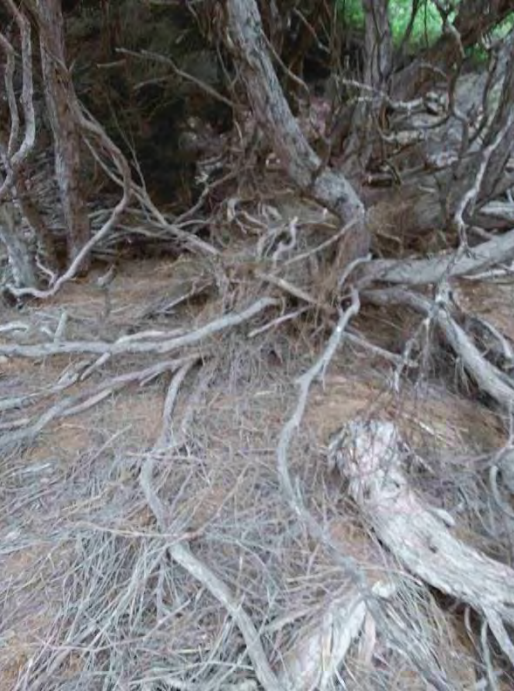
Work Section No.	82

Track Category	New Track	
Length (m)	36	
Cross Slope (%)	5 - 15	
Vegetation	melaleuca scrub	
Gradient (%)	35	
Substrate	soil, sandy soil	
Signage	Will need marker to indicate exit off bedrock.	
Descriptions/ Comments	End platform and start ascent up bank through melaleuca.	
Recommended Work (Text Details)	Install steps using local stone. Fly up from near boulder field.	
Stone Steps 900x200x400mm (ea.)	40	
Clear vegetation - person days.	0.3

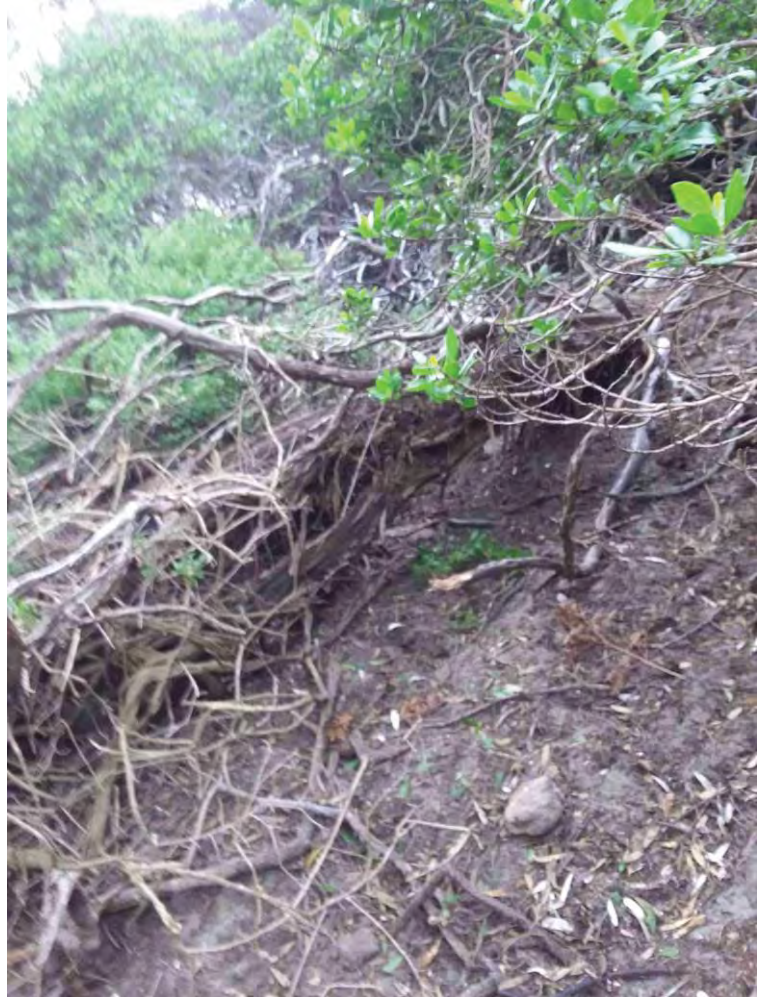
Work Section No.	84
Track Category	New Track
Length (m)	7
Cross Slope (%)	0
Vegetation	light
Gradient (%)	40
Substrate	crumbly bedrock
Geotech Assessment Recommended	yes
Descriptions/ Comments	Route descends steeply down crumbling bedrock towards coastal rock platform.
Recommended Work (Text Details)	Chisel bedrock to make ramp. Keep route away from cliff edge to avoid fall height issues. Will need Geotech assessment.
Chisel tread (Person Days)	1

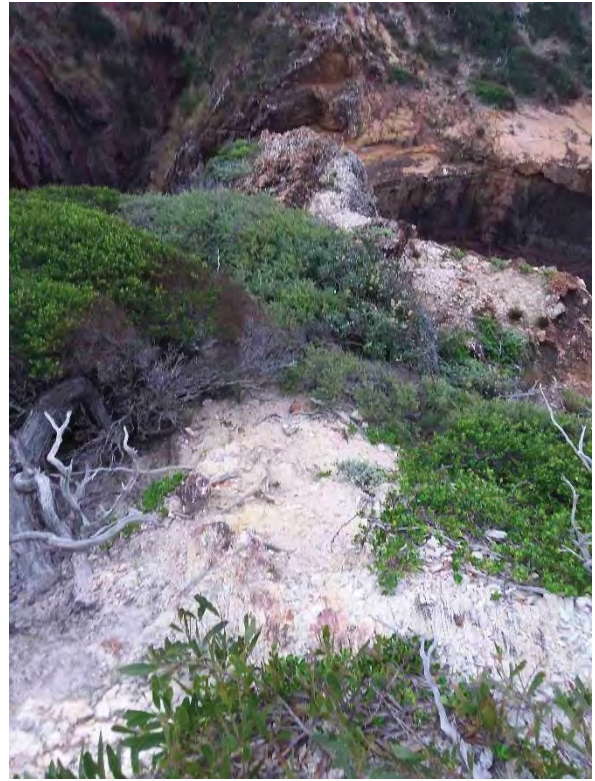
Work Section No.	85
Track Category	New Track
Length (m)	27
Cross Slope (%)	0
Vegetation	light
Gradient (%)	25
Substrate	bedrock
Geotech Assessment Recommended	yes
Descriptions/ Comments	Tread changes from crumbly bedrock to bedrock and reduces in grade. Will need Geotech assessment. Descends to coastal rock platform.
Recommended Work (Text Details)	Carve two steps at start of section. Keep route away from cliff edge to avoid fall height hazards (will need to deviate from track log).
Chiselled step(900-1200x300x200mm) (ea.)	2

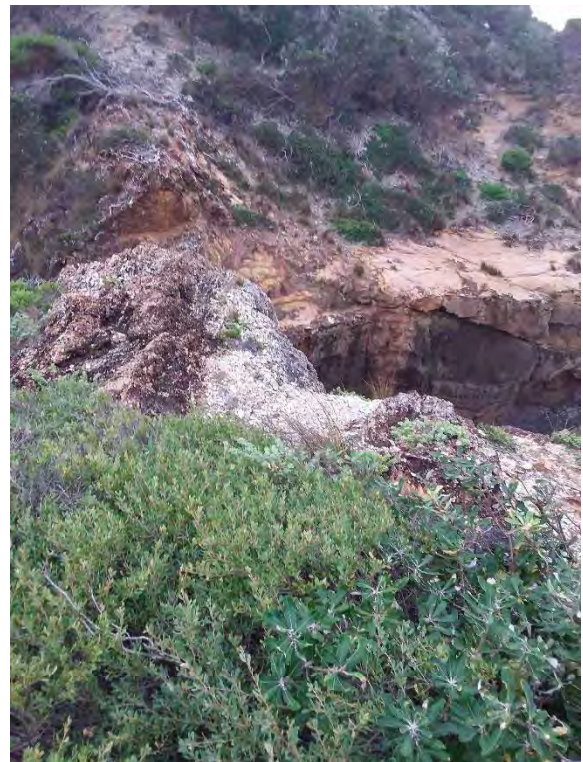
Work Section No.	86
Track Category	New Track
Length (m)	16
Cross Slope (%)	30
Vegetation	none
Gradient (%)	20
Substrate	bedrock
Signage	Will need some stencilled arrows on bedrock to indicate route.
Geotech Assessment Recommended	yes
Descriptions/ Comments	Route follows bedrock platform.
Recommended Work (Text Details)	No work required.

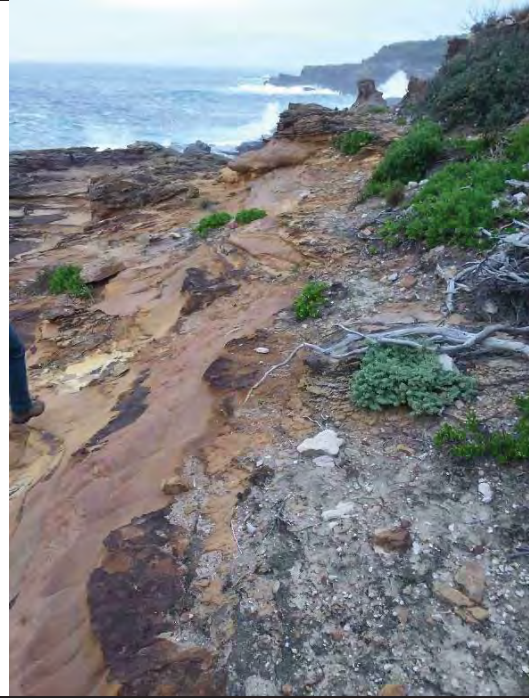
Work Section No.	87
Track Category	New Track
Length (m)	4
Cross Slope (%)	0
Vegetation	none
Gradient (%)	100
Substrate	bedrock
Signage	Will need some stencilled arrows on bedrock to indicate route.
Geotech Assessment Recommended	yes
Descriptions/ Comments	Mini escarpment. Although there is an easier route to get down, it goes too near the cliff edge.
Recommended Work (Text Details)	Move or fly in large boulder to base of mini escarpment to make step and carve 4 steps into bedrock for upper section.
Stone Steps 900x200x400mm (ea.)	3
Chiselled step(900-1200x300x200mm) (ea.)	4

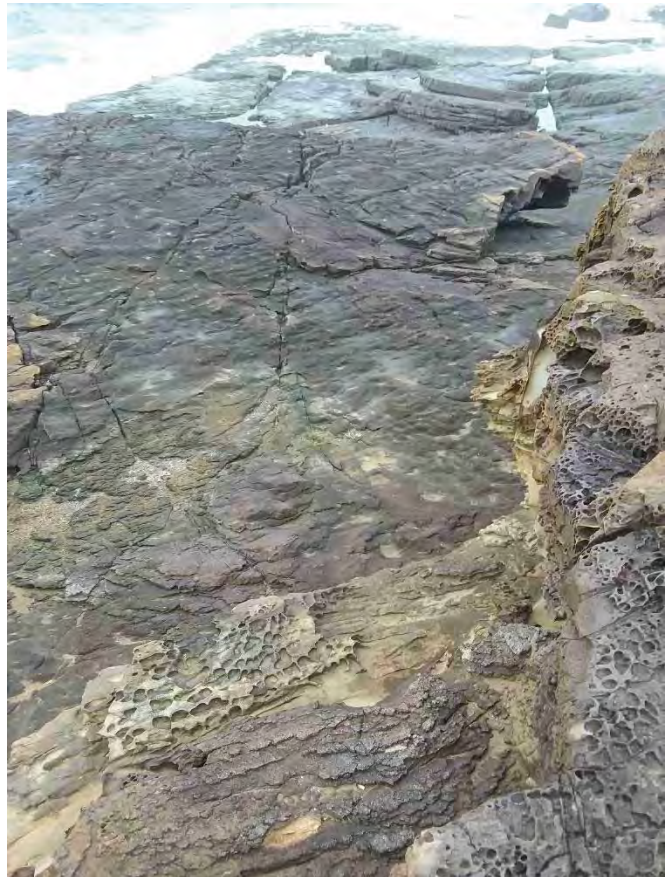
Work Section No.	88
Track Category	New Track
Length (m)	48
Cross Slope (%)	5
Vegetation	none
Gradient (%)	5
Substrate	bedrock
Signage	Will need some stencilled arrows on bedrock to indicate route.
Geotech Assessment Recommended	yes

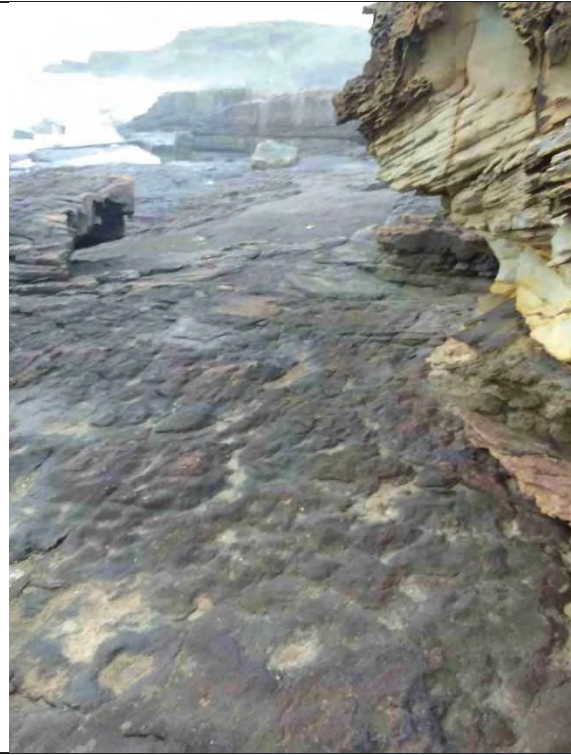
Work Section No.	89
Track Category	New Track
Length (m)	13
Cross Slope (%)	0
Vegetation	none
Gradient (%)	50
Substrate	boulders, bedrock
Signage	Will need some stencilled arrows on boulders to indicate route.
Geotech Assessment Recommended	yes
Descriptions/ Comments	End platform, start boulders.
Recommended Work (Text Details)	Rearrange boulders and install steps using local stone to make passable.
Stone work - (Person Days)	8
Stone Steps 900x200x400mm (ea.)	3

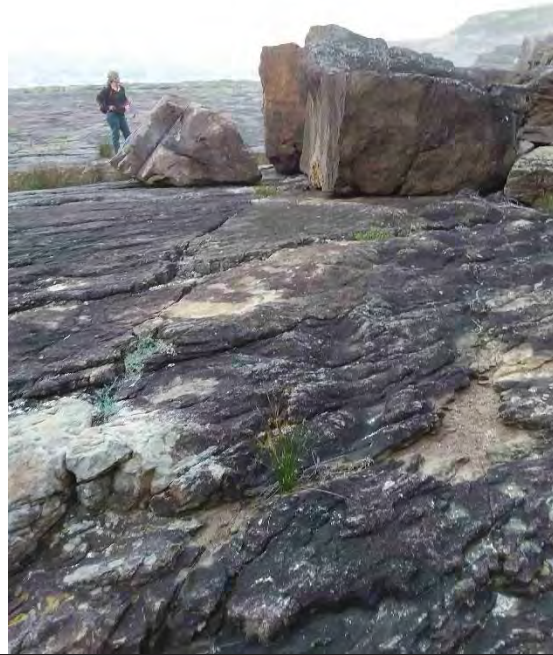
Work Section No.	90
Track Category	New Track
Length (m)	290
Cross Slope (%)	5
Vegetation	none
Gradient (%)	5
Substrate	bedrock
Signage	Will need some stencilled arrows on bedrock to indicate route.
Geotech Assessment Recommended	yes
Descriptions/ Comments	Route follows bedrock.
Recommended Work (Text Details)	No work required.

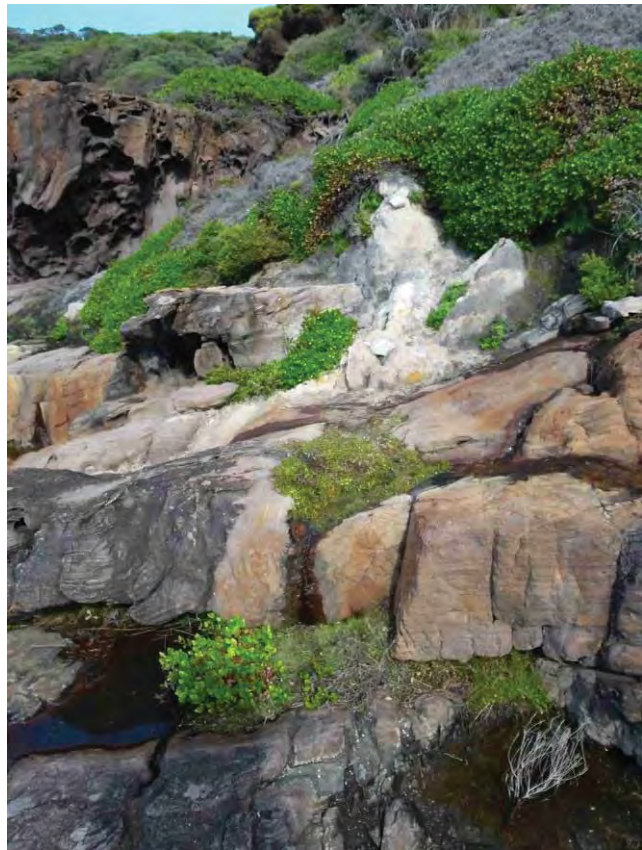
Work Section No.	91
Track Category	New Track
Length (m)	15
Cross Slope (%)	0 - 10
Vegetation	light
Gradient (%)	15 - 50
Substrate	bedrock, soil
Signage	Will need some stencilled arrows on bedrock to indicate route.
Geotech Assessment Recommended	yes
Descriptions/ Comments	Rock platform ends and climbs to next rock ledge through sandy soil.
Recommended Work (Text Details)	Install stone steps using local stone. Move local stone to site with helicopter.
Stone Steps 900x200x400mm (ea.)	15

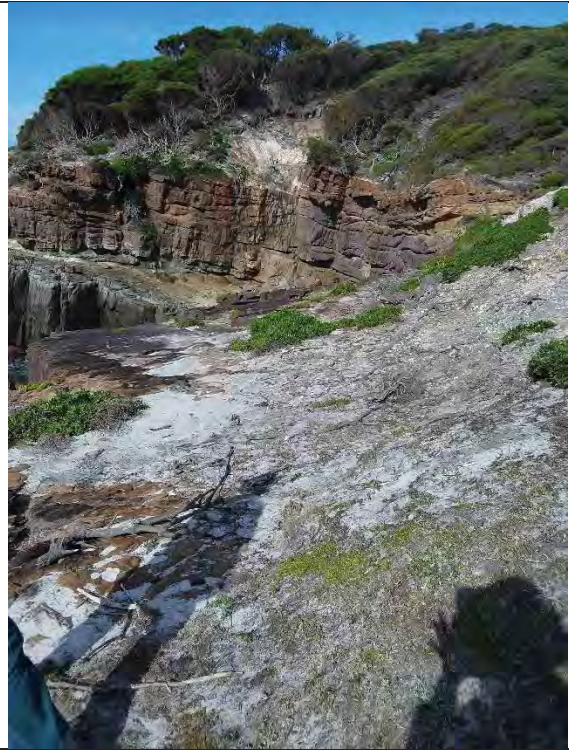
Work Section No.	92
Track Category	New Track
Length (m)	23
Cross Slope (%)	0 - 10
Vegetation	light
Gradient (%)	0
Substrate	Bedrock, thin layer of soil covering bedrock in places.
Geotech Assessment Recommended	yes
Descriptions/ Comments	End climb, start bedrock ledge.
Recommended Work (Text Details)	Very light hand benching.
Benching by hand (Person Days)	0.2

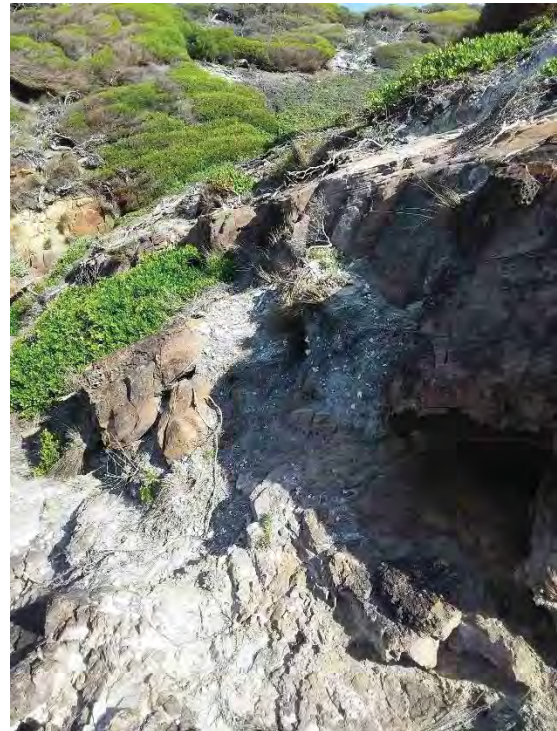
Work Section No.	93
Track Category	New Track
Length (m)	9
Cross Slope (%)	50
Vegetation	light
Gradient (%)	40
Substrate	soil, rock, bedrock
Geotech Assessment Recommended	yes
Descriptions/ Comments	Route leaves bedrock platform and climbs up mini escarpment.
Recommended Work (Text Details)	Dig footing 5x1x0.5m, build retaining wall 5x2x0.4m. Install stone steps using local stone flown to site. Chisel last step into bedrock.
Stone Steps 900x200x400mm (ea.)	7
Retaining wall/causeway rock (m ³)	2
Chiselled step(900-1200x300x200mm) (ea.)	1
Excavate/chisel footing - (Person Days)	2.5

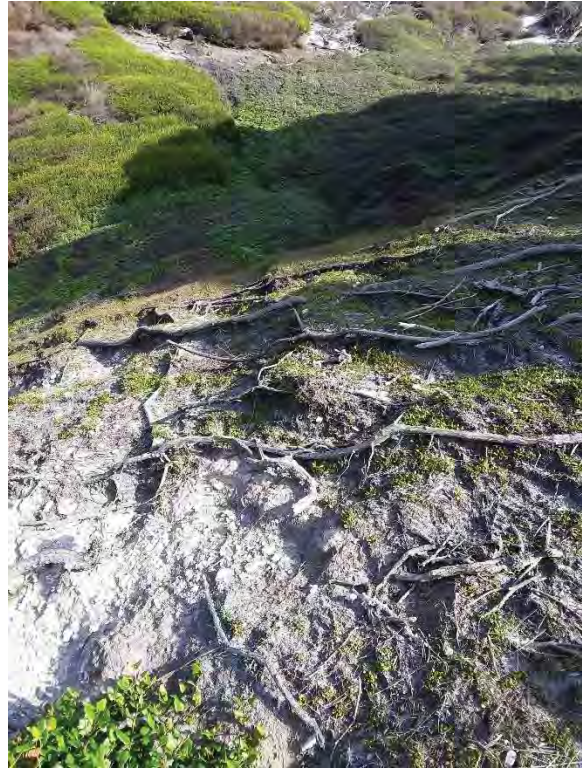
Work Section No.	94
Track Category	New Track
Length (m)	6
Cross Slope (%)	20
Vegetation	light
Gradient (%)	10
Substrate	soil, bedrock possibly close to surface
Geotech Assessment Recommended	yes
Descriptions/ Comments	Route contours cross gentle slope.
Recommended Work (Text Details)	Light hand benching. Bedrock may be close to surface - if so will need to chisel bench.
Benching by hand (Person Days)	3

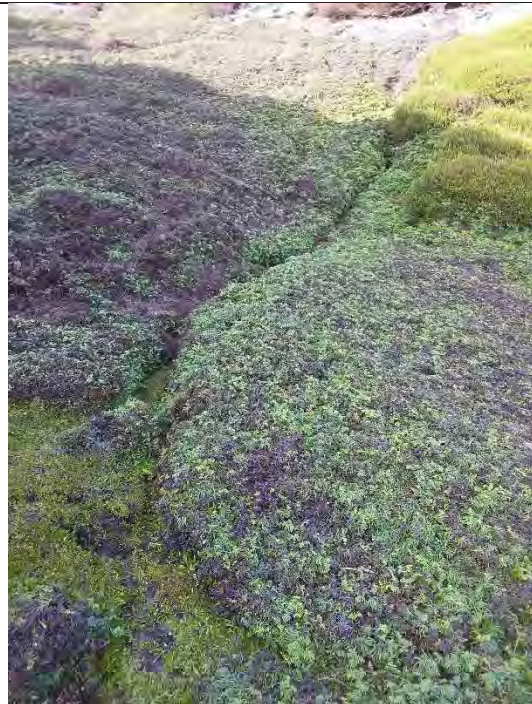
Work Section No.	95
Track Category	New Track
Length (m)	13
Cross Slope (%)	25
Vegetation	light
Gradient (%)	10 - 30
Substrate	boggy soil
Descriptions/ Comments	Route crosses boggy gully.
Recommended Work (Text Details)	Install stepping stones across boggy gully - will need to fly stones in.
Stepping stones 1000x400x400mm (ea.)	16

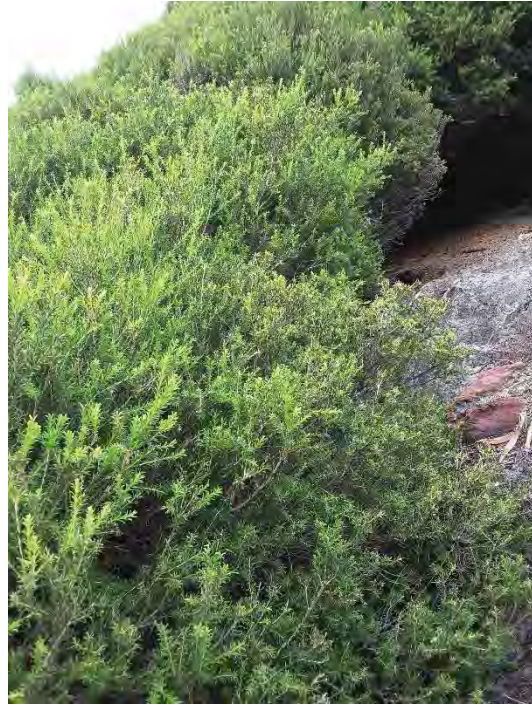
Work Section No.	96
Track Category	New Track
Length (m)	36
Cross Slope (%)	50
Vegetation	thick melaleuca
Gradient (%)	10 - 15
Substrate	soil
Descriptions/ Comments	Route leaves boggy section and contours along steep cross slope through dense melaleuca scrub. Keep track away from cliff edge.
Recommended Work (Text Details)	Full hand benching.
Benching by hand (Person Days)	1
Clear vegetation - person days.	0.2

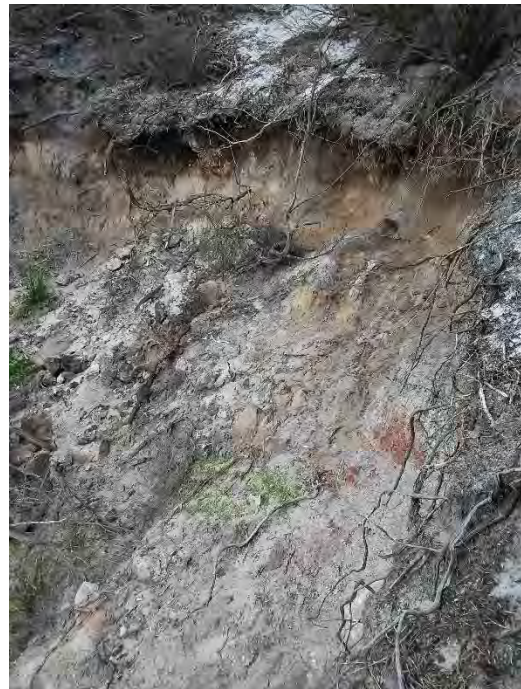
Work Section No.	97
Track Category	New Track
Length (m)	23
Cross Slope (%)	70
Vegetation	none
Gradient (%)	0 - 15
Substrate	soil
Geotech Assessment Recommended	yes
Descriptions/ Comments	Route contours through site of old landslip.
Recommended Work (Text Details)	Full hand benching on 70% cross slope.
Benching by hand (Person Days)	3

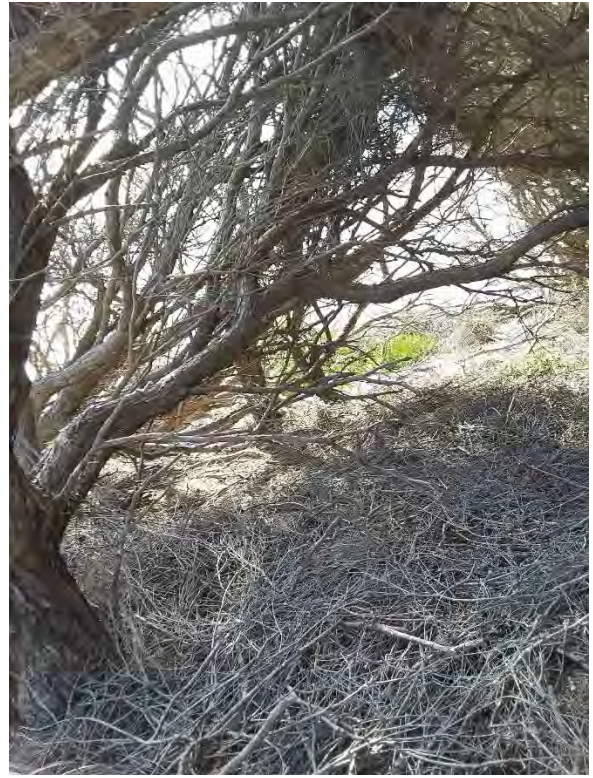
Work Section No.	98
Track Category	New Track
Length (m)	13
Cross Slope (%)	35
Vegetation	melaleuca scrub
Gradient (%)	0 - 15
Substrate	soil
Geotech Assessment Recommended	yes
Descriptions/ Comments	Route leaves land slip site and contours across gentler slope through melaleuca scrub.
Recommended Work (Text Details)	Full hand benching.
Benching by hand (Person Days)	0.5

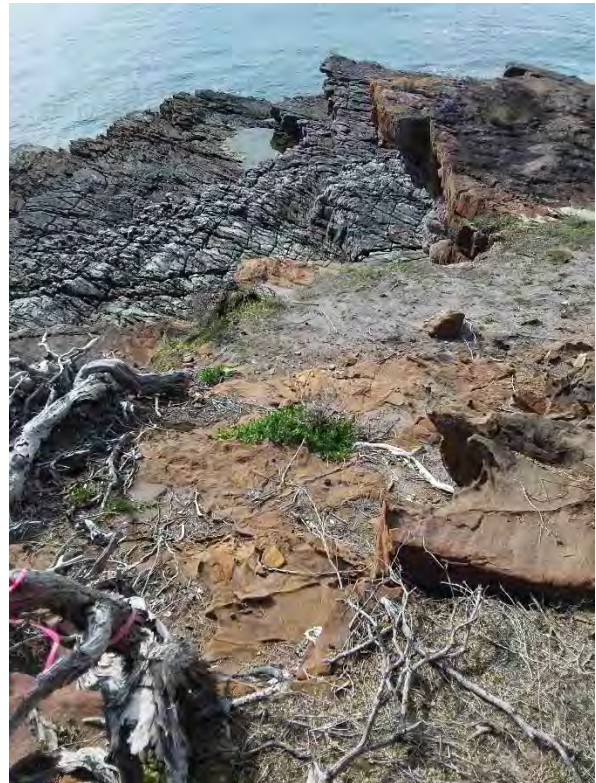
Work Section No.	99
Track Category	New Track
Length (m)	3
Cross Slope (%)	0 - 5
Vegetation	none
Gradient (%)	60
Substrate	bedrock
Geotech Assessment Recommended	yes
Descriptions/ Comments	Short descent down small ledge. Keep track away from cliff edge.
Recommended Work (Text Details)	Carve four steps or foot holds into small cliff to rock platform.
Chiselled step(900-1200x300x200mm) (ea.)	3

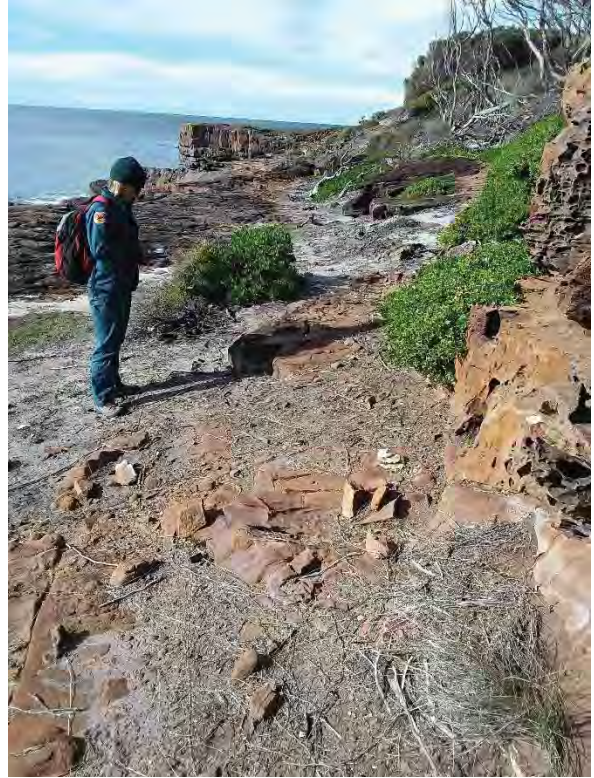
Work Section No.	100
Track Category	New Track
Length (m)	23
Cross Slope (%)	10
Vegetation	none
Gradient (%)	0
Substrate	bedrock
Signage	Will need some stencilled arrows on bedrock to indicate route.
Geotech Assessment Recommended	yes
Descriptions/ Comments	Route follows bedrock. Small midden found.
Recommended Work (Text Details)	No work required.

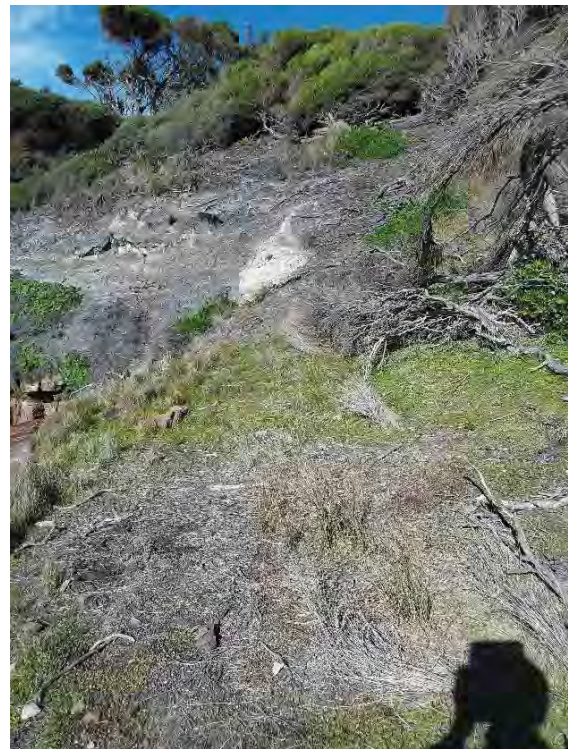
Work Section No.	101
Track Category	New Track
Length (m)	32
Cross Slope (%)	50
Vegetation	light
Gradient (%)	10
Substrate	soil, bedrock may be below surface
Descriptions/ Comments	Rock platform ends, start benching. Could reroute higher to avoid minor midden and carve step if necessary.
Recommended Work (Text Details)	Full benching, if bedrock found will need to chisel bench.
Chisel tread (Person Days)	3

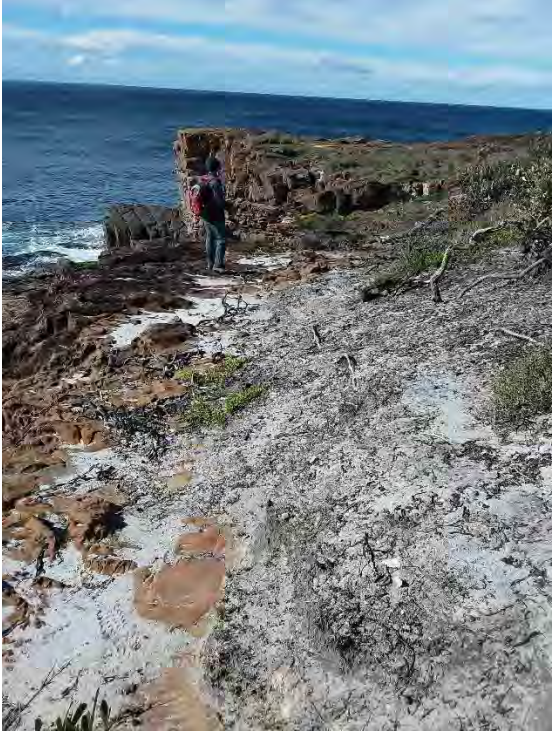
Work Section No.	102

Track Category	New Track	
Length (m)	14	
Cross Slope (%)	5	
Vegetation	none	
Gradient (%)	10	
Substrate	bedrock	
Signage	Will need some stencilled arrows on bedrock to indicate route.	
Descriptions/ Comments	Route follows bedrock.	
Recommended Work (Text Details)	No work required.

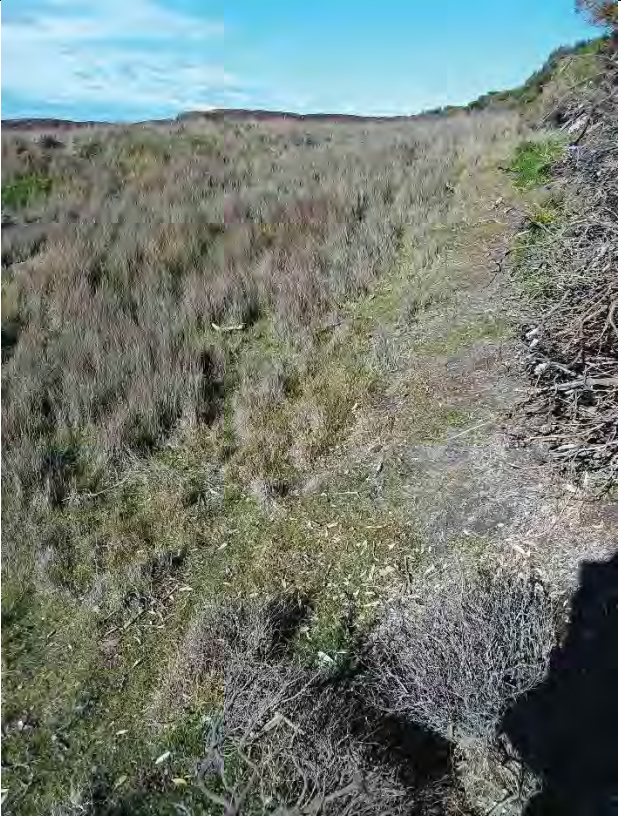
Work Section No.	103

Track Category	New Track	
Length (m)	23	
Cross Slope (%)	25	
Vegetation	grass	
Gradient (%)	10	
Substrate	soil	
Descriptions/ Comments	End bedrock, start short section of benching with gentle cross slope.	
Recommended Work (Text Details)	Light hand benching.	
Benching by hand (Person Days)	0.5

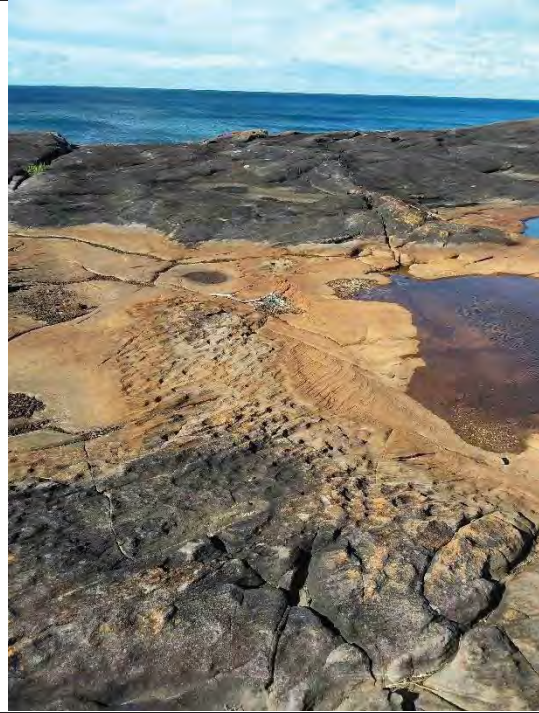
Work Section No.	104
Track Category	New Track
Length (m)	88
Cross Slope (%)	5
Vegetation	none
Gradient (%)	5
Substrate	bedrock
Descriptions/ Comments	End benching, start bedrock.
Recommended Work (Text Details)	No work required.

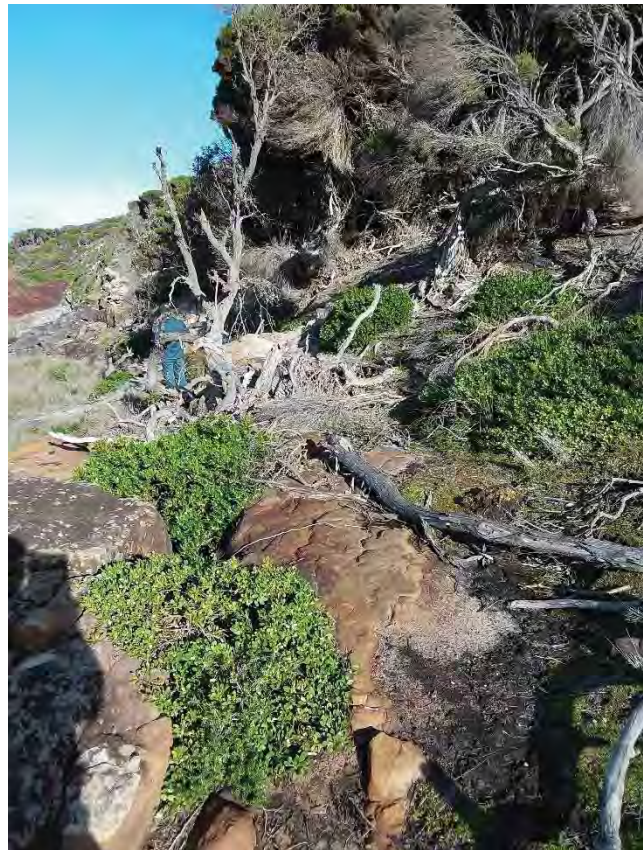
Work Section No.	105
Track Category	New Track
Length (m)	143
Cross Slope (%)	10 - 50
Vegetation	thick melaleuca
Gradient (%)	10
Substrate	Bedrock for first 7m then soil.
Descriptions/ Comments	Start alternative upper route - avoids fall height issues and need for stepping stones. Goes near site of collapsed cabin with asbestos material - will need to be professionally removed. Climbs and contours across steep cross slope. If machine benching, will have to fly digger in or access site from existing track.
Recommended Work (Text Details)	Machine benching - full bench.
Machine benching (m)	143
Clear vegetation (Person Days)	1

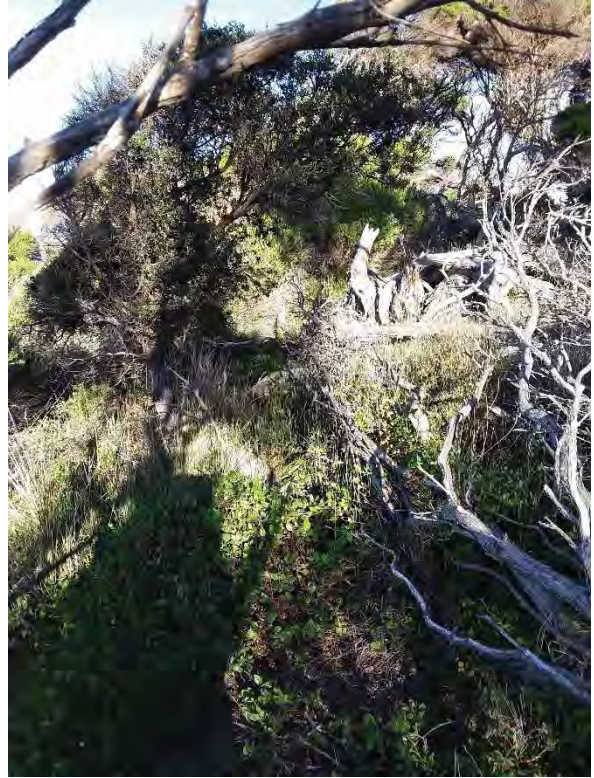
Work Section No.	106
Track Category	New Track
Length (m)	32
Cross Slope (%)	5
Vegetation	melaleuca
Gradient (%)	0 - 5
Substrate	soil
Descriptions/ Comments	End steep cross slope, start following cliff top. Site of collapsed cabin with tiles and asbestos found - will need to cost in removal of asbestos.
Recommended Work (Text Details)	Machine benching.
Machine benching (m)	32
Clear vegetation (Person Days)	0.25

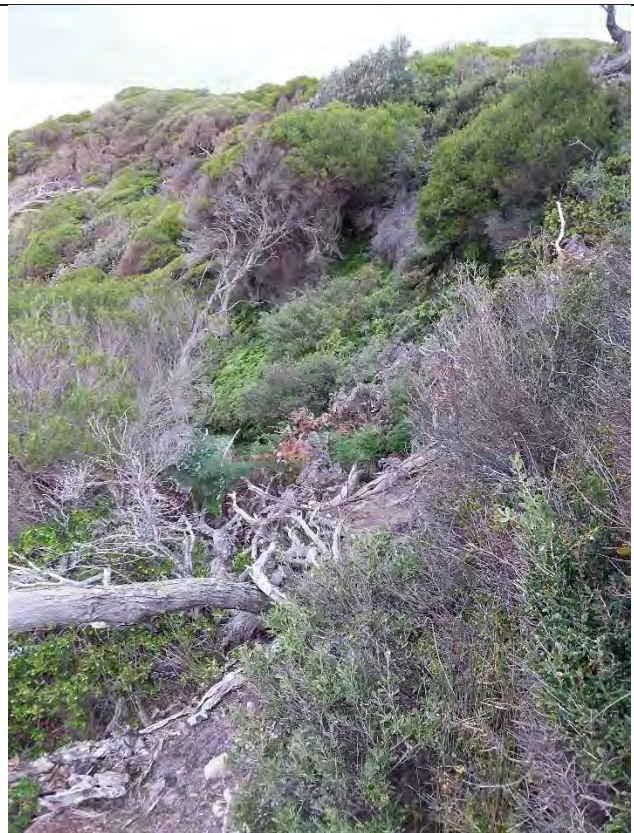
Work Section No.	107
Track Category	New Track
Length (m)	10
Cross Slope (%)	60
Vegetation	Thick scrub
Gradient (%)	10
Substrate	soil, some rock
Descriptions/ Comments	Start descending and contouring cross steep cross slope.
Recommended Work (Text Details)	Full benching by hand - cannot machine bench due to steep cross slope.
Machine benching (m)	10
Clear vegetation (Person Days)	0.1

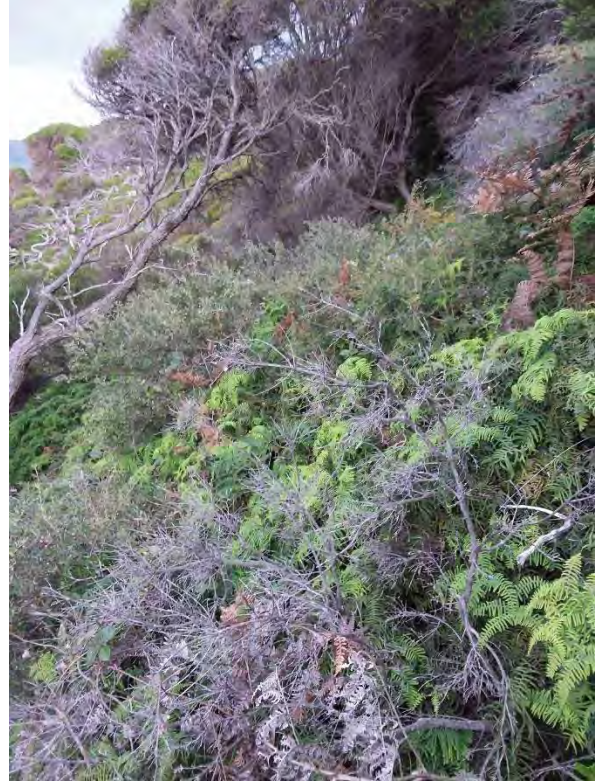
Work Section No.	108
Track Category	New Track
Length (m)	14
Cross Slope (%)	60
Vegetation	coral fern
Gradient (%)	10
Substrate	soil
Descriptions/ Comments	Route contours through damp section with coral fern.
Recommended Work (Text Details)	Install stepping stones. Fly in nearby local stone.
Stepping stones 1000x400x400mm (ea.)	13
Clear vegetation (Person Days)	0.1

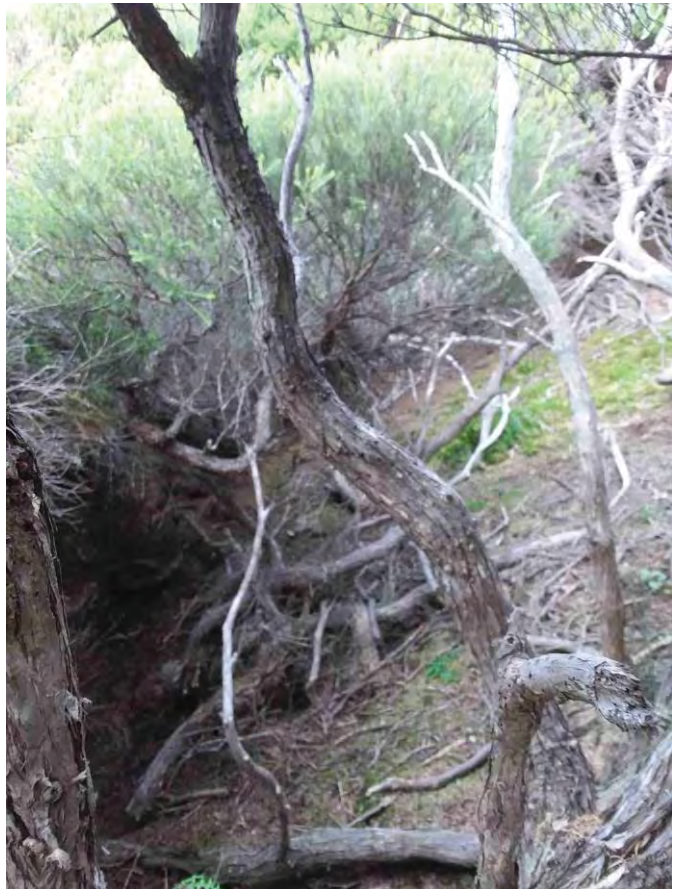
Work Section No.	109
Track Category	New Track
Length (m)	328
Cross Slope (%)	50
Vegetation	Thick melaleuca, open grassy area towards end of section.
Gradient (%)	10
Substrate	Soil - may be bedrock near surface in grassy area towards end of section.
Descriptions/ Comments	End coral fern. Continues contouring along cross slope. Avoid rock outcrop by going above.
Recommended Work (Text Details)	Full machine bench. Possibly chisel tread for 10m
Chisel tread (Person Days)	5
Machine benching (m)	328
Clear vegetation (Person Days)	3
