Ben Boyd National Park

Light to Light Walk

Recommended Alignment and Construction

TRACK AND TRAIL MANAGEMENT SERVICES PTY LTD

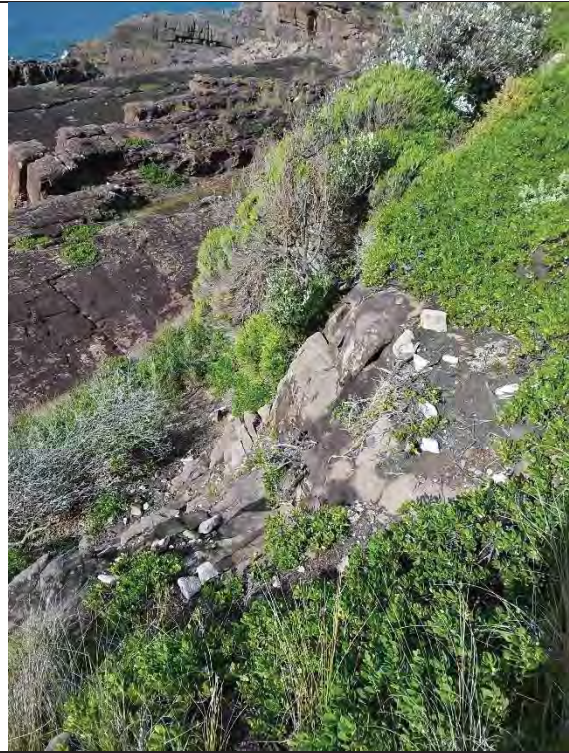
Work Section No.	110
Track Category	New Track
Length (m)	4
Cross Slope (%)	5
Vegetation	none
Gradient (%)	50
Substrate	bedrock
Descriptions/ Comments	Start descent down sloping bedrock.
Recommended Work (Text Details)	Tread is ok as is but could carve 9 foot holds to make more walker friendly.
Chisel tread (Person Days)	2

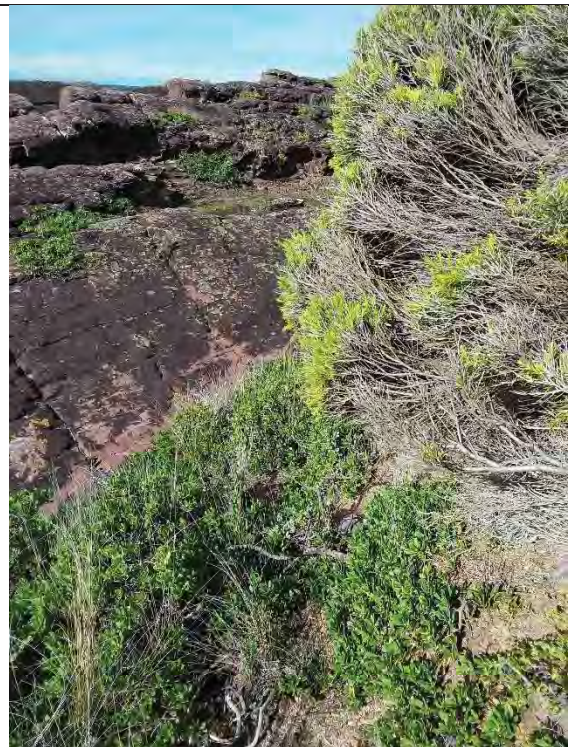
Work Section No.	111
Track Category	New Track
Length (m)	8
Cross Slope (%)	25
Vegetation	One tree to clear.
Gradient (%)	10
Substrate	soil
Descriptions/ Comments	Short section of benching.
Recommended Work (Text Details)	Hand bench.
Machine benching (m)	25
Clear vegetation (Person Days)	0.1

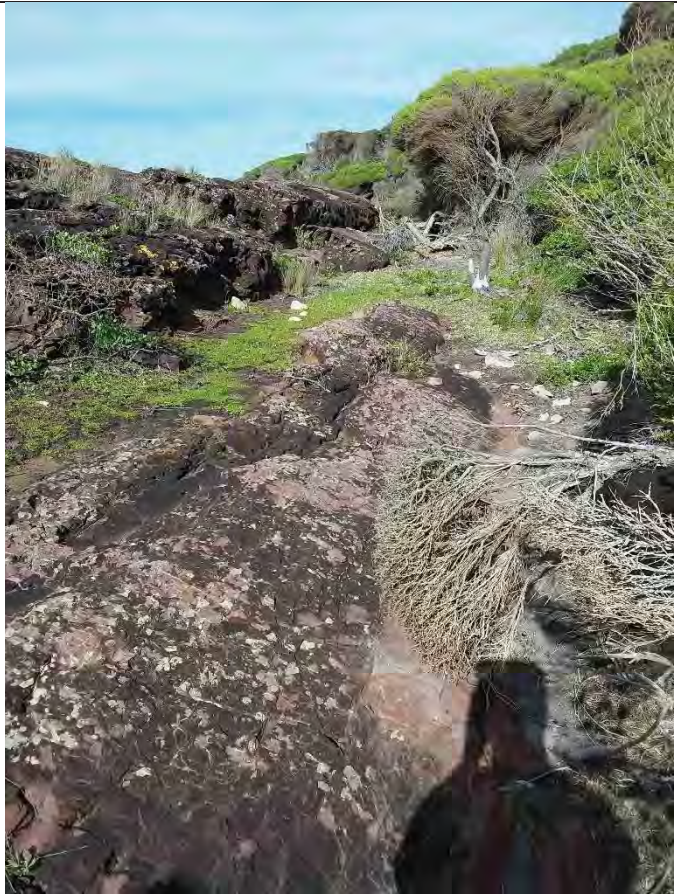
Work Section No.	112
Track Category	New Track
Length (m)	53
Cross Slope (%)	0 - 20
Vegetation	none
Gradient (%)	5 - 20
Substrate	bedrock
Signage	Will need some stencilled arrows on bedrock to indicate route.
Descriptions/ Comments	Route follows bedrock.
Recommended Work (Text Details)	No work required.

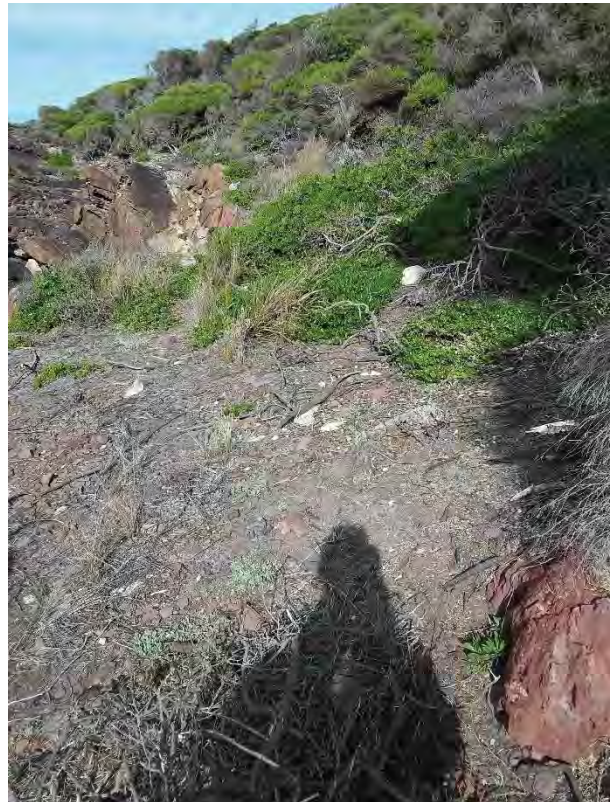
Work Section No.	113
Track Category	New Track
Length (m)	21
Cross Slope (%)	10 - 30
Vegetation	Light to medium bushes.
Gradient (%)	10
Substrate	soil
Geotech Assessment Recommended	yes
Descriptions/ Comments	Route leaves bedrock and contours along slope. May need to move route up slope slightly to keep away from cliff edge.
Recommended Work (Text Details)	Hand bench.
Benching by hand (Person Days)	1

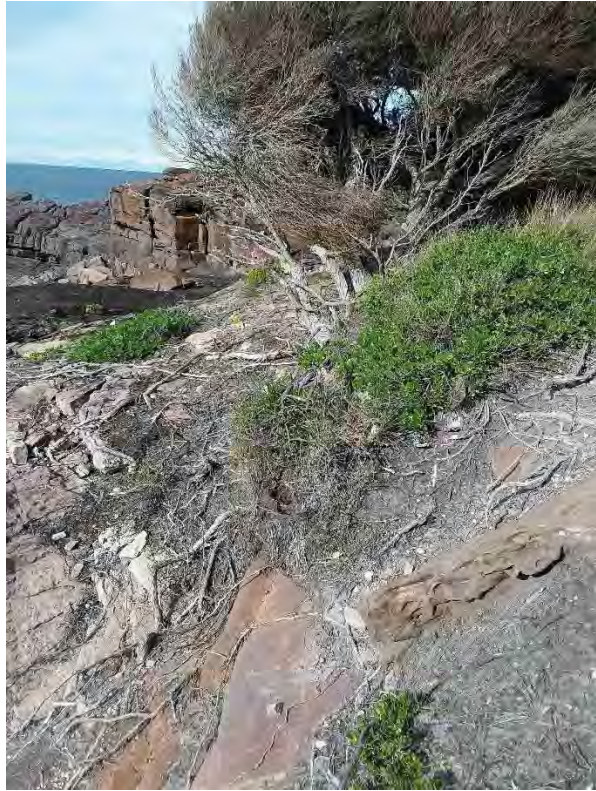
Work Section No.	114
Track Category	New Track
Length (m)	10
Cross Slope (%)	25
Vegetation	melaleuca bushes
Gradient (%)	10
Substrate	Shallow soil with bedrock underneath.
Geotech Assessment Recommended	yes
Descriptions/ Comments	Route goes over shallow soil and bedrock.
Recommended Work (Text Details)	Carve tread.
Excavate/chisel footing - (Person Days)	1
Clear vegetation (Person Days)	0.1

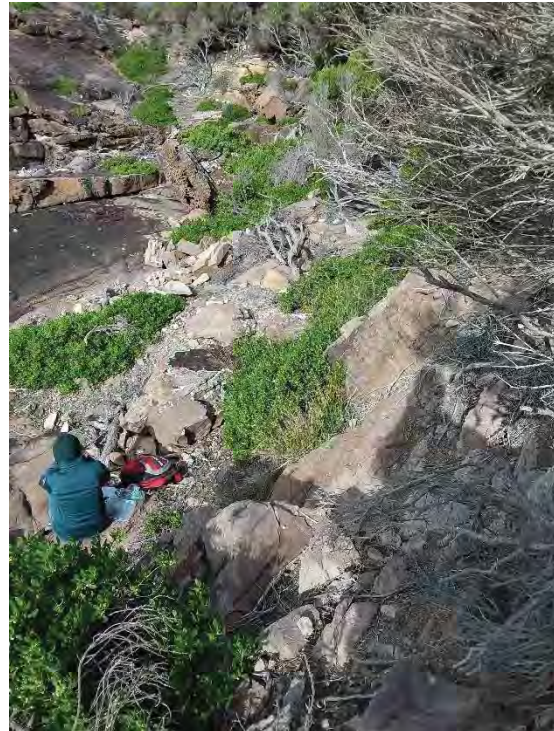
Work Section No.	115
Track Category	New Track
Length (m)	5
Cross Slope (%)	25
Vegetation	light
Gradient (%)	50
Substrate	crumbly bedrock
Signage	Will need some stencilled arrows on bedrock to indicate route.
Descriptions/ Comments	Route drops down low escarpment.
Recommended Work (Text Details)	Carve steps.
Chiselled step(900-1200x300x200mm) (ea.)	8

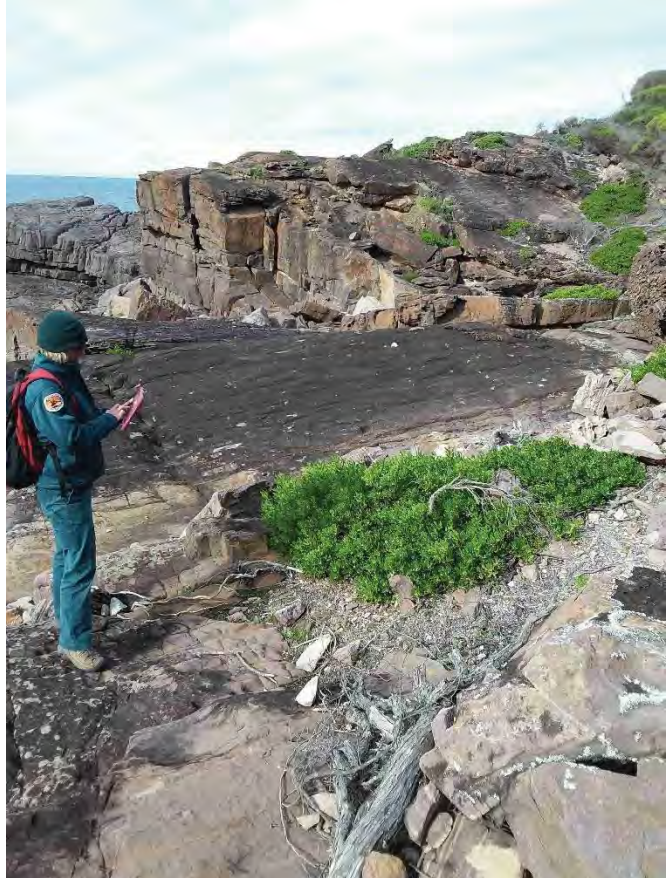
Work Section No.	116
Track Category	New Track
Length (m)	131
Cross Slope (%)	5
Vegetation	none
Gradient (%)	10
Substrate	Bedrock with some patches of soil and boulders.
Signage	Will need some stencilled arrows on bedrock to indicate route.
Descriptions/ Comments	Route follows bedrock.
Recommended Work (Text Details)	Will need some light benching on small sections of soil and some boulder moving and chiselling to define track.
Stone work - (Person Days)	0.5
Chisel tread (Person Days)	4
Benching by hand (Person Days)	0.5

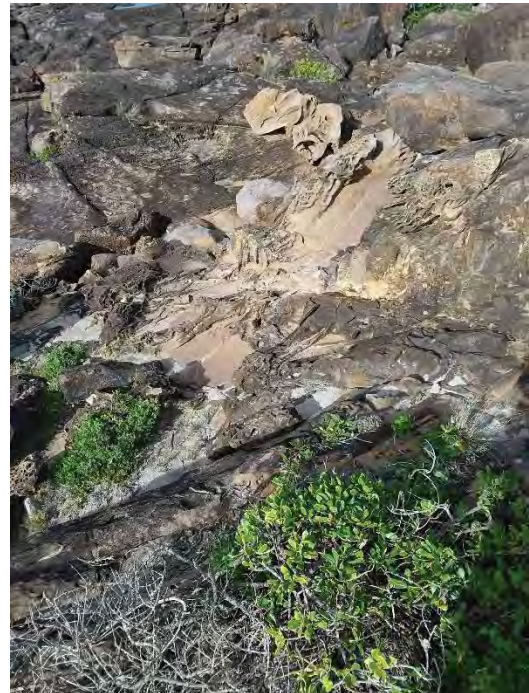
Work Section No.	117
Track Category	New Track
Length (m)	5
Cross Slope (%)	30
Gradient (%)	40
Substrate	bedrock
Signage	Will need some stencilled arrows on bedrock to indicate route.
Descriptions/ Comments	Route goes down sloping uneven bedrock.
Recommended Work (Text Details)	Chisels steps.
Chiselled step(900-1200x300x200mm) (ea.)	7

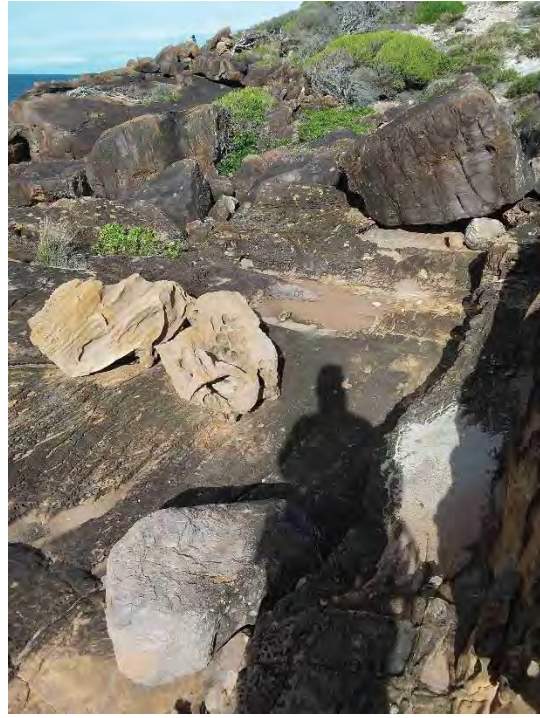
Work Section No.	118
Track Category	New Track
Length (m)	15
Cross Slope (%)	0 - 25
Vegetation	none
Gradient (%)	10
Substrate	bedrock
Signage	Will need some stencilled arrows on bedrock to indicate route.
Descriptions/ Comments	Route follows bedrock.
Recommended Work (Text Details)	Clear boulders to define track.
Stone work - (Person Days)	6

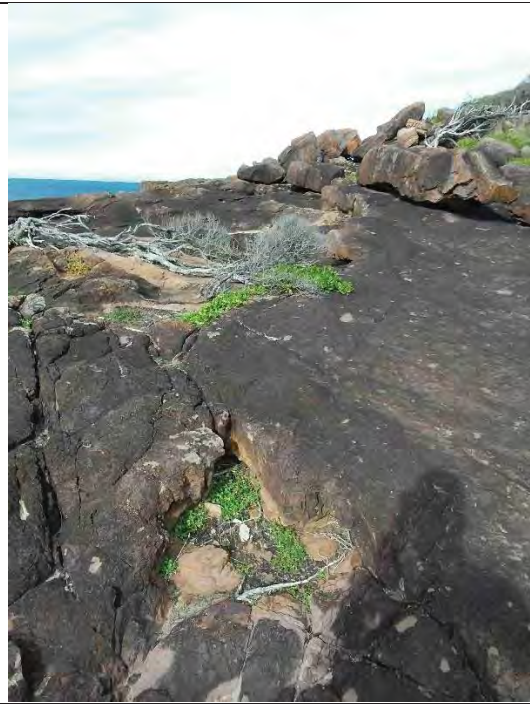
Work Section No.	119
Track Category	New Track
Length (m)	21
Cross Slope (%)	5
Vegetation	none
Gradient (%)	25
Substrate	bedrock
Signage	Will need some stencilled arrows on bedrock to indicate route.
Descriptions/ Comments	Route follows bedrock.
Recommended Work (Text Details)	No work required.

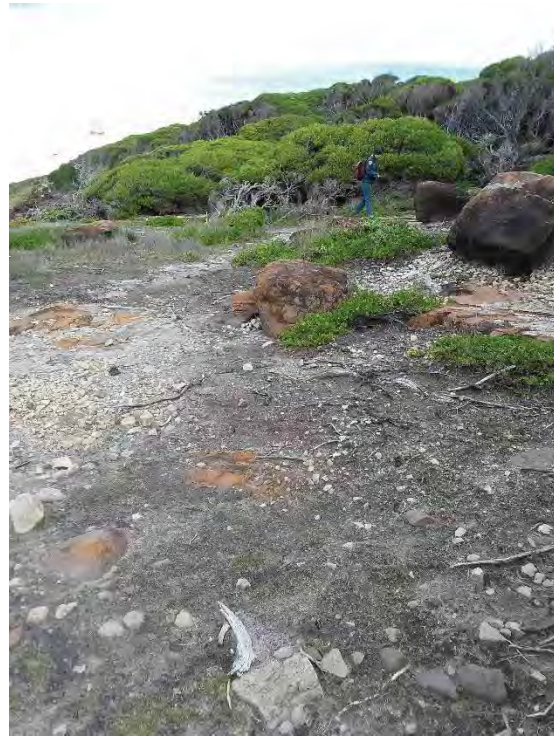
Work Section No.	120
Track Category	New Track
Length (m)	32
Cross Slope (%)	5
Vegetation	Patch of melaleuca.
Gradient (%)	10
Substrate	soil and bedrock
Signage	Will need a marker to indicate exit from coastal platform.
Descriptions/ Comments	Route starts climbing away from coast through melaleuca.
Recommended Work (Text Details)	Light machine benching.
Machine benching (m)	32
Clear vegetation (Person Days)	0.2

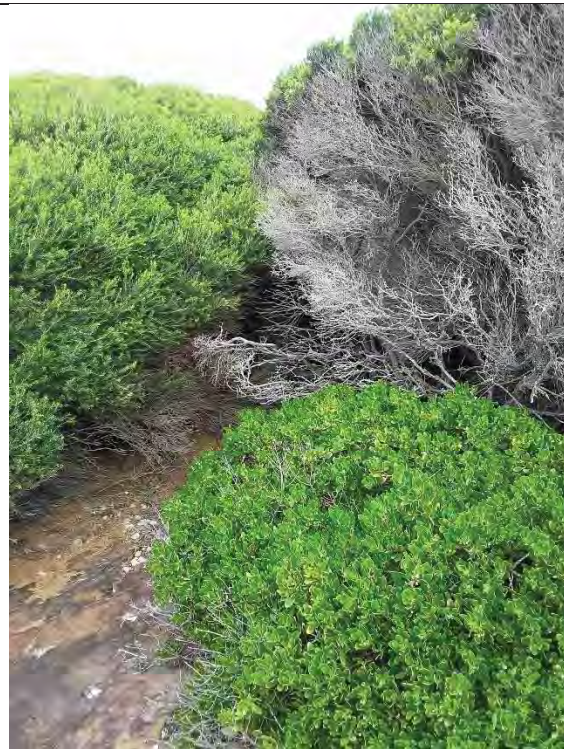
Work Section No.	121
Track Category	New Track
Length (m)	55
Cross Slope (%)	35 -50
Vegetation	Thick melaleuca
Gradient (%)	10
Substrate	soil
Descriptions/ Comments	Contours and climbs cross steep cross slope.
Recommended Work (Text Details)	Machine benching.
Machine benching (m)	55
Clear vegetation - person days.	0.5

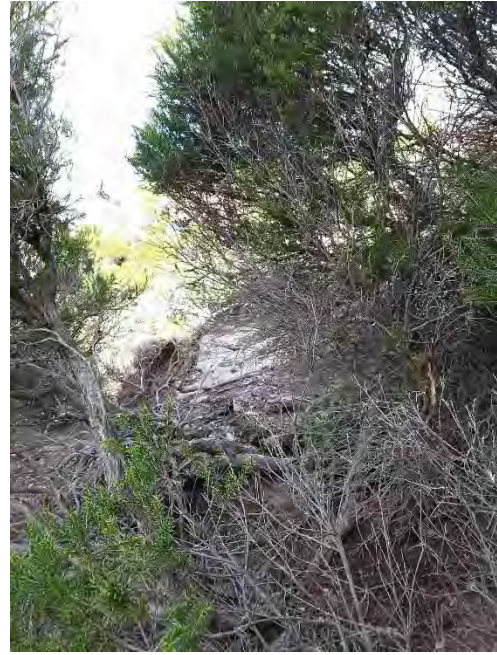
Work Section No.	122
Track Category	New Track
Length (m)	21
Cross Slope (%)	45
Vegetation	Thick melaleuca
Gradient (%)	10
Substrate	bedrock with some soil
Descriptions/ Comments	Route crosses patch of bedrock.
Recommended Work (Text Details)	Chisel tread.
Chisel tread (Person Days)	7
Clear vegetation - person days.	0.2

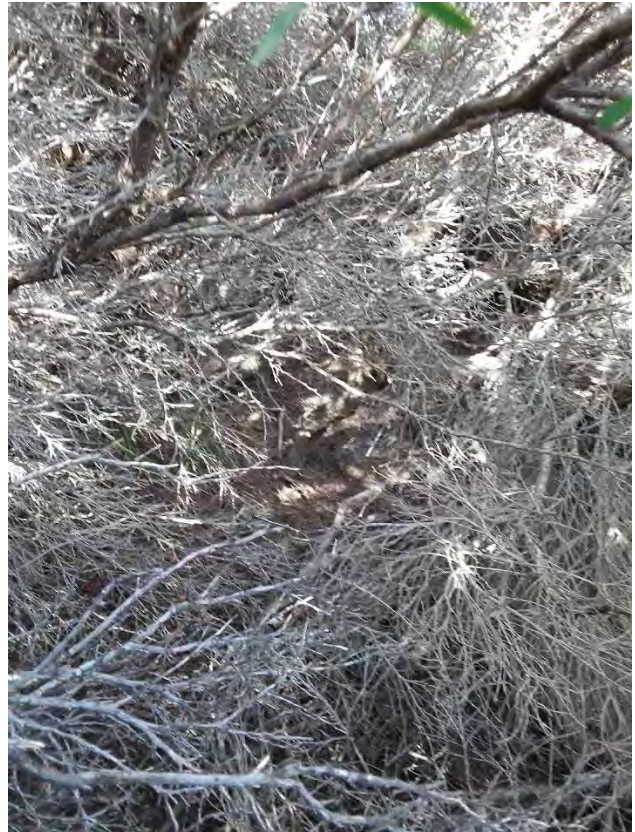
Work Section No.	123
Track Category	New Track
Length (m)	120
Cross Slope (%)	20 - 50
Vegetation	Thick melaleuca
Gradient (%)	10
Substrate	soil
Descriptions/ Comments	Route continues contouring along slope to arrive at lighthouse complex. Can adjust route to that marked to improve separation from lighthouse and optimize coastal views.
Recommended Work (Text Details)	Machine benching.
Machine benching (m)	120
Clear vegetation (Person Days)	1

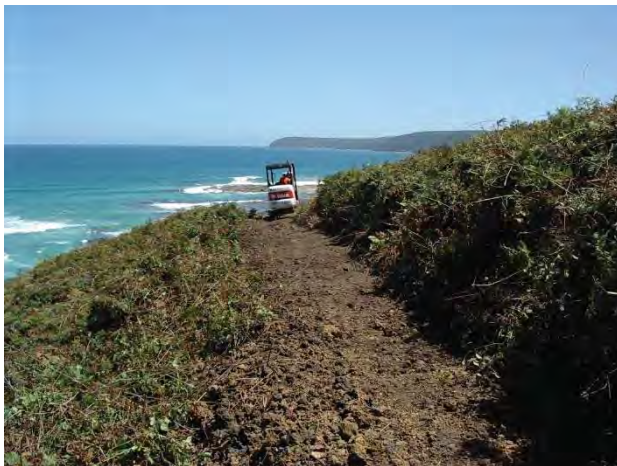
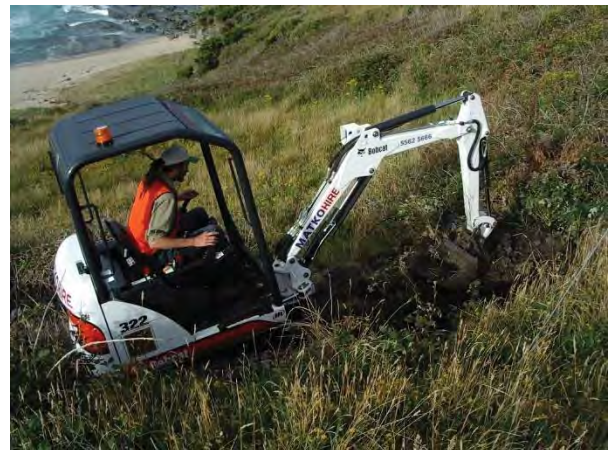
The majority of the new track alignment can be built by mini excavator. It is recommended that track width by maximum of 800mm. Mini excavators with vehicle width of one metre or less are recommended to minimise the tendency to build to the width of the excavator. Page 114 of the NPWS Parks Facilities Manual 5.3.1 Standard Track Profiles should be used as a guide in new track formation.

Typical small excavator suitable for walking track construction

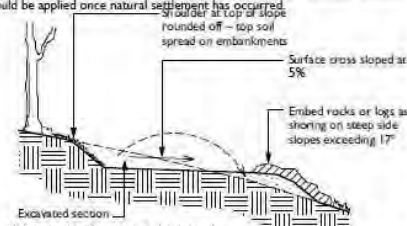
Park Facilities Manual
5.3 Tracks

Built up

Refurbish eroding track

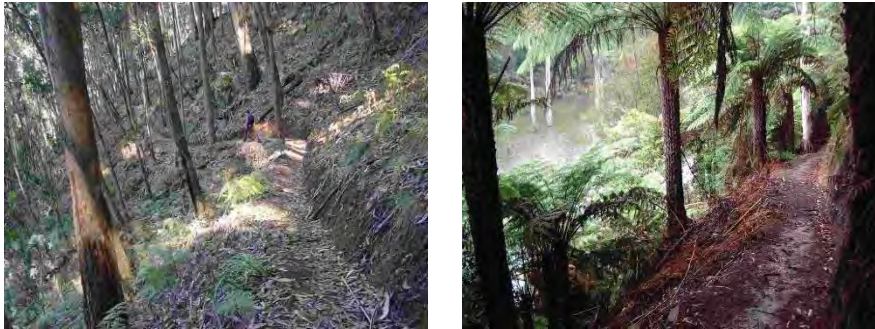
Hand benching is recommended on steep cross slopes, where it may be impractical to use a mini-excavator. All hand benching should be a full bench where the entire tread is benched into the hill slope. This means that the track surface is completely solid and is not partly using the excavated fill to form the track surface. The down slope fill batter should have cut vegetation pulled over it to reduce the short term bareness of the slope and will assist in vegetation re-establishing. The upslope cut batter should be shaped at an approximately uniform angle leaning back slightly into the slope. All exposed root material should be trimmed flush. The photos show two fully benched tracks on hill slopes greater than 25°.

Examples of full bench done by hand

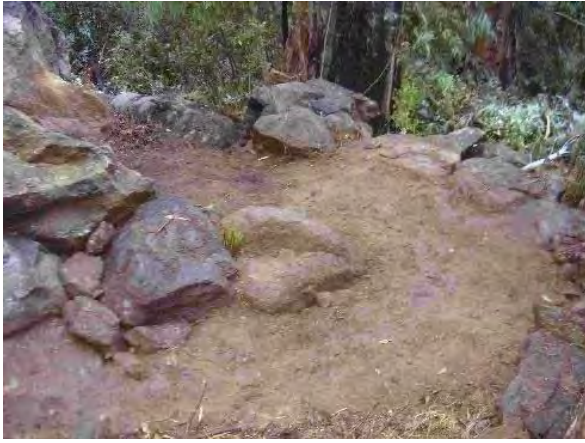
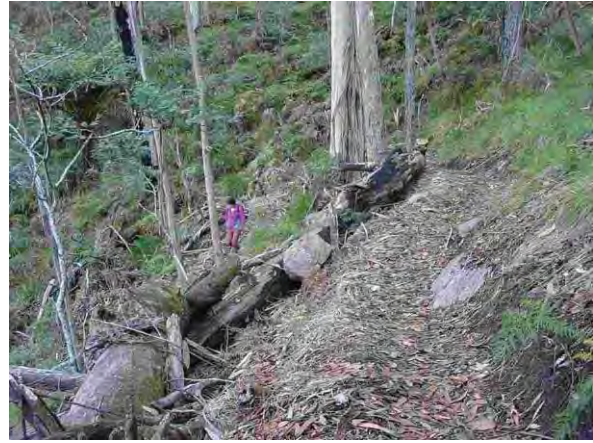
Climbing turns are built to change direction across the fall line without an abrupt change in direction. They do not require the construction of a platform, such as occurs in a switchback. They enable better separation of the upper and lower portions than a switch backed track. Climbing turns need a wide radius and require a grade dip or water bar just before turning directly through the fall line. Consideration needs to be made to site climbing turns to prevent shortcutting by using local features such as large trees or rock outcrops. If obstacles are not available manoeuvring logs or rocks to discourage shortcutting may be necessary.

Examples of climbing turns

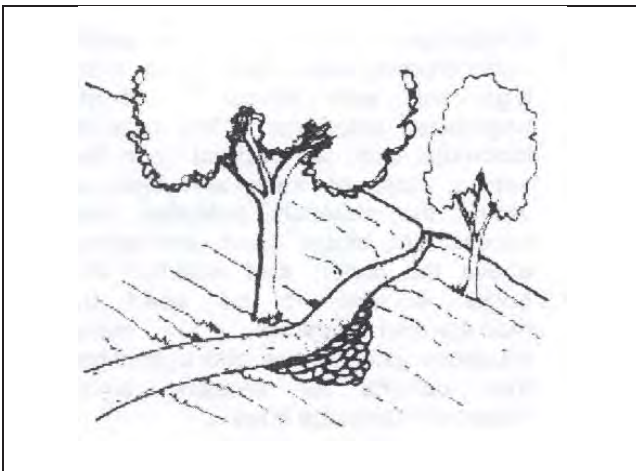
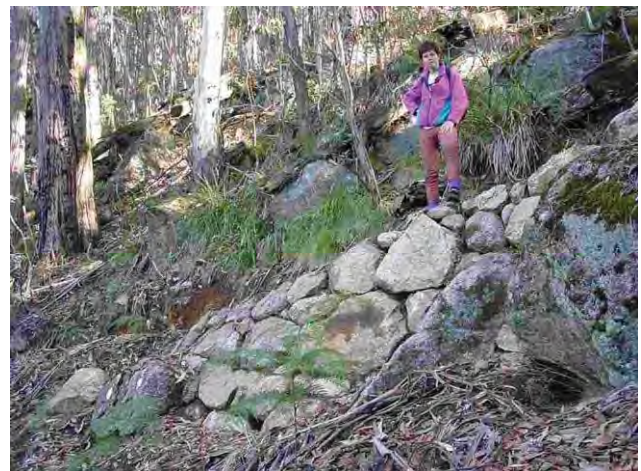
Retaining walls are built on the lower side of the track where slippage or erosion occurs. They are particularly useful when benching a track on a slope and it necessary to go around a large tree or boulder, which cannot be removed, and to go above or below would dramatically alter the track gradient. In areas of slippage they are also useful to build up the track edge to prevent it from collapsing down slope.

The best retaining walls are built from interlocking rock, which is constructed in an off-vertical manner (i.e. the wall leans into itself with the base being wider than its top). A strong foundation is required for a good retaining wall. The wall is backfilled with rubble and gravel/soil, which allows free drainage, preventing the build-up of water/moisture behind the wall, which could push it out. The diagram shows typical stone retaining wall around a large obstacle. The photo shows a retaining wall which was constructed around a rock outcrop.

Examples of rock retaining walls

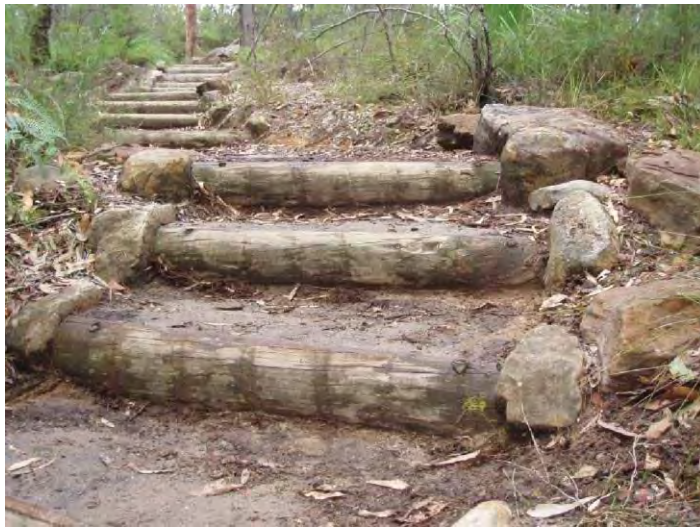
Timber steps have been recommended where the gradient is too steep for a graded surface. Page 96 of the NPWS Parks Facilities Manual 5.5.5 Steps and Stairways can be used as a guide for step construction. For the coast track the existing and new steps are recommended to be from half split tread pine rounds in preference to straight edged timber sleepers. The recommended dimensions are 900x200x100 with two pre-drilled holes for staking with galvanised pipe.

Example of half round TP timber steps
(Edge rocks seen here are not necessary on most of the Coast Track steps)

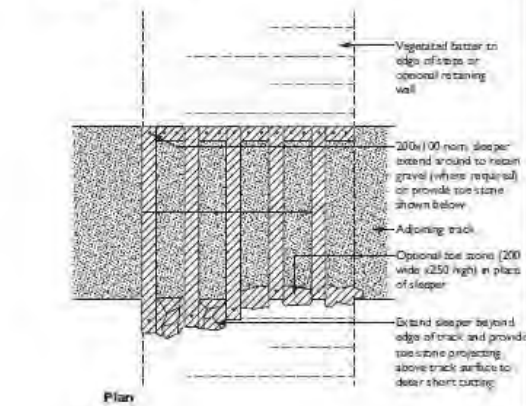
Plan

5.5.5 Sleeper

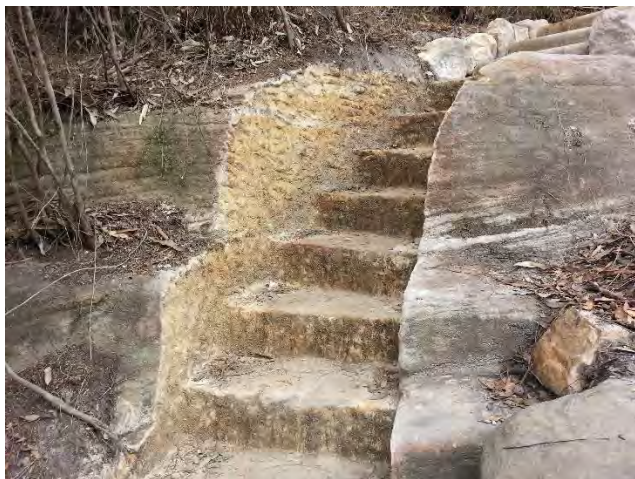
Where the track ascends over large boulder and rock slab surfaces, well planned and crafted rock chisel can form a stepped surface to safely ascend a potentially hazardous or awkward natural surface. Rock chiselling can avoid the need to install ugly and intrusive staircase or the expense and difficulty of building stone steps over a rock surface.

Chiselled steps in Ku-ring-Gai Chase NP

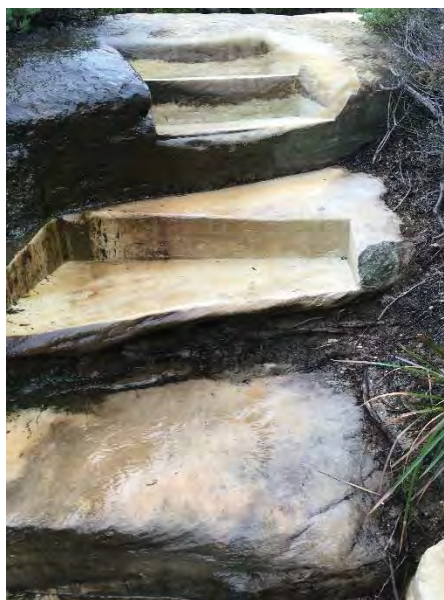
Chiselled steps in Royal NP

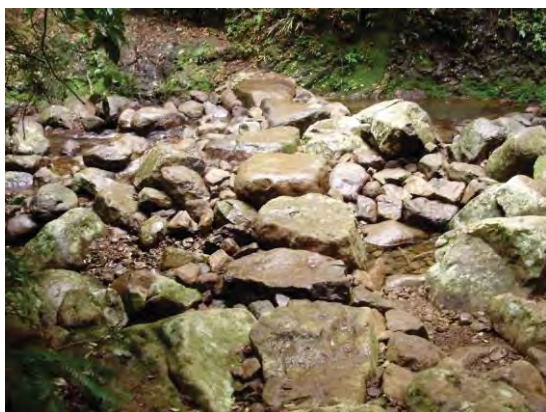
Rock inserted into a drainage line at regular intervals can form a pleasant and easy means to cross a shallow creek or poorly drained area via stepping stones.

Example of stepping stones through a creek which floods in Lamington NP, Qld

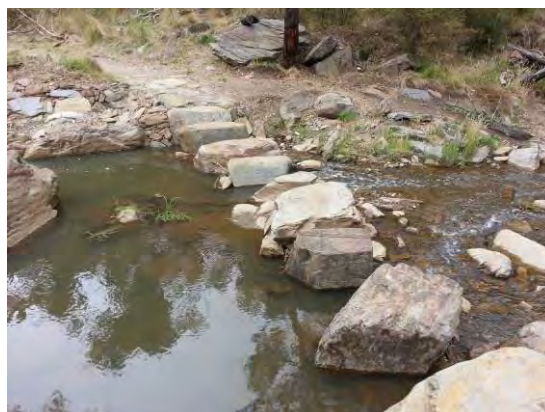
Stepping stones across an intermittent creek in Anakie Gorge, Victoria
